# Gabriel Commons

## Property Condition Assessment

3831-3897 SW Canby St., Oregon 97216

CBS Ref.: 16-045.00

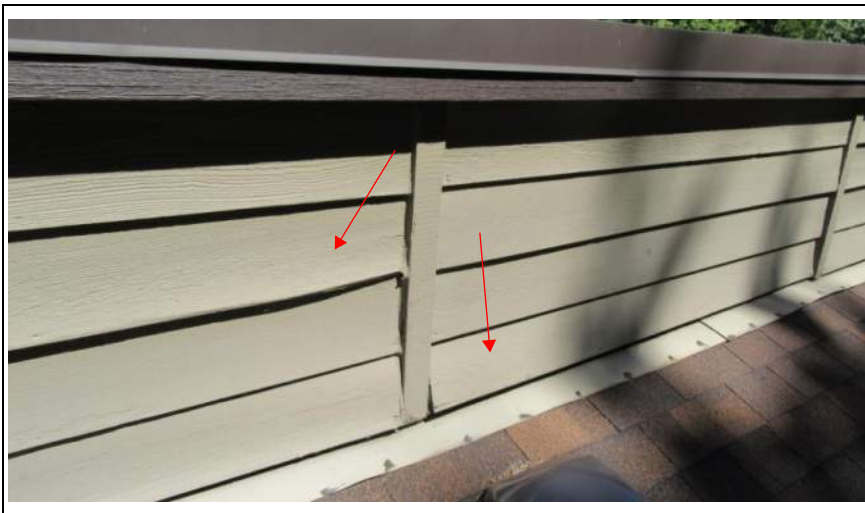
**Photo 34**

Typical head wall configuration.

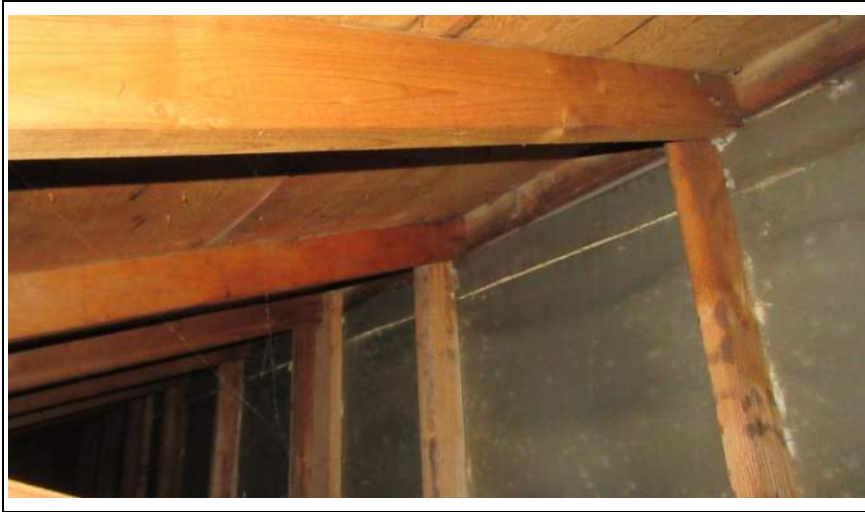
**Photo 36**

Gable walls, lap siding is installed as single-wall construction. The weather barrier was often damaged or deteriorated.

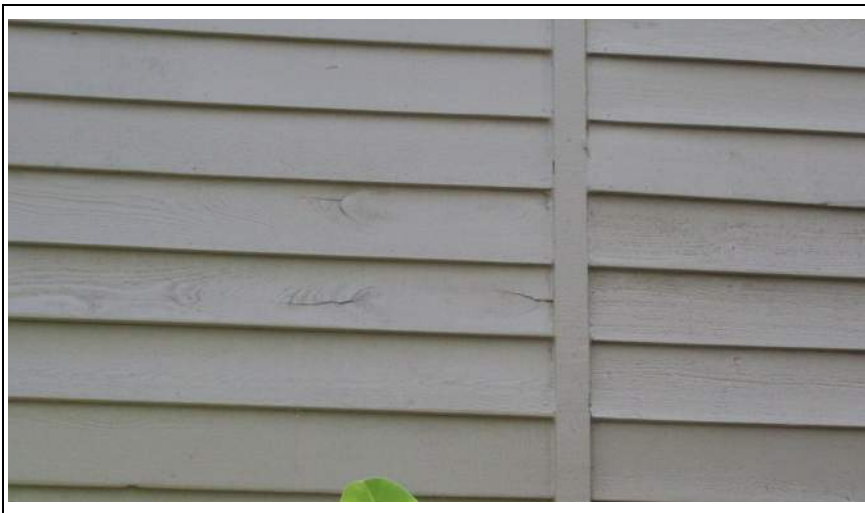
**Photo 40**

At side walls, T1-11 siding was lapped under the lap siding above to project the leading edge.

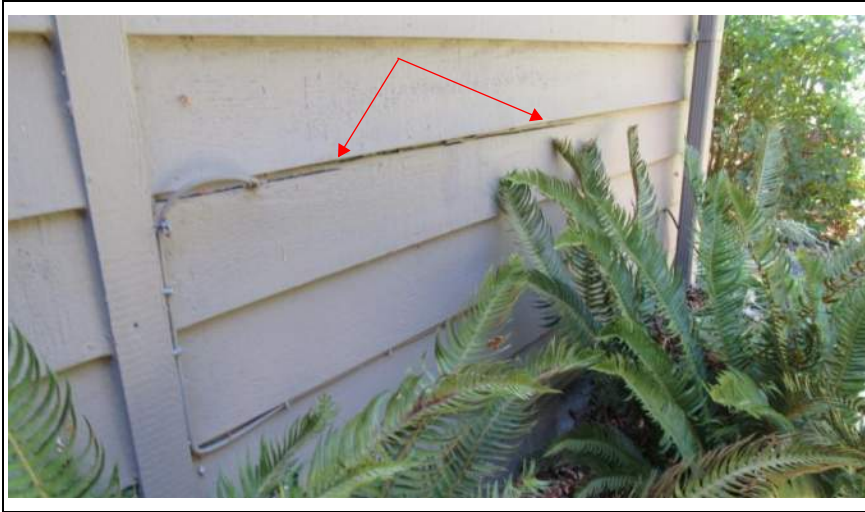
Warping of siding is creating open voids that can allow water ingress, which will further deteriorate the cladding.

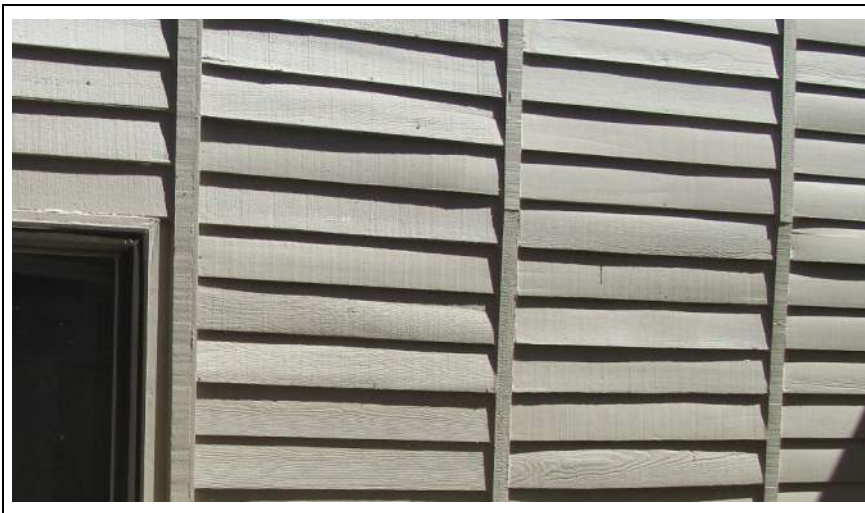
**Photo 43**

Cracked cedar siding was observed throughout the complex. Conditions like these create avenues for water intrusion.

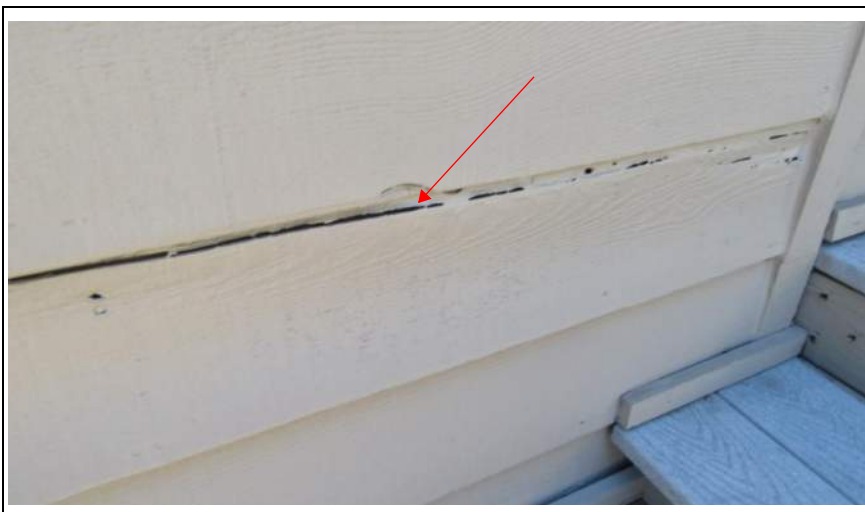
**Photo 44**

Irregularities in the wall surfaces created by aging siding.

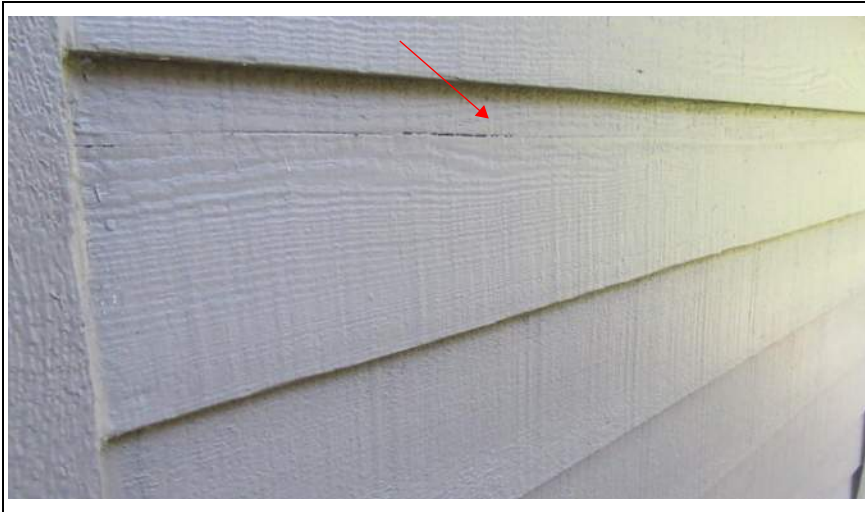
**Photo 45**

Typical crack in the beveled cedar siding.

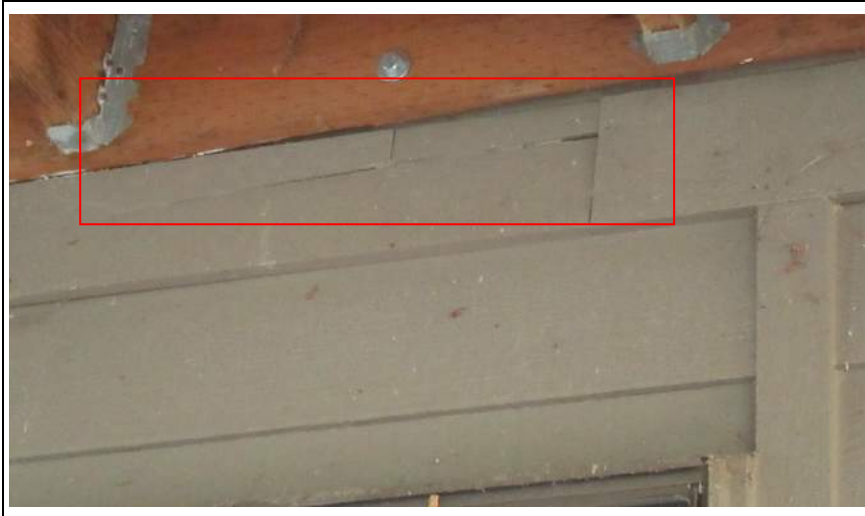
**Photo 46**

Typical crack in siding.

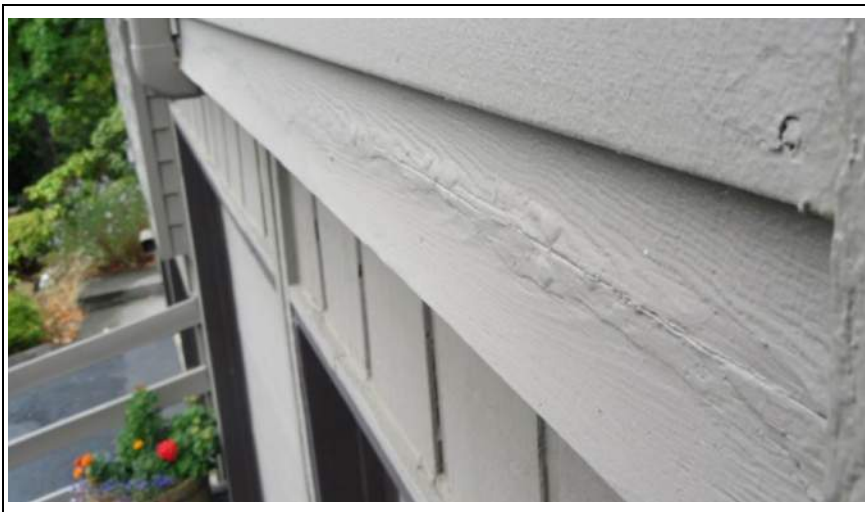
**Photo 47**

Damaged siding under the ledger.

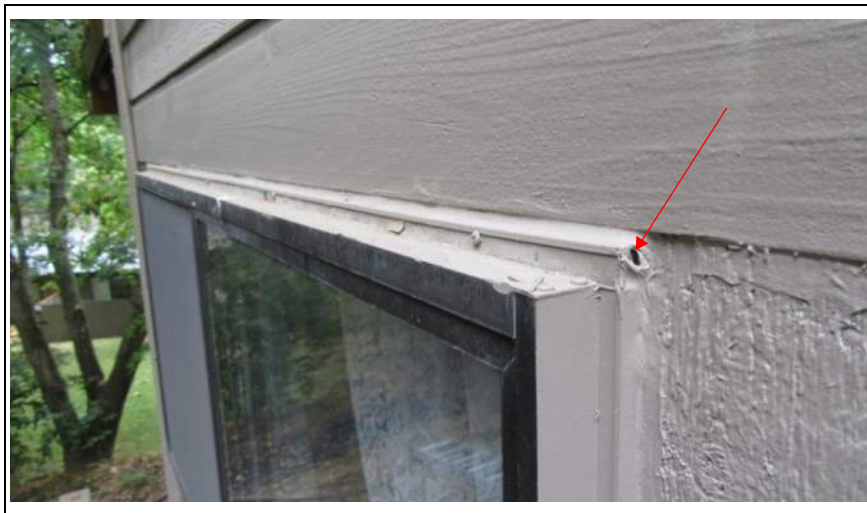
**Photo 49**

Replacement window with brick-mold trim around perimeter. Trim is not flashed and joint sealant had failed.

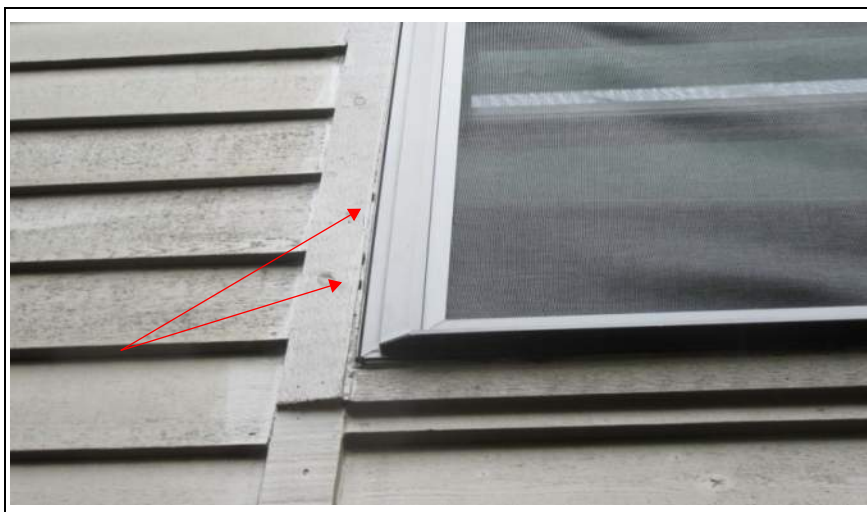
**Photo 50**

Typical jump-frame window. A replacement window has been installed within the frame of the original window and sealed at the perimeter. Sealant joints have failed, permitting water ingress.

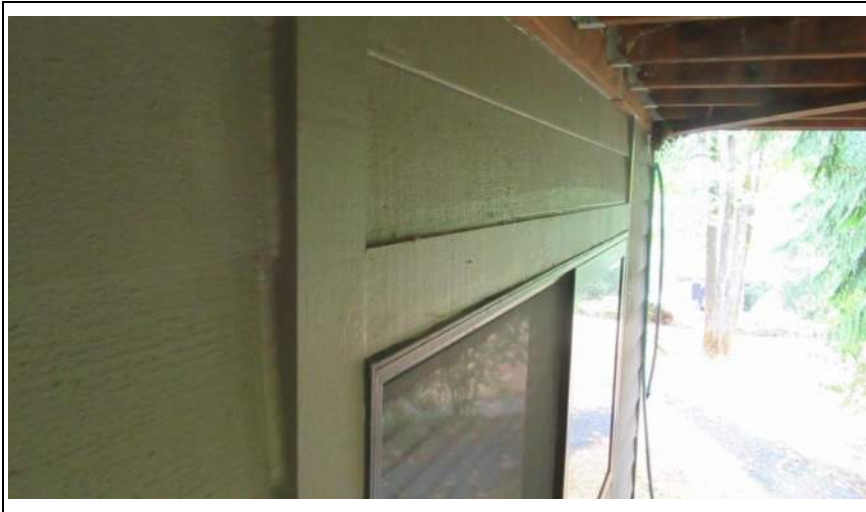
**Photo 51**

Typical joint sealant failure at window frames. Joint sealant requires a minimum of 3/8 in. width at a ratio of 2:1 to provide adequate dimension for proper performance.

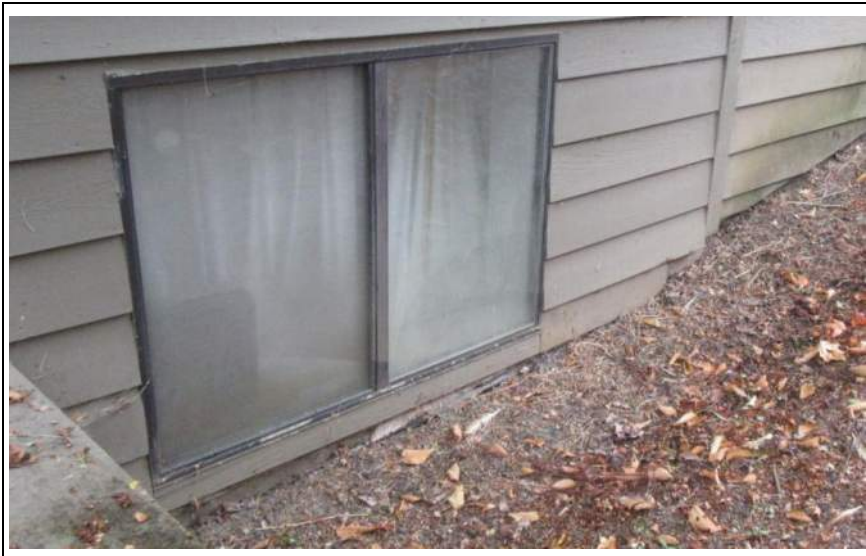
**Photo 52**

In most cases, head flashing is not provided above window heads or horizontal projecting trim.

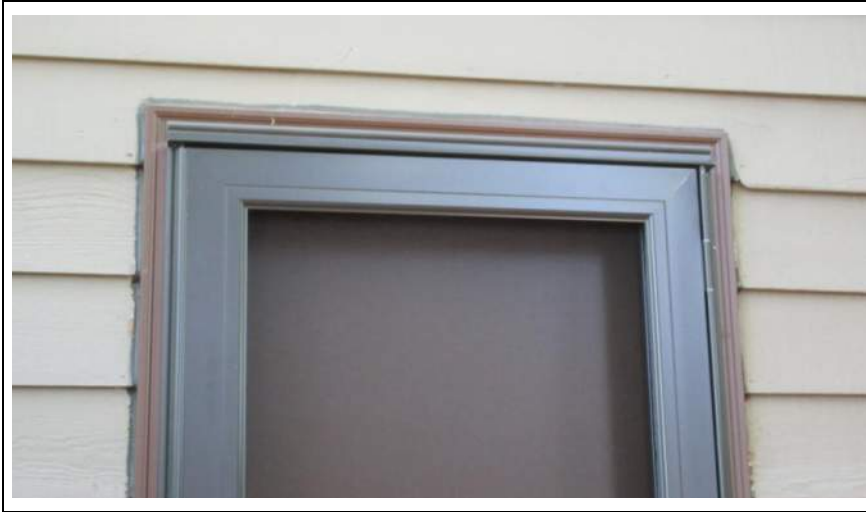
**Photo 54**

Newly replaced sliding glass door does not meet today's best practices. Sheet metal flashing is omitted and joint sealant was improperly applied.

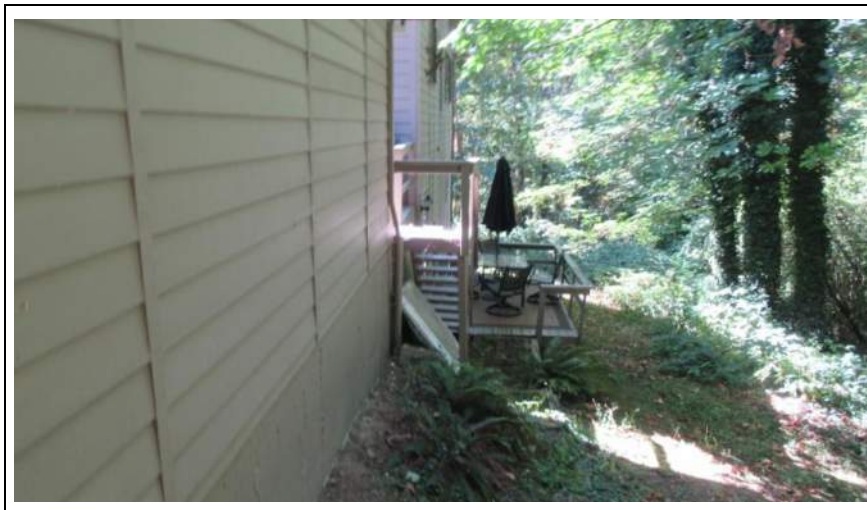
**Photo 58**

Vertical trims in the cladding assembly run continuously from top to bottom of the assembly. Sealant failure along that line can permit bulk water to enter the cladding assembly.

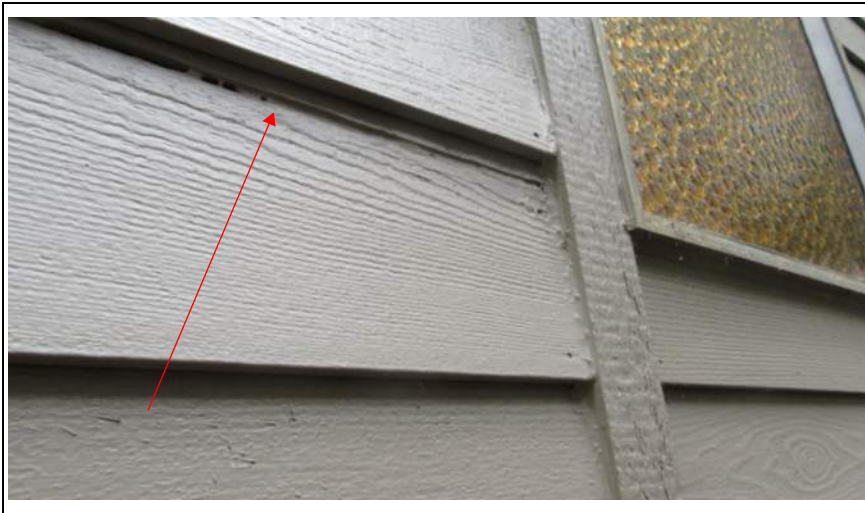
**Photo 61**

Where siding is cupping, small voids in the cladding assembly are formed, that can permit water entry.

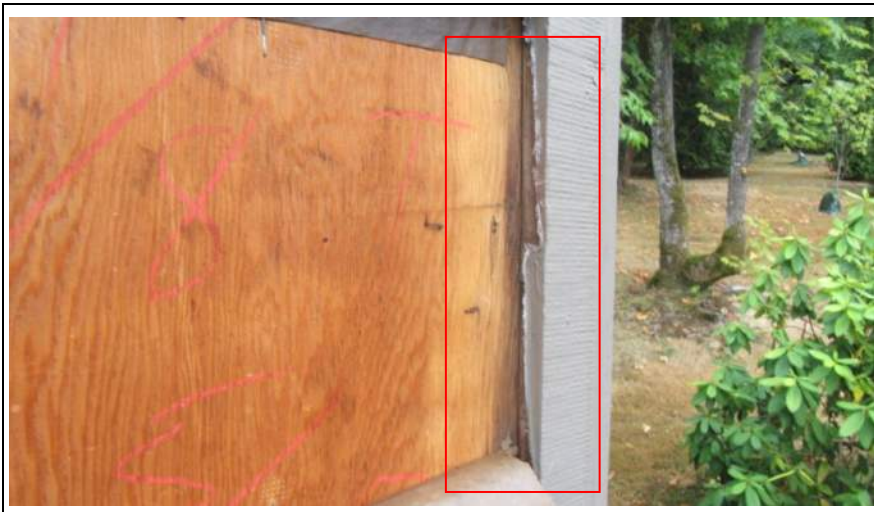
**Photo 62**

Cracked siding near vertical trim creates additional avenues for water intrusion.

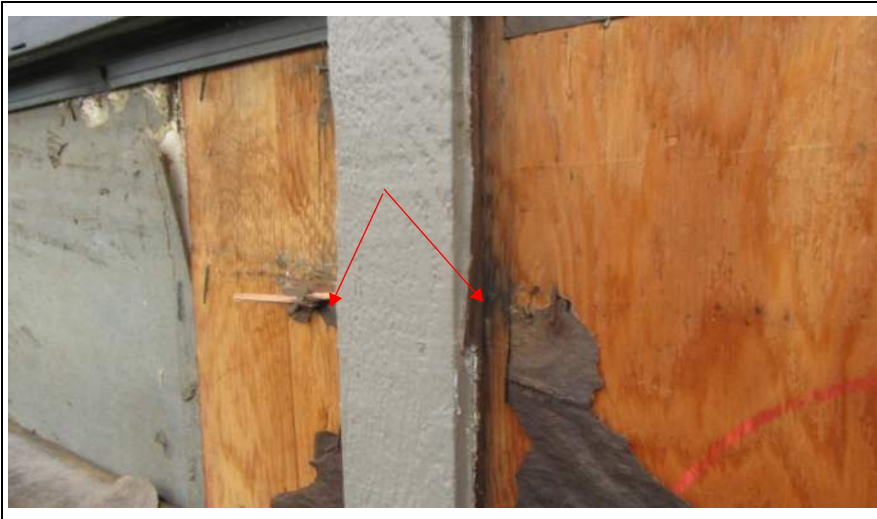
**Photos 63**

Invasive openings indicated that vertical trim locations are permitting water ingress.

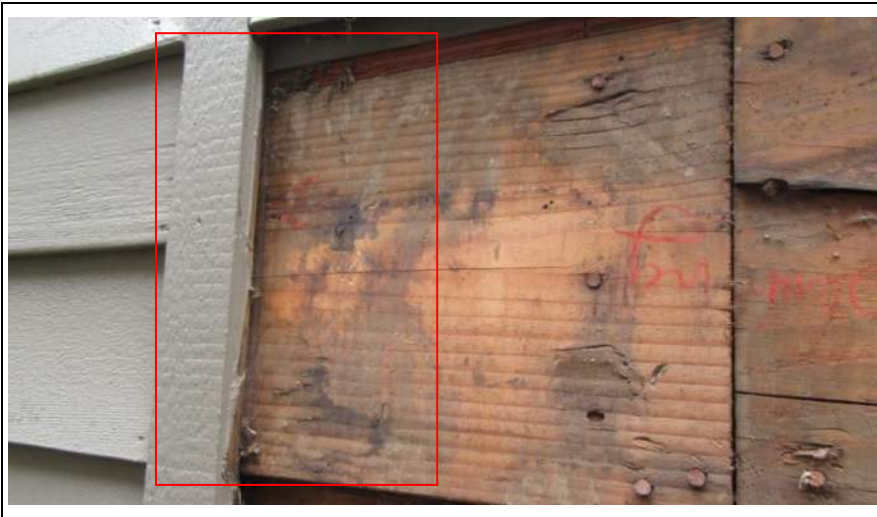
**Photo 64**

Typical staining on wall sheathing at vertical trim locations.

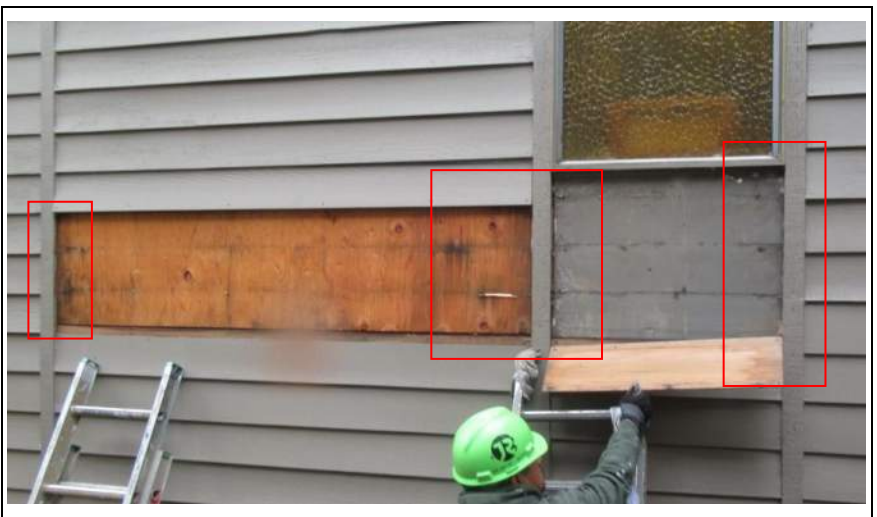
**Photos 65**

At floor lines, stud framing is becoming exposed. Additionally, water can migrate behind the gypsum sheathing into the stud cavities at these locations.

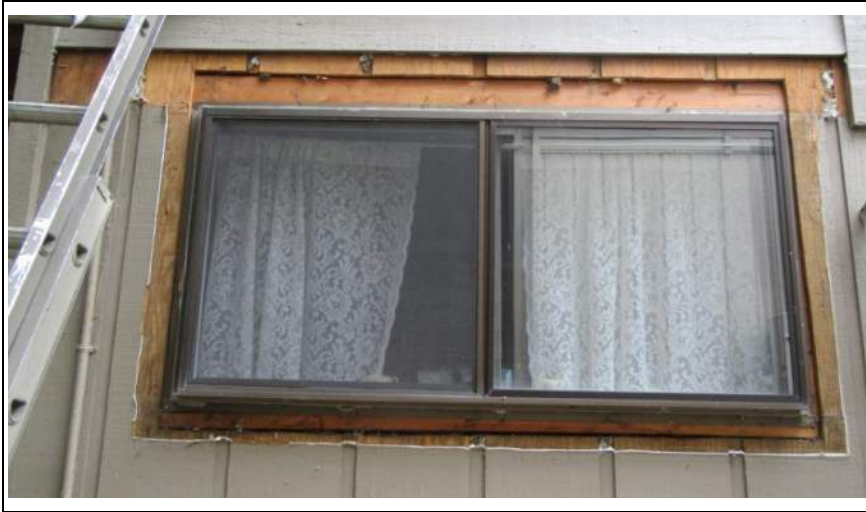
**Photo 66**

Water staining clearly shows water is entering at the vertical trim and migrating along the top edge of the beveled siding.

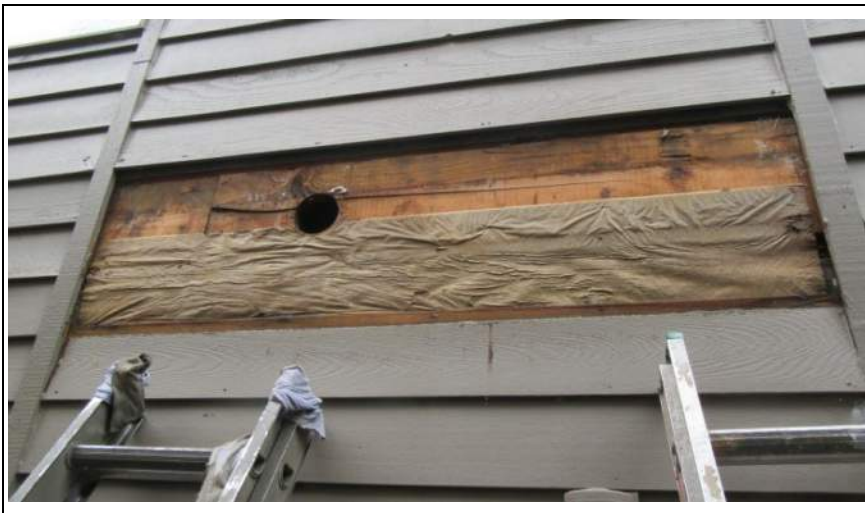
**Photo 70**

Weather barrier present well below the window, where water ingress at the window or above will migrate behind the paper and become trapped.

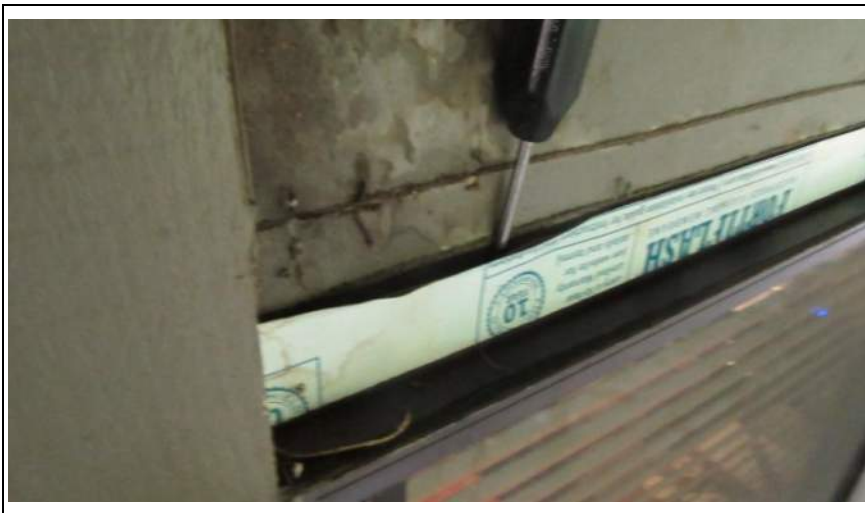
**Photo 82**

Jump-framed window not installed to mitigate air leakage.

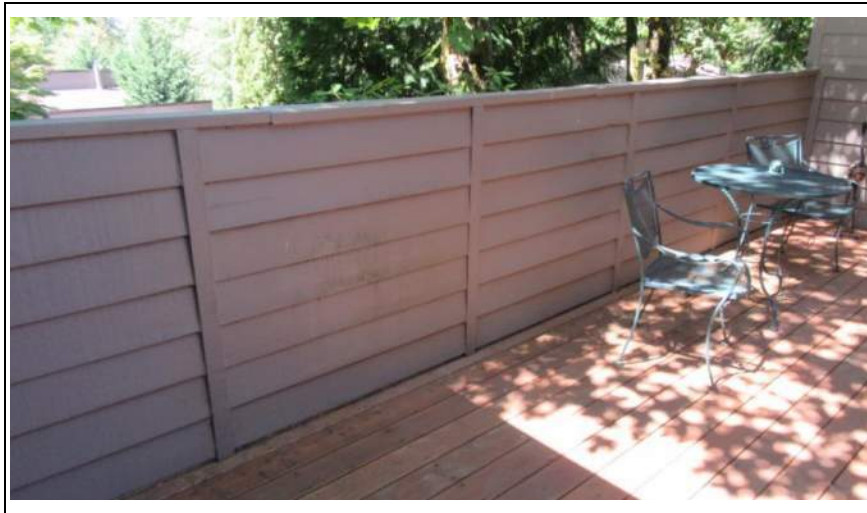
**Photo 88**

Typical guard wall assembly. The horizontal surface consists of wood and is not protected by sheet metal flashing. Organic growth and warped, or otherwise damaged siding, was typical.

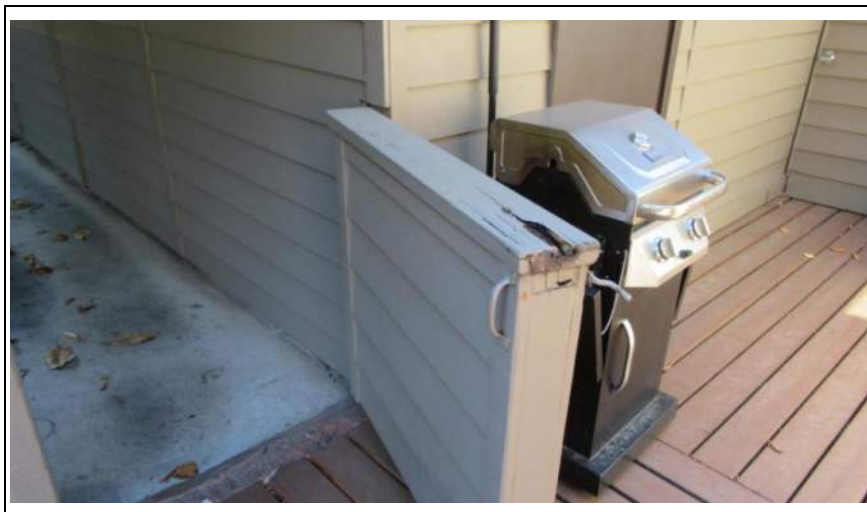
**Photo 89**

Typical guard wall condition. Water intrusion likely at joints in the wood cap. Further investigation recommended.

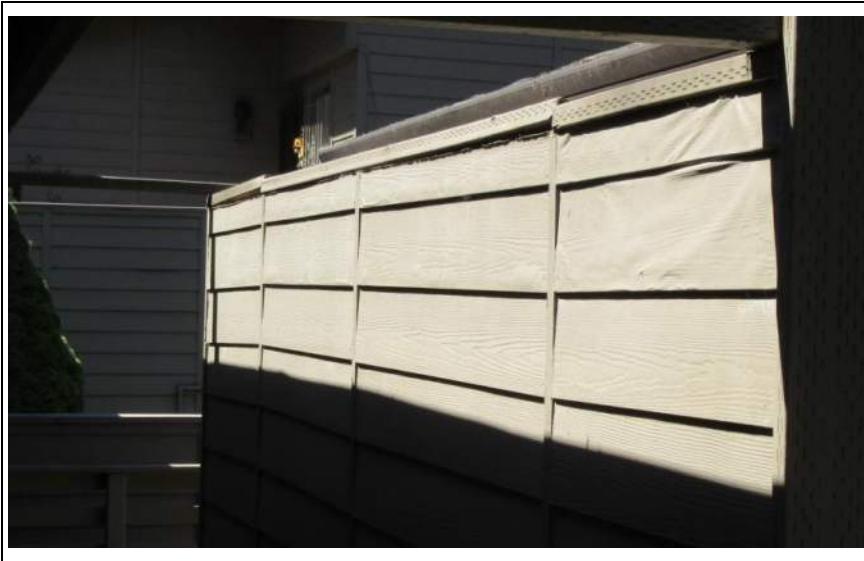
**Photo 90**

Typical damage to wood guard wall cap.

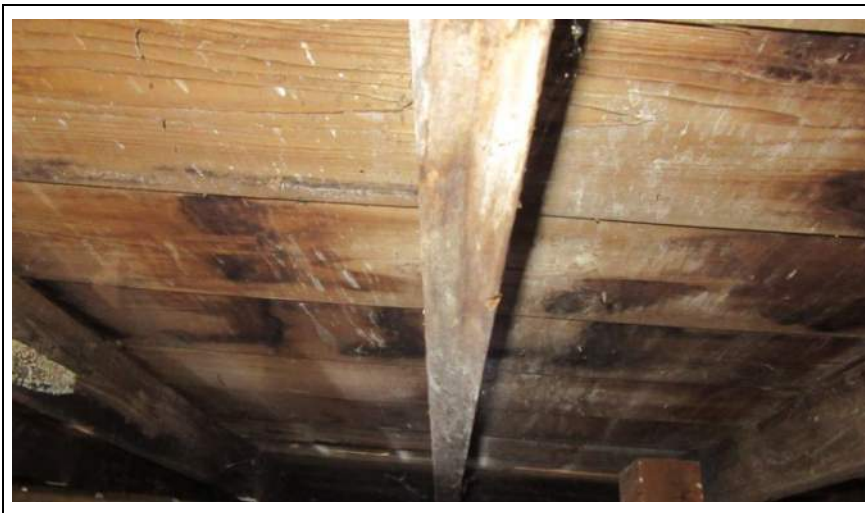
**Photo 94**

Typical joints, such as this, are prone to water intrusion.

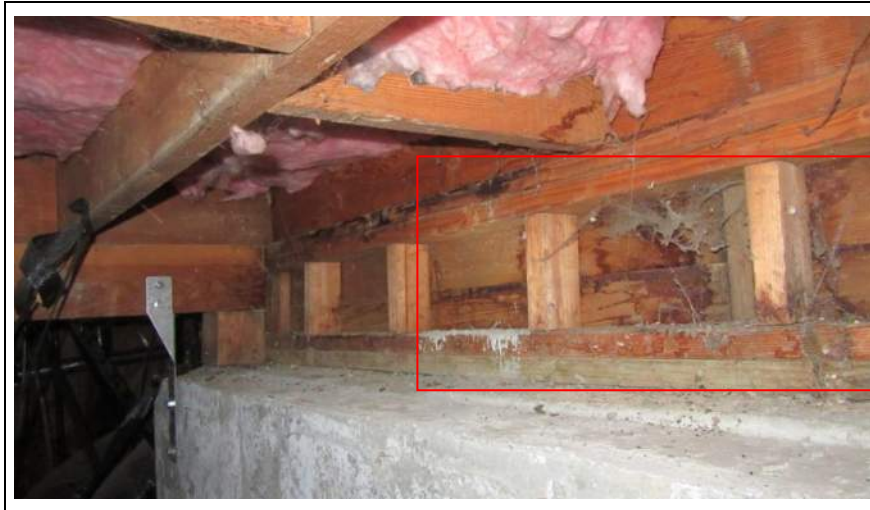
Evidence of water intrusion, due to improperly anchored and flashed deck ledgers was observed in units 47/49 Further investigation is recommended.

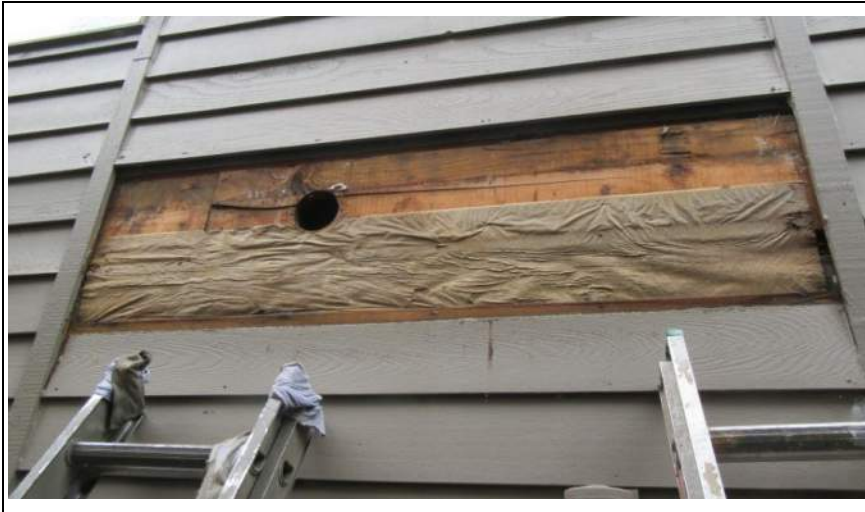
At some units, ledgers are not flashed, nor are projecting guard walls.

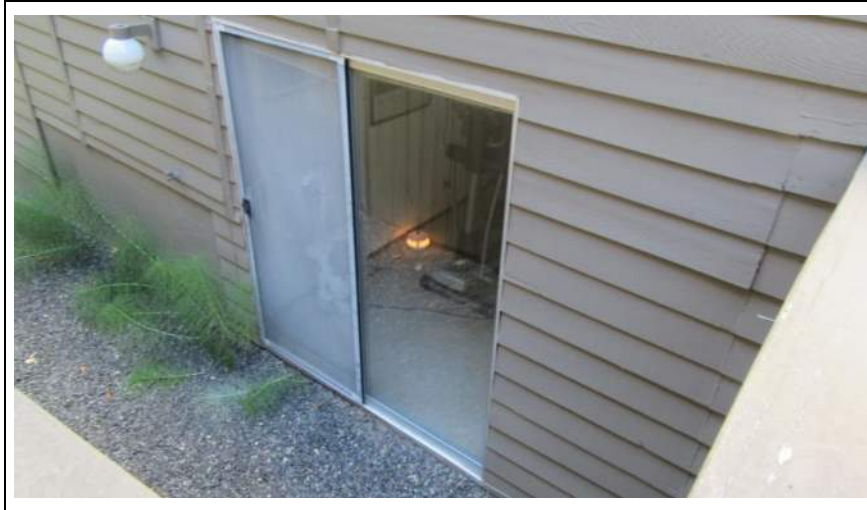
Original aluminum window frames are not integrated with the weather barrier and are not thermally broken to mitigate heat transfer.

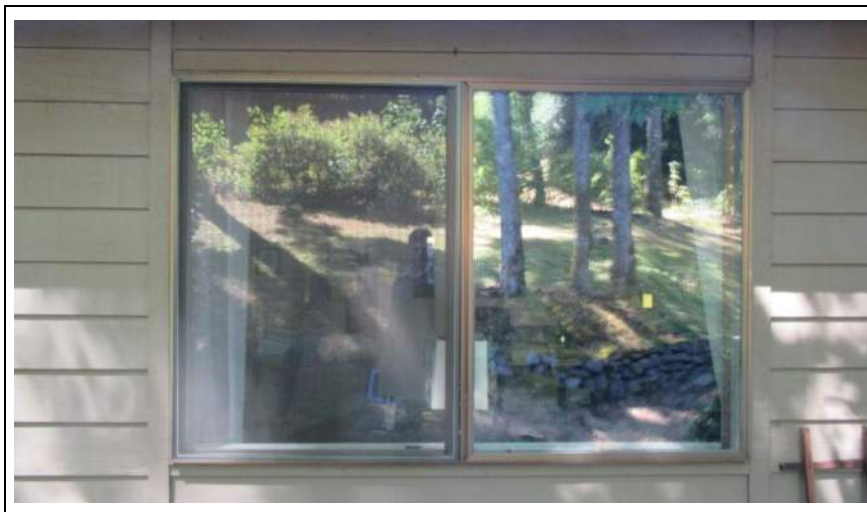
**Photo 115**

Original aluminum sliding doors are not thermally broken.

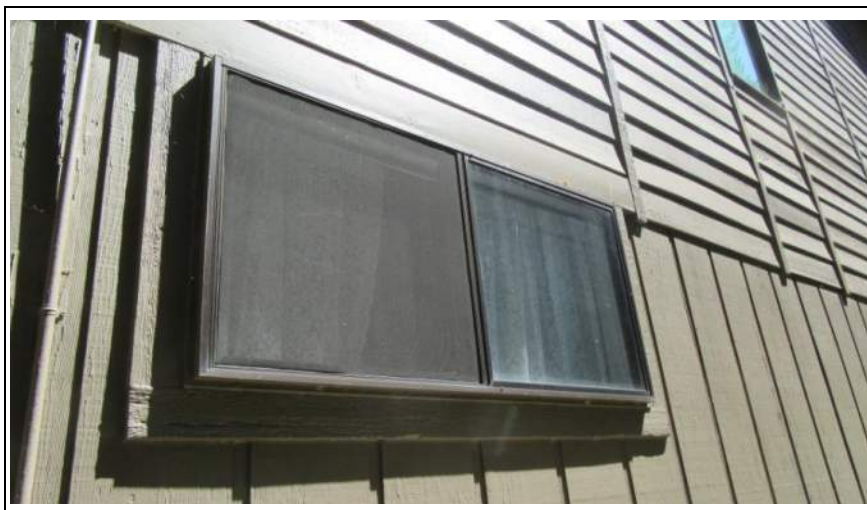
**Photo 116**

Aluminum jump-framed windows are not thermally broken.

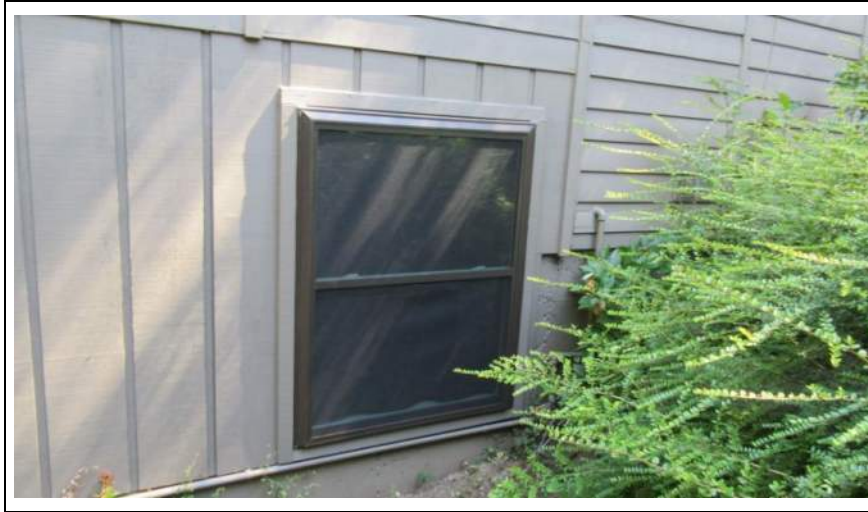
**Photo 117**

Aluminum jump-frame windows are installed within the original aluminum window frames and are not thermally broken.

Jump-framed windows are dependant of sealant between the frames and do not improve the water tightness of the original assembly.

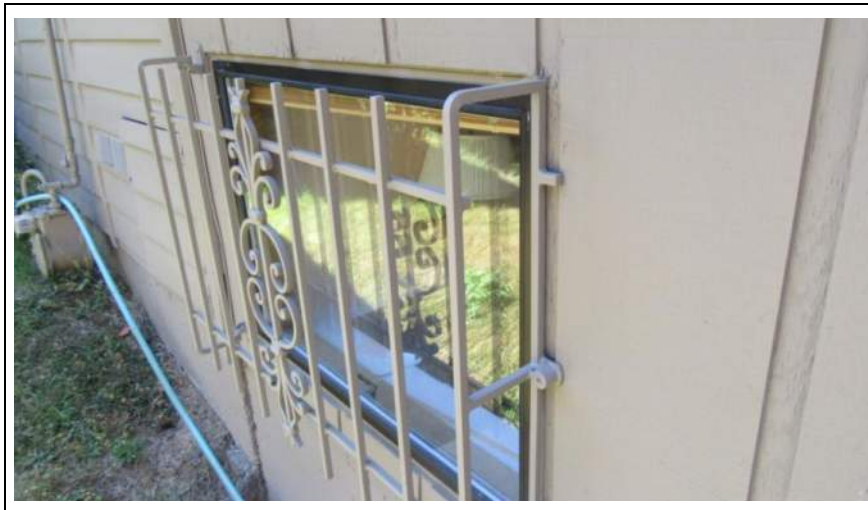
**Photo 118**

Vinyl windows have been installed as replacement window throughout the complex. In most cases, the newer windows do not integrate with the weather barrier.

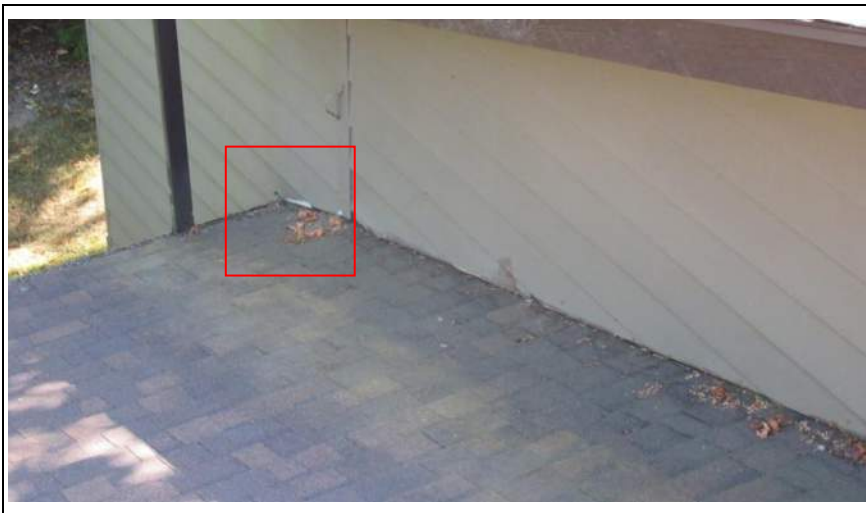
**Photo 157**

Diverter flashing was not installed at roof to wall transitions.

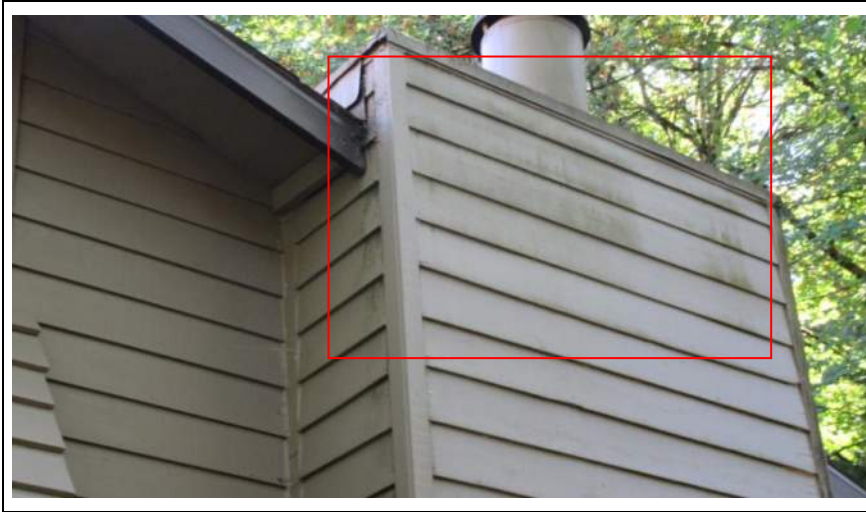
Typical condensation staining at the perimeter of the building.

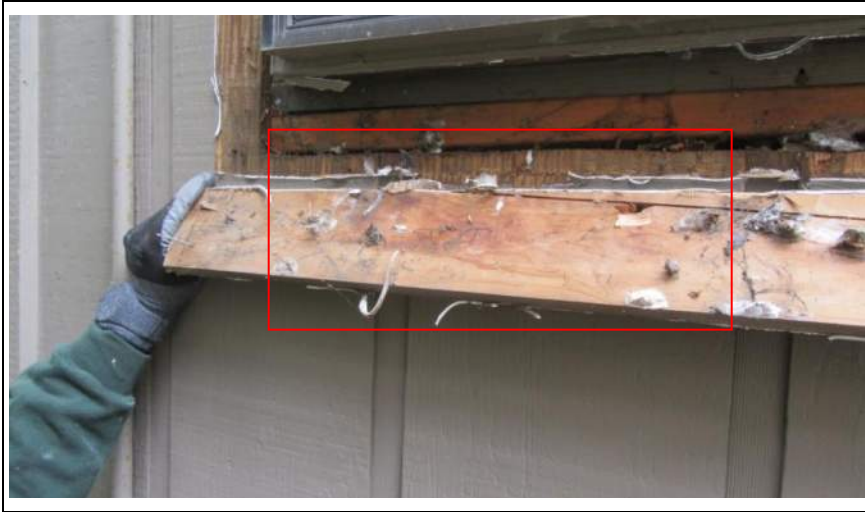
Staining on the bottom side of the interior face of the trim is indication that water is pooling on the window frame behind the cladding.

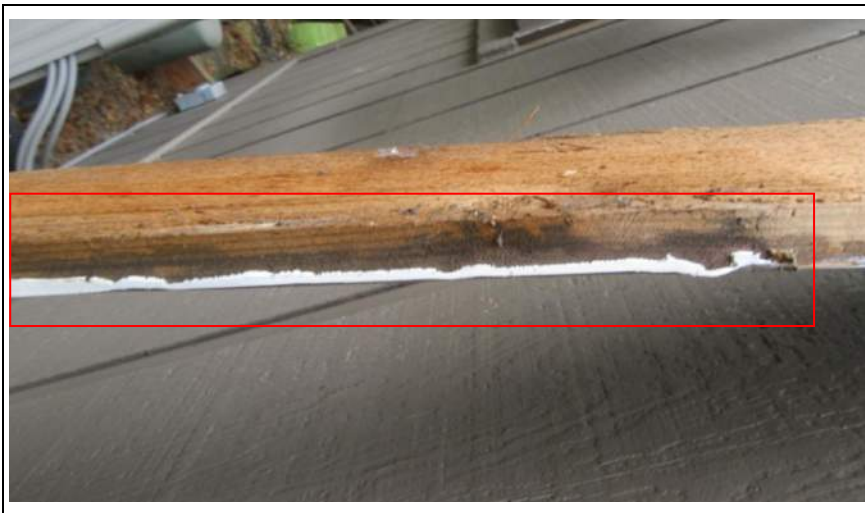
**Photo 7**

Opening 1 - Unit 47:  
Water staining behind trim at the sill.

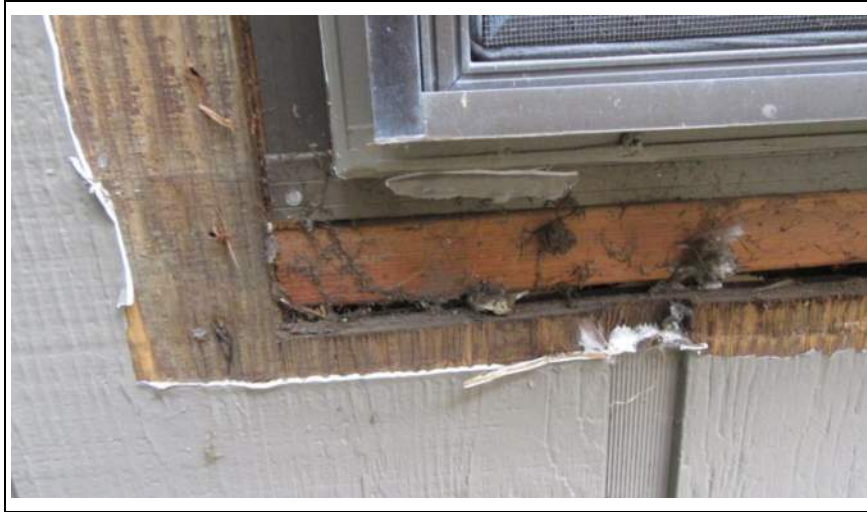
Opening 1 - Unit 47:  
Overall of window opening. Jump-framed window installed onto wood framing. Building paper or membrane flashings are not present.

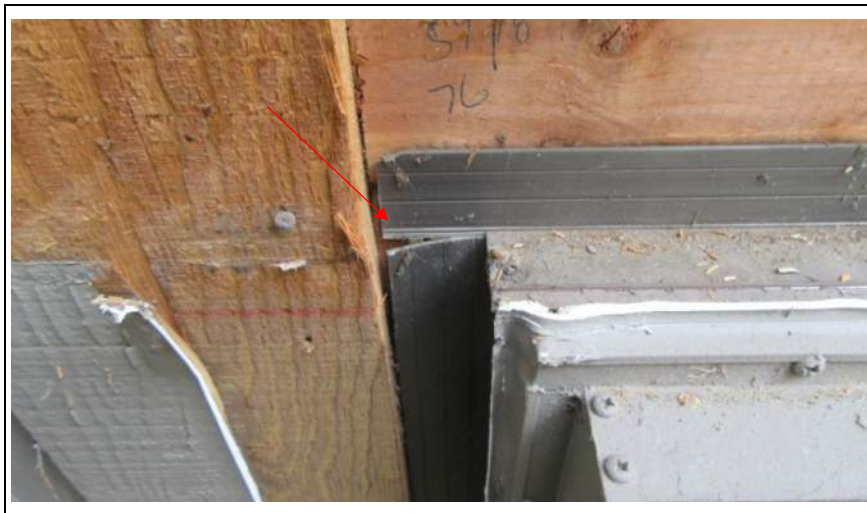
**Photo 10**

Opening 1 - Unit 47:  
Stained T1-11 indicating moisture is getting behind the trim.

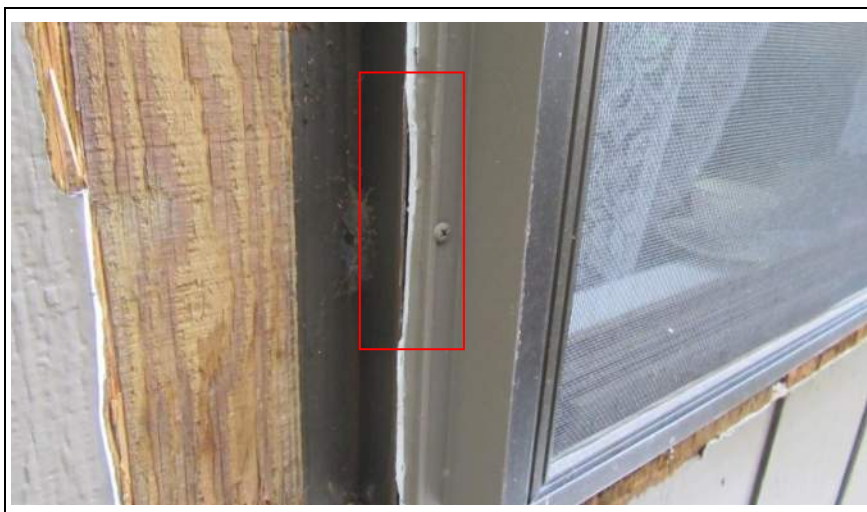
**Photo 11**

Opening 1 - Unit 47:  
Jump-frame aluminum window is a window that is installed by mounting the new frame to the original. Sealant is all that prevents water infiltration at this joint. The original window frame is damaged at the corner.

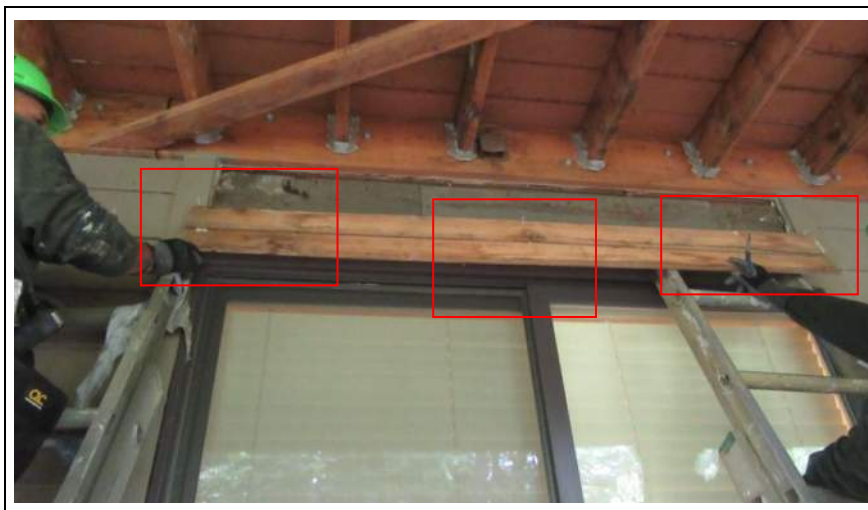
**Photo 17**

Opening 2 - Unit 31:  
Sheet metal flashing is not provided  
above projecting wood trim.

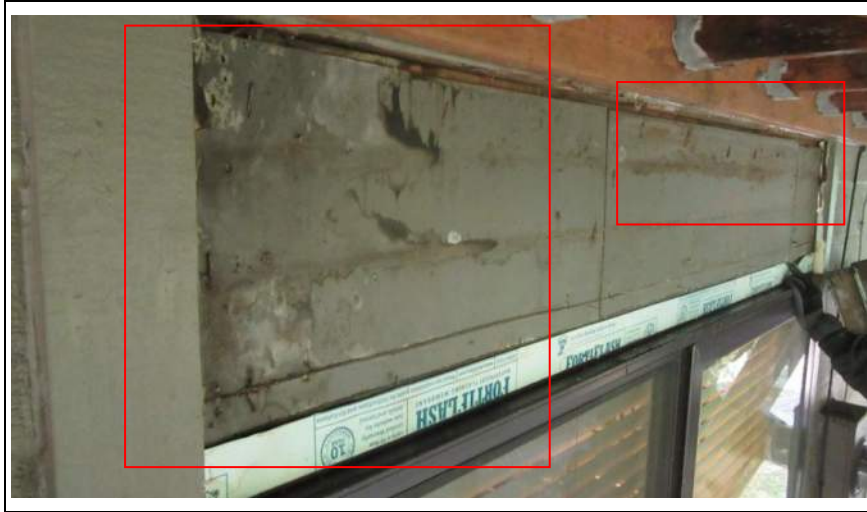
**Photo 18**

Opening 2 - Unit 31:  
Siding removed below ledger.  
Staining behind siding and on  
gypsum sheathing indicate bulk  
water behind the assembly.

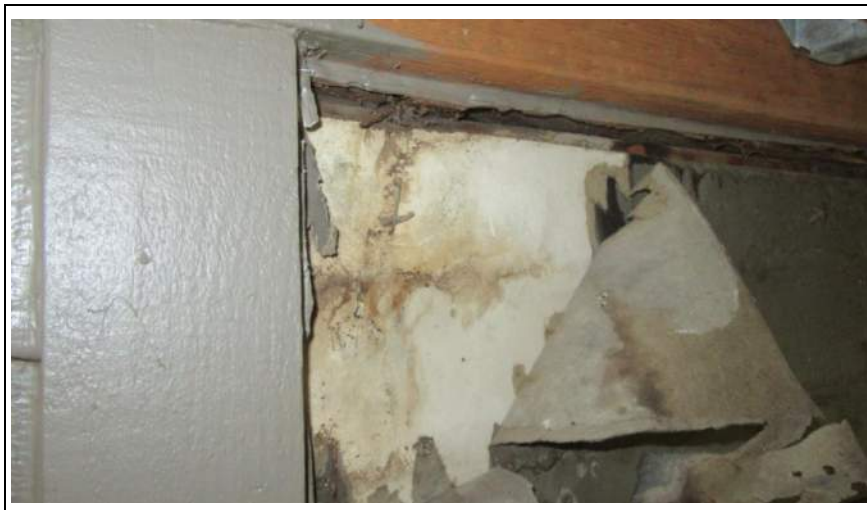
Water damage and organic growth present on wall sheathing.

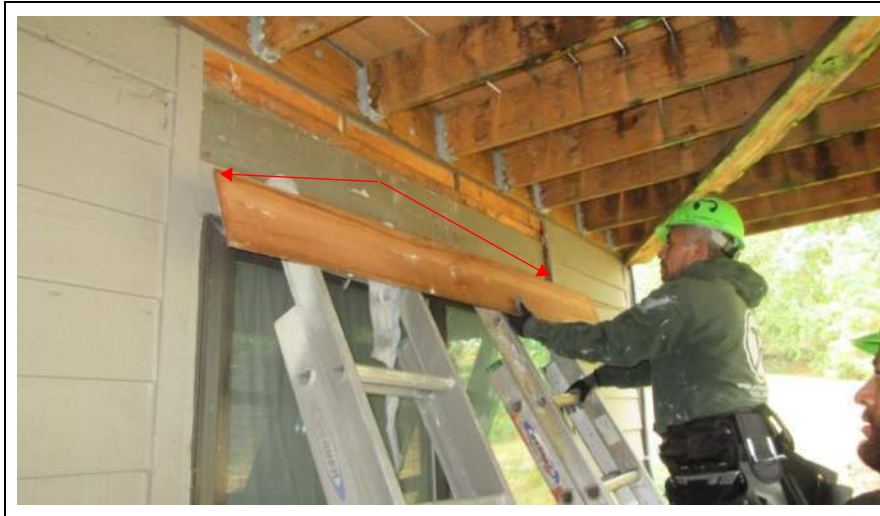
**Photos 27**

Opening 3 - Unit 93:  
Sheet metal flashing not provided  
above projecting wood trim.

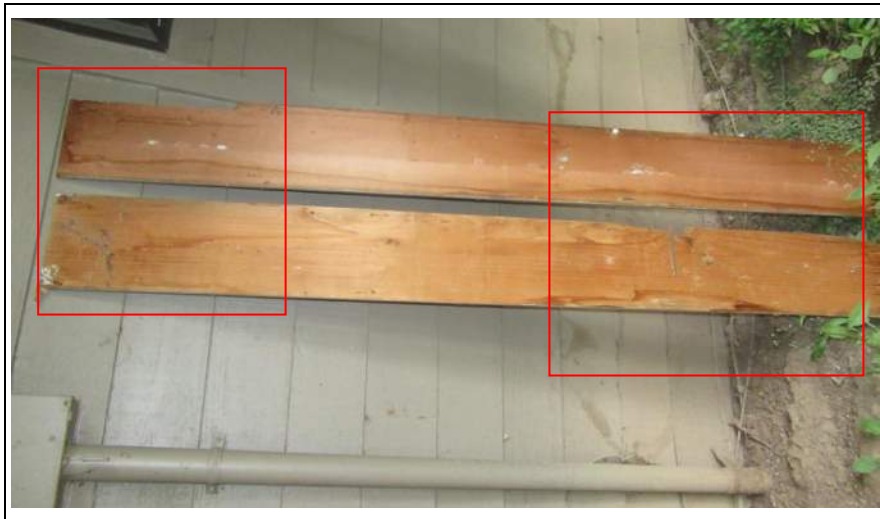
**Photo 28**

Opening 3 - Unit 93:  
Water staining is visible on the  
underside of the siding.

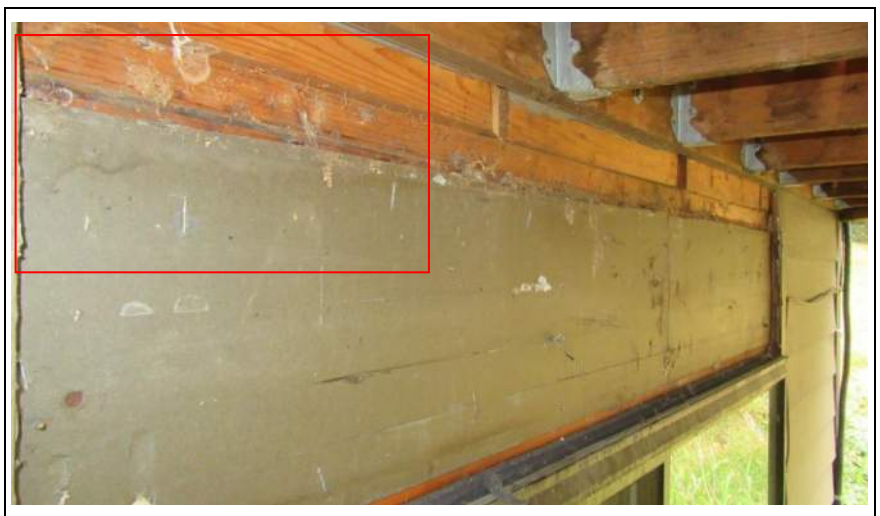
**Photos 29**

Opening 3 - Unit 93:  
Typical water staining behind the  
siding.

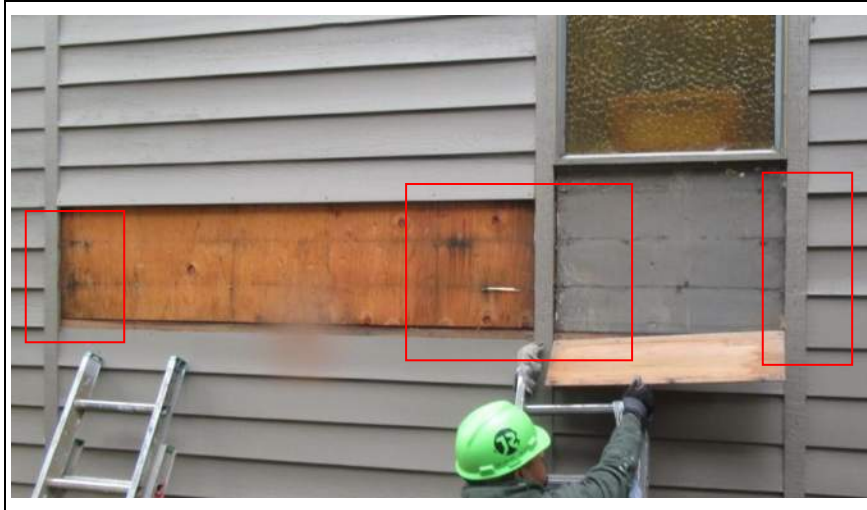
Opening 5 - Unit 81:  
Typical water staining behind siding.
