# Gabriel Commons

## Property Condition Assessment

3831-3897 SW Canby St., Oregon 97216

CBS Ref.: 16-045.00

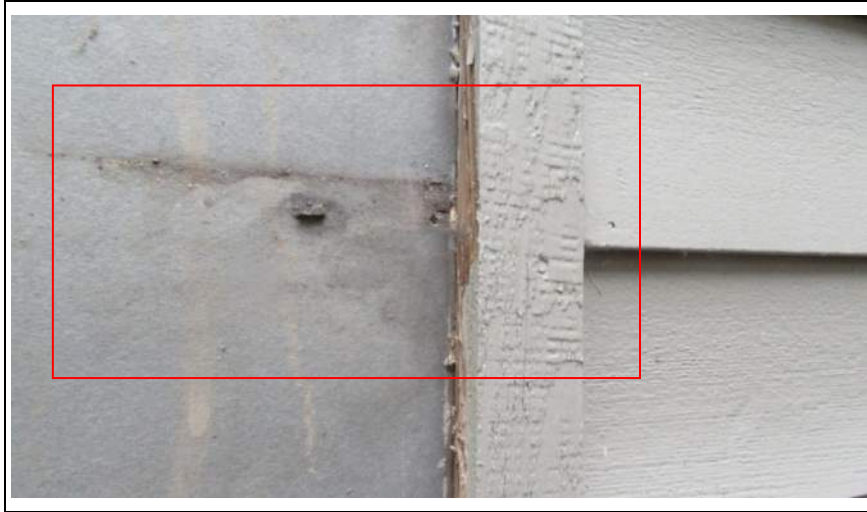
Organic growth and damaged gypsum sheathing.

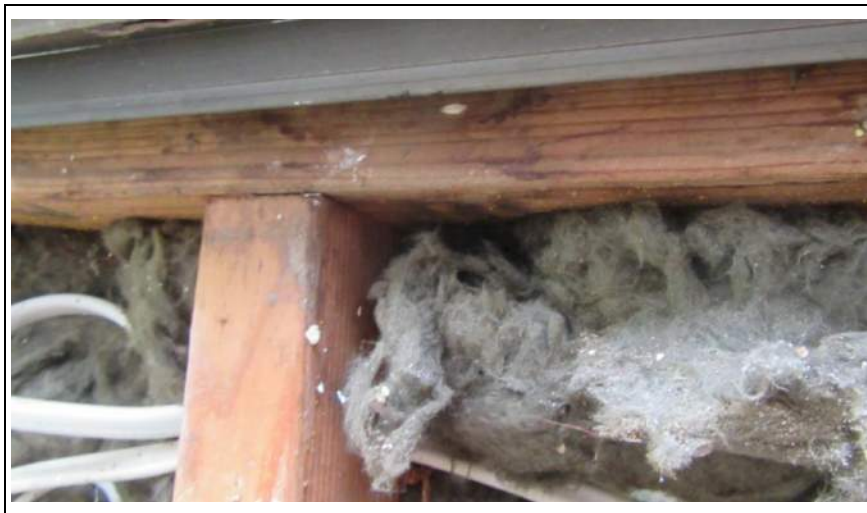
**Photo 49**

Opening 5 - Unit 81:  
Typical water entry points along the vertical joint formed by vertical trim and beveled cedar siding.

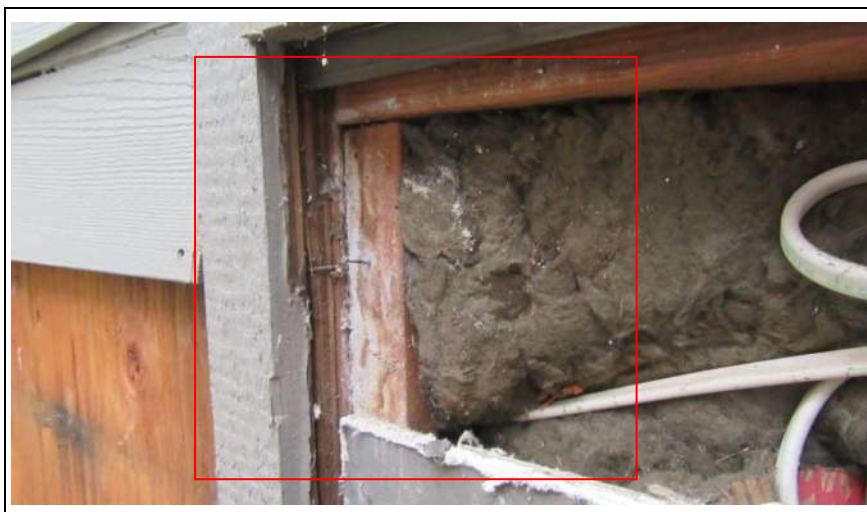
**Photo 50**

Opening 5 - Unit 81:  
Visible water staining on the wood framing.

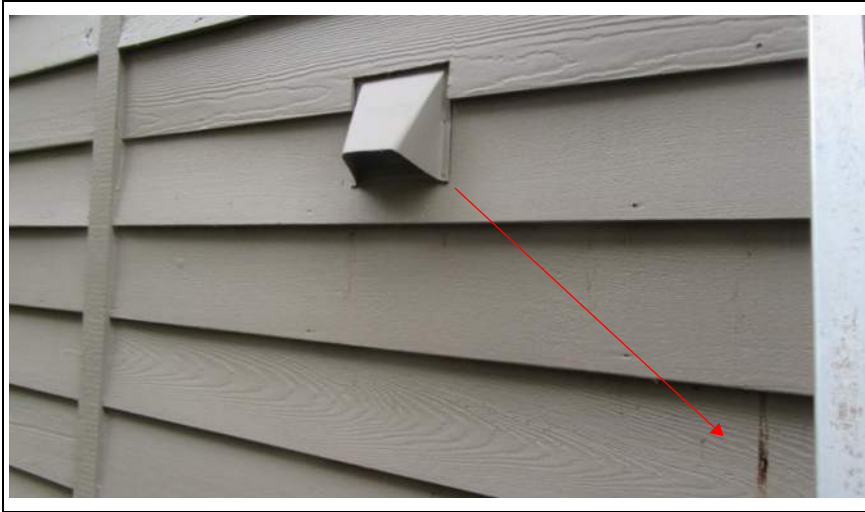
Water damaged siding.

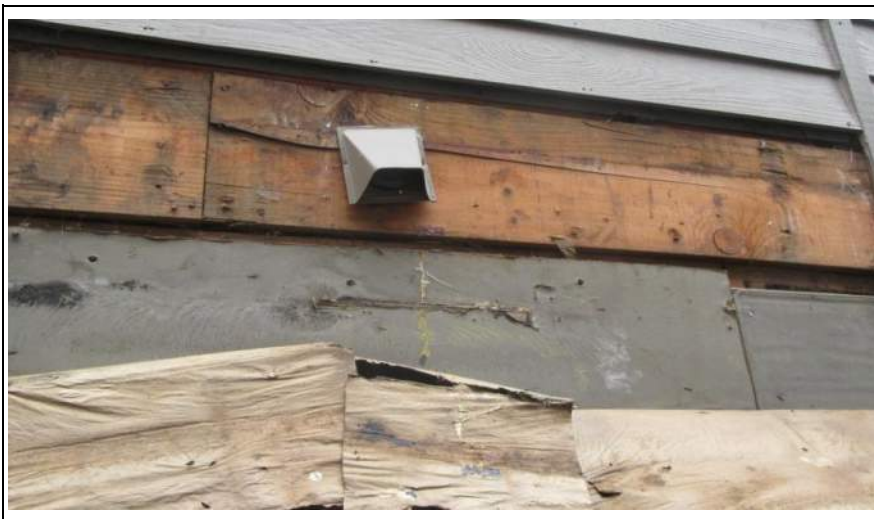
**Photo 62**

Opening 7 - Unit 77:  
Streaking was emanating from behind the cladding.

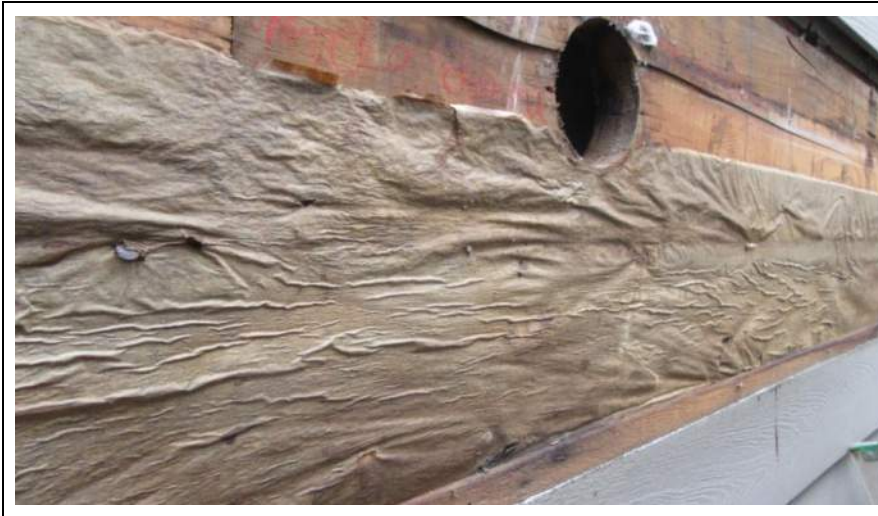
**Photos 63**

Opening 7 - Unit 77:  
Continuous weather barrier was not applied. The weather barrier present below was heavily damaged due to prolonged exposure to moisture. Water staining and organic growth was visible on the sheathing.

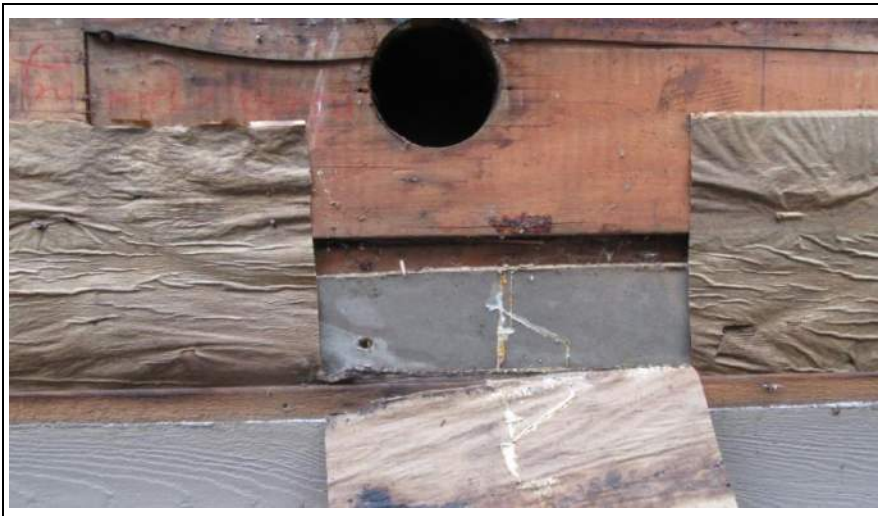
**Photo 64**

The weather barrier was damaged due to prolonged exposure to moisture. Water staining was also visible on the wood framing.

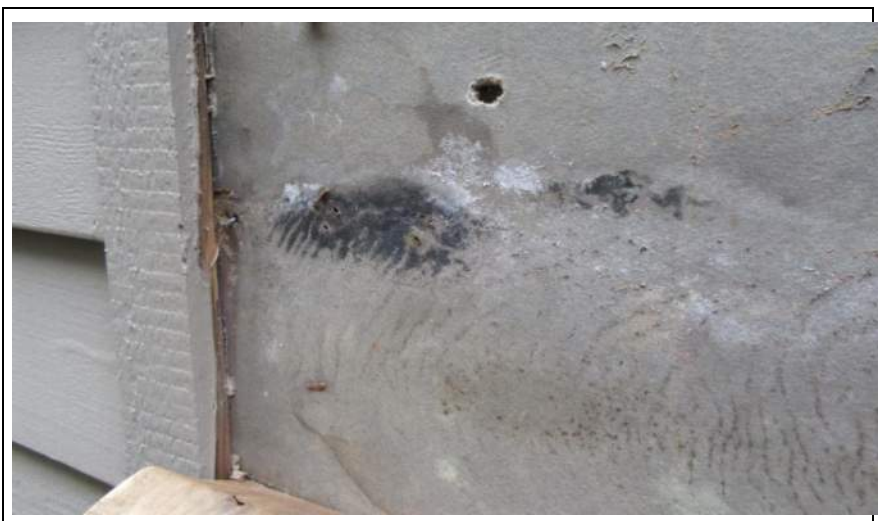
**Photos 65**

The vent penetration was not flashed or sealed to prevent air leakage.
