# **GABRIEL COMMONS**

**3831 – 3897 SW Canby St.  
Portland, OR 97219**

## **PRELIMINARY SIDING ASSESSMENT**

**November 30, 2018**

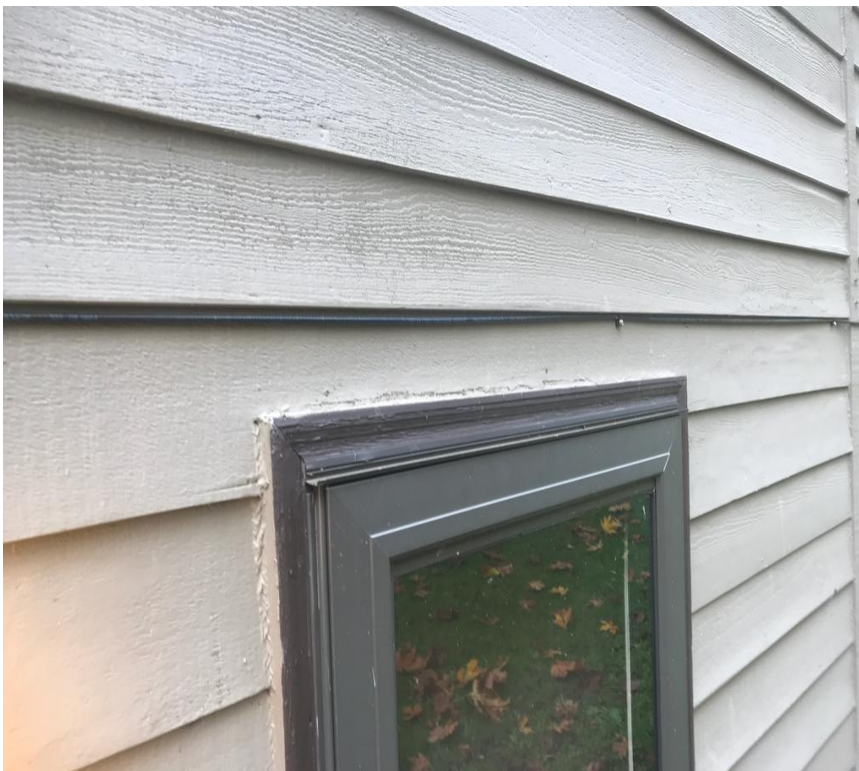
**1.2 – Invasive Opening #1**

Door head has metal flashing that is sealed to the siding with sealant, limiting water egress.

Severity Rating: 4

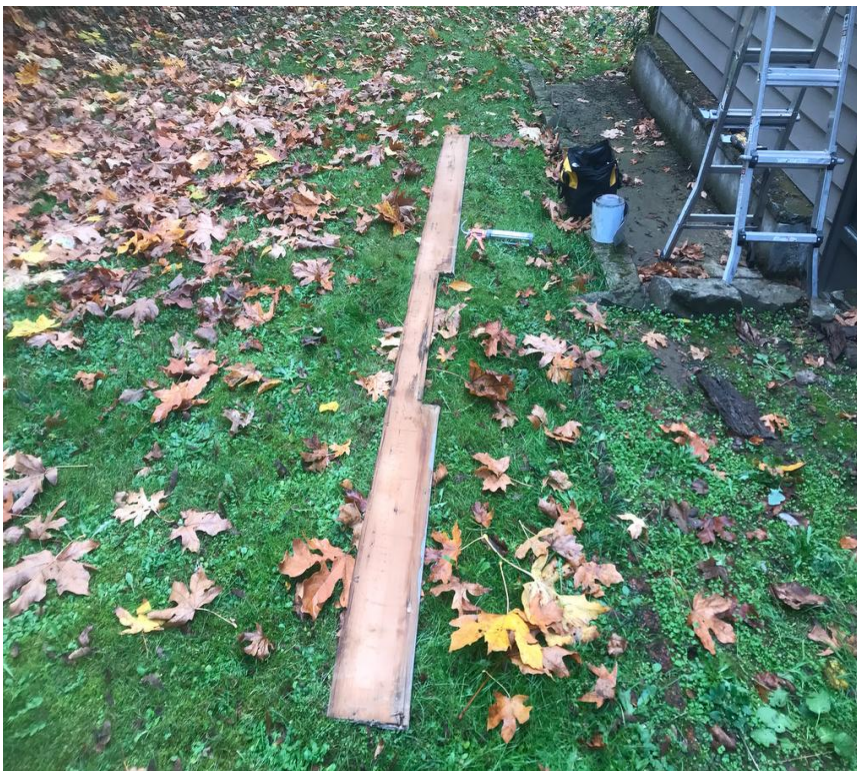
**1.4 – Invasive Opening #1**

The back of the siding is not primed to limit water absorption. There is water staining seen on the siding at the door head and the lower edge of the siding.

Severity Rating: 3

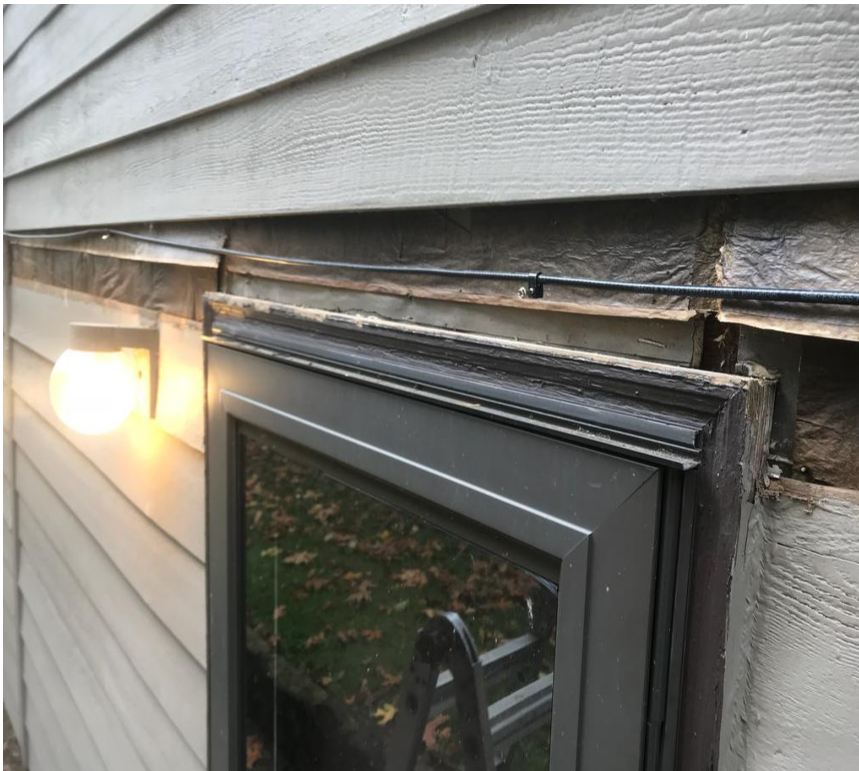
**1.5 – Invasive Opening #1**

The weather barrier behind the siding appears to be an asphalt impregnated kraft paper which may be a vapor retarder and likely does not meet the current code requirement for an exterior water-resistant barrier (WRB). The kraft paper is very brittle and is not properly installed.

Severity Rating: 3

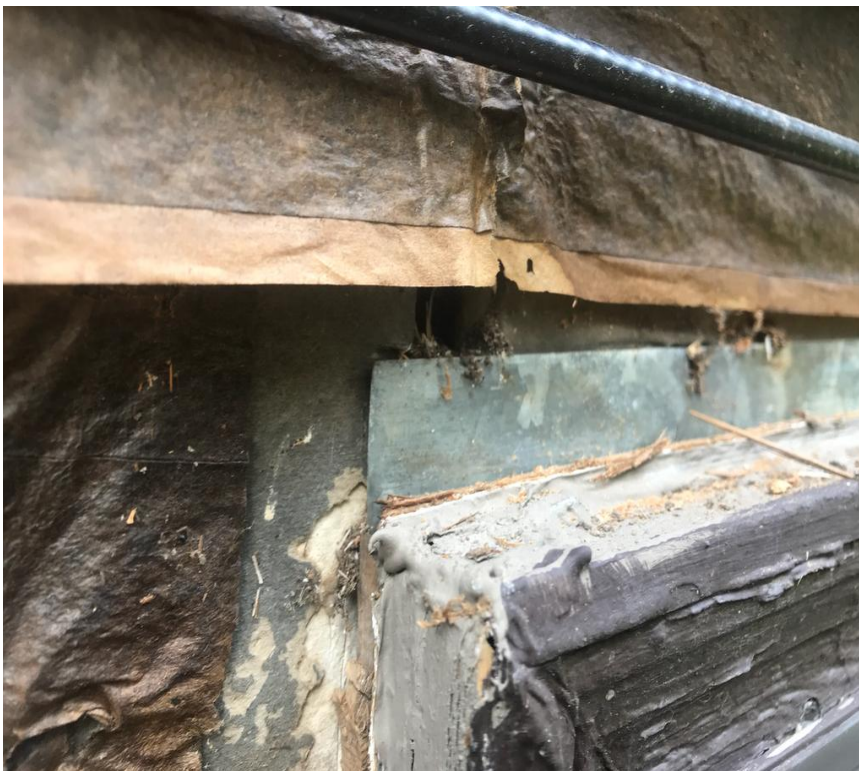
**1.6 – Invasive Opening #1**

The kraft WRB does not properly lap over the metal head flashing or is lapped tight to the door jamb, which can lead to water intrusion.

Severity Rating: 3

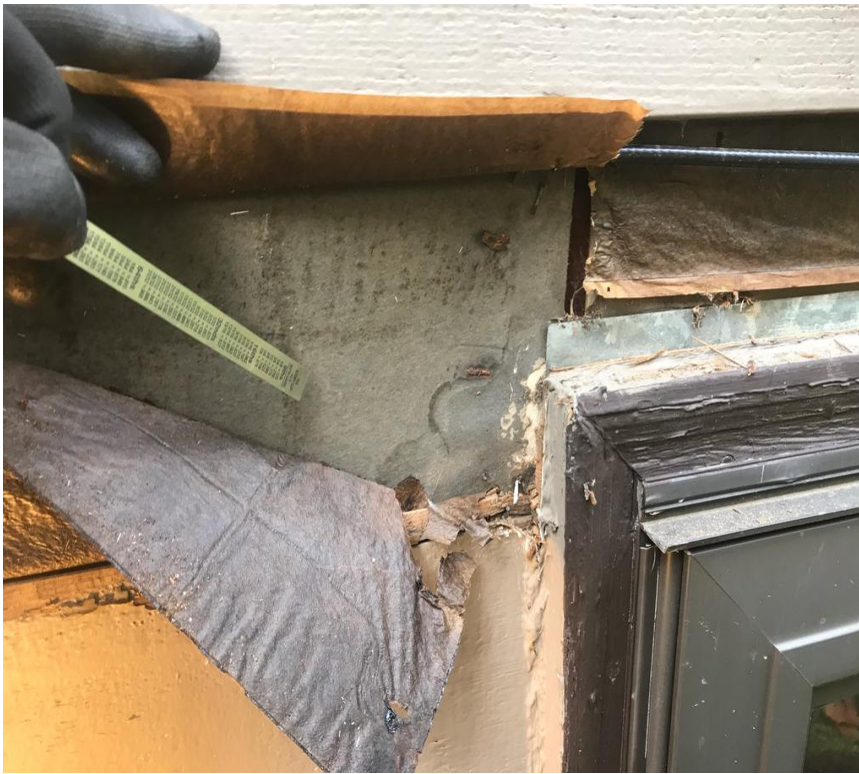
**1.7 – Invasive Opening #1**

The underlying gypsum shows signs of water intrusion but was dry at time of observations.

Severity Rating: 3

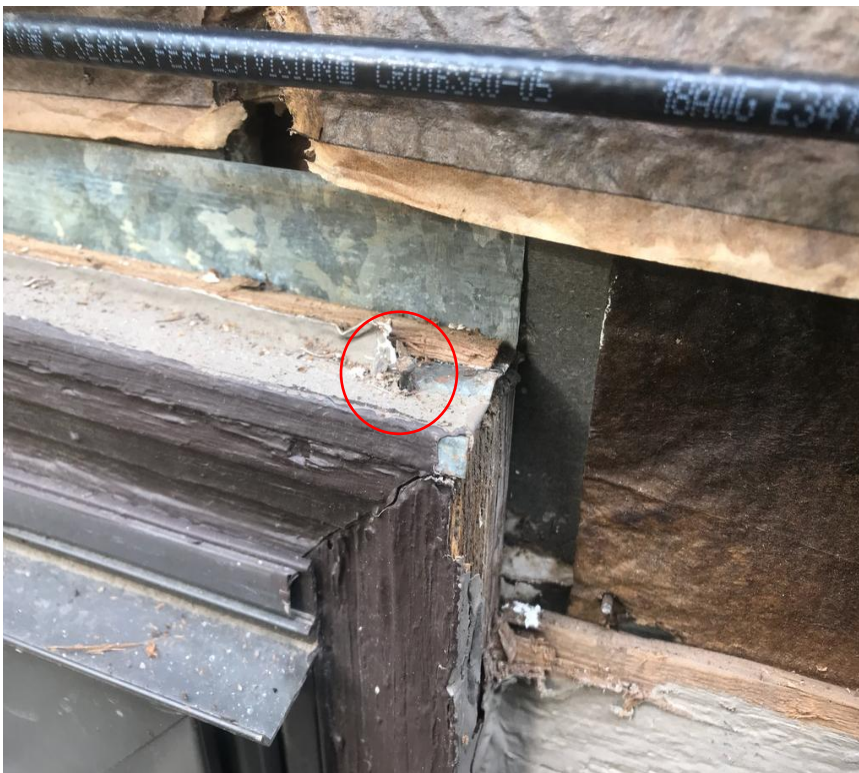
**1.8 – Invasive Opening #1**

The head flashing is nailed through the horizontal leg of the flashing, which can cause water intrusion.

Severity Rating: 3

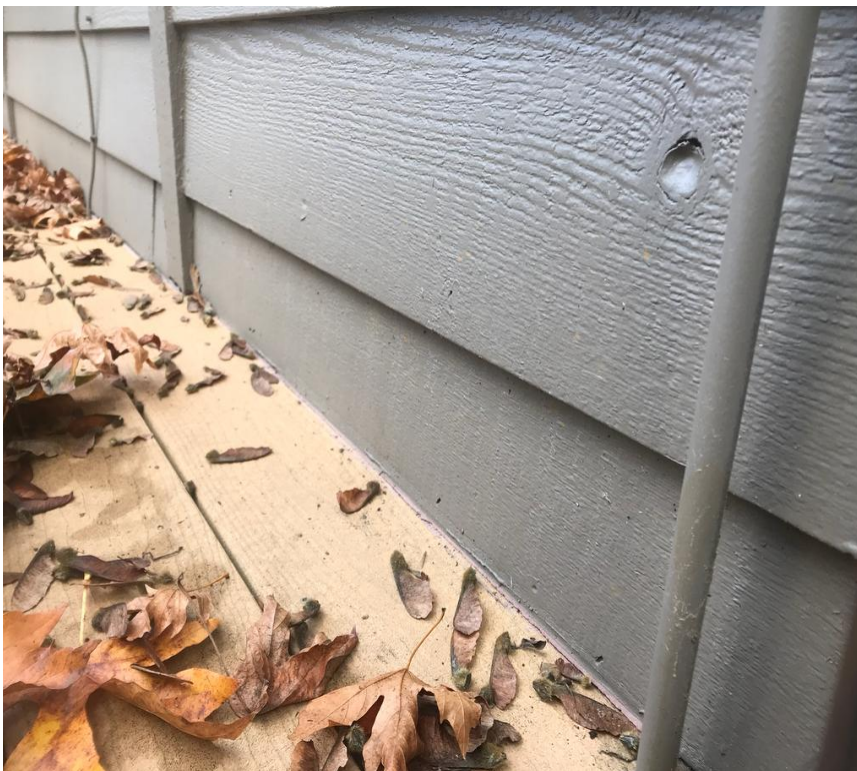
**2.2 – Invasive Opening #2**

Ledger metal flashing at the deck-to-wall location is not present. The siding is caulked to the deck top to limit water intrusion which is not the proper method of waterproofing at this location. The sealant is failing, allowing water intrusion.

Severity Rating: 2

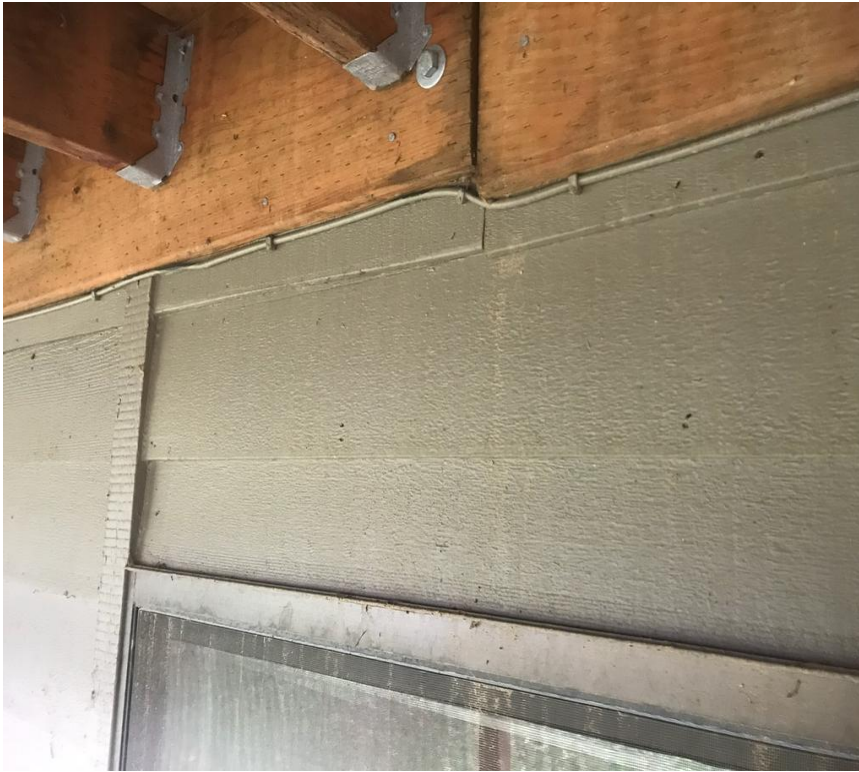
**2.3 – Invasive Opening #2**

Water staining observed on siding below ledger splice. Note that ledger appears to have settled or was installed out of tolerance.

Severity Rating: 3

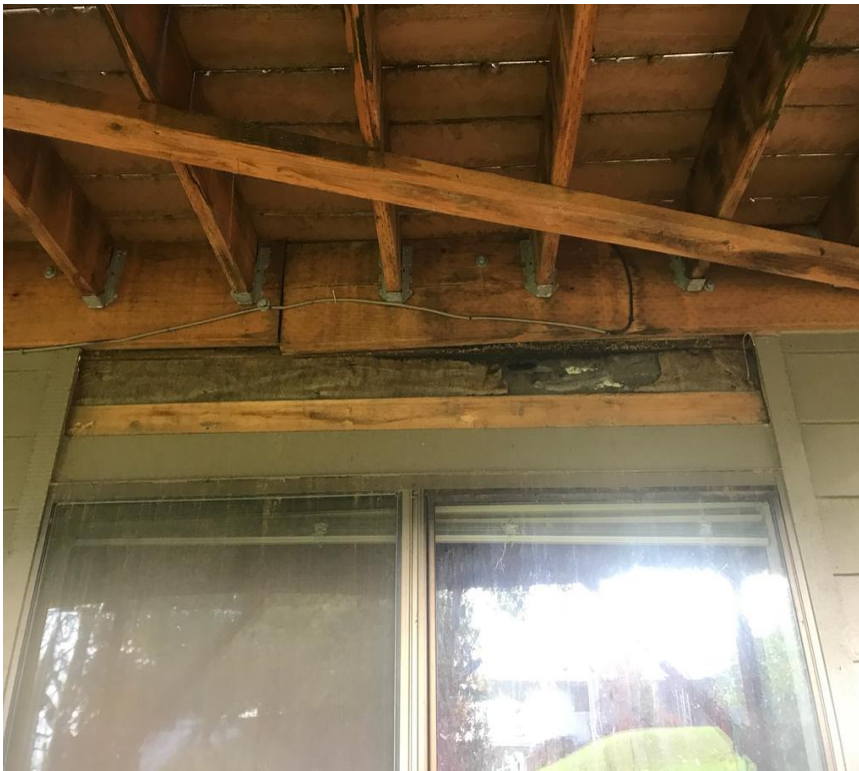
**2.4 – Invasive Opening #2**

Water observed behind siding, coming from behind the deck ledger.

Severity Rating: 2

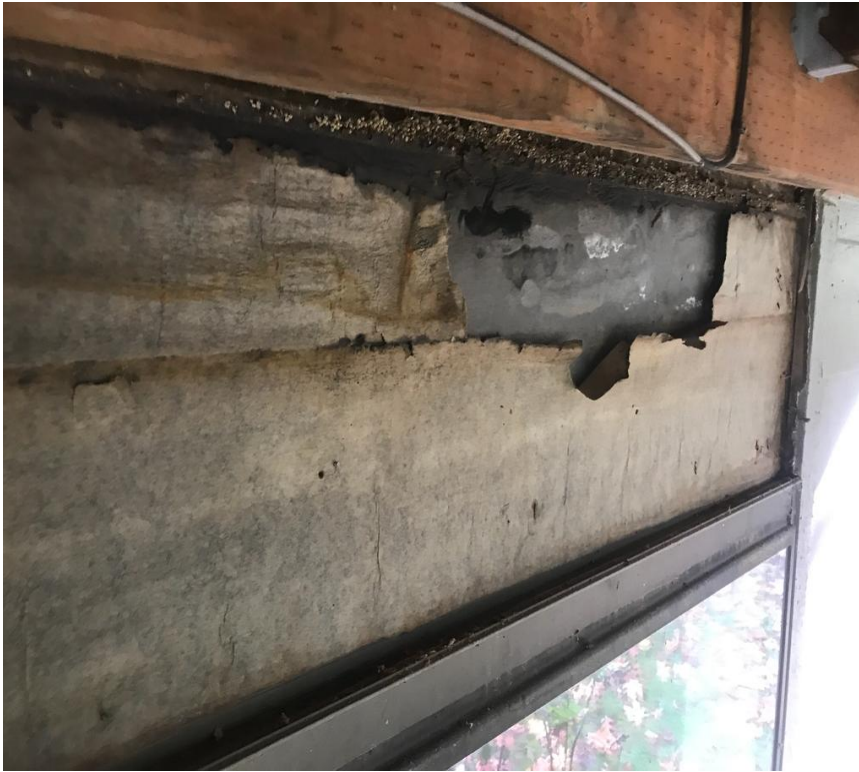
**2.5 – Invasive Opening #2**

The kraft WRB is disintegrating and the underlying gypsum is wet due to leaking behind the deck ledger.

Severity Rating: 2

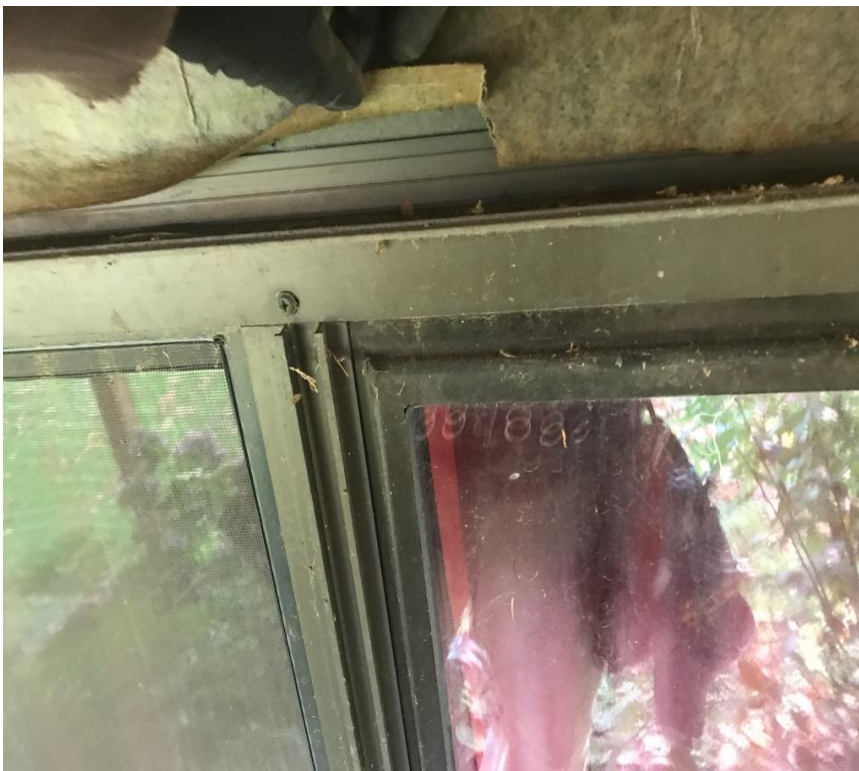
**2.6 – Invasive Opening #2**

Kraft WRB marginally laps over the window head flange without flashing. Siding is sealed to window head, limiting water egress.

Severity Rating: 3

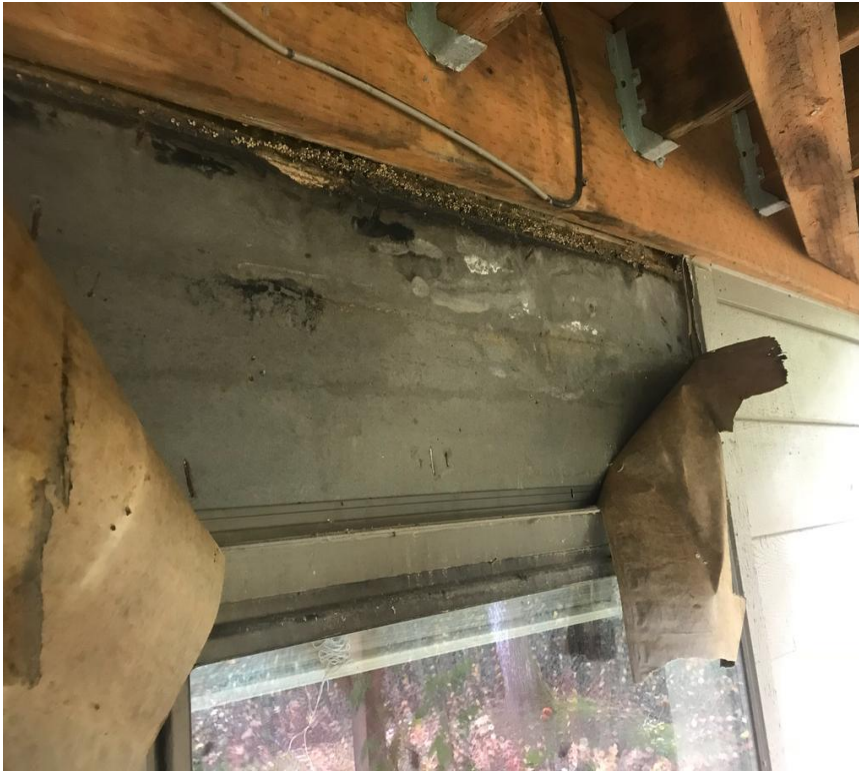
**2.7 – Invasive Opening #2**

Delamination and signs of organic growth observed at the gypsum paper face below deck.

Severity Rating: 2

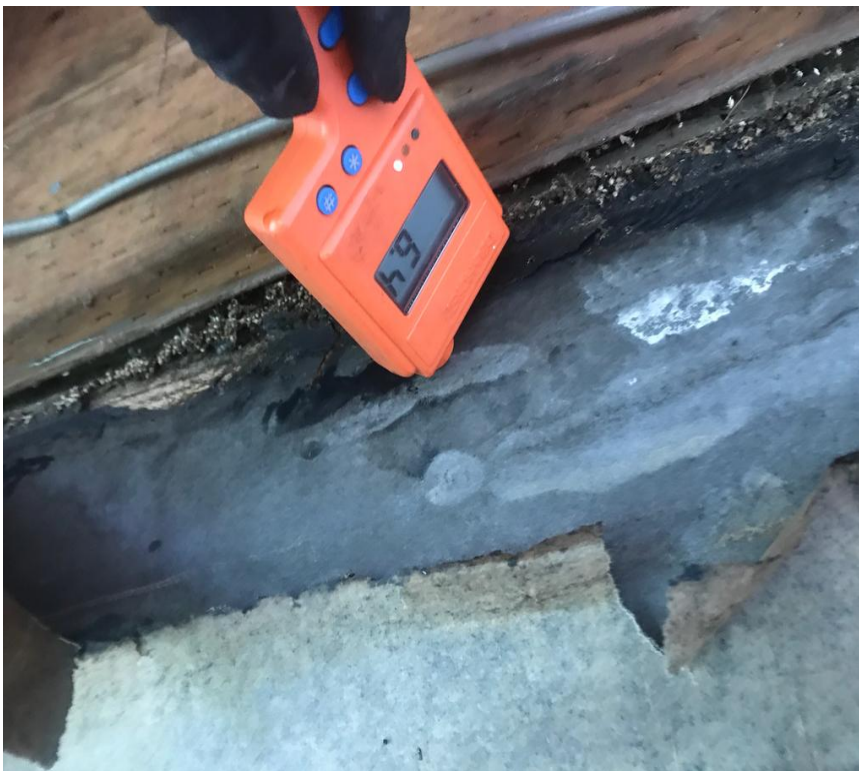
**2.8 – Invasive Opening #2**

High moisture reading in the exterior gypsum below the deck (6.4 mass percent, see Moisture Readings, p. 5).

Severity Rating: 2

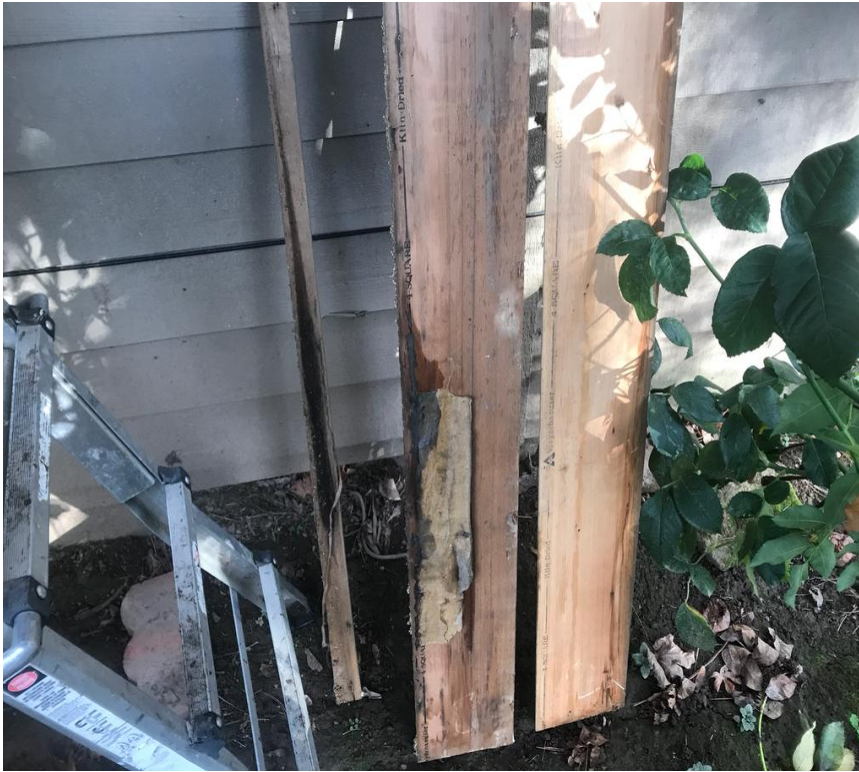
**2.9 – Invasive Opening #2**

The back of the siding is unprimed and wet from water intrusion.

Severity Rating: 2

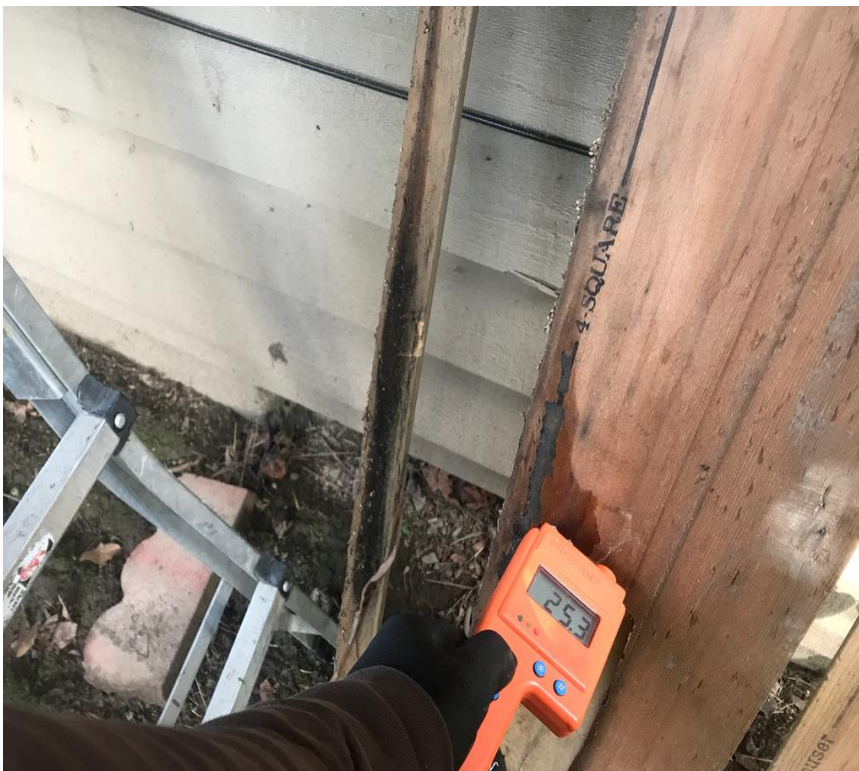
**2.10 – Invasive Opening #2**

High moisture reading (25.3 mass percent) in the back of the siding.

Severity Rating: 2

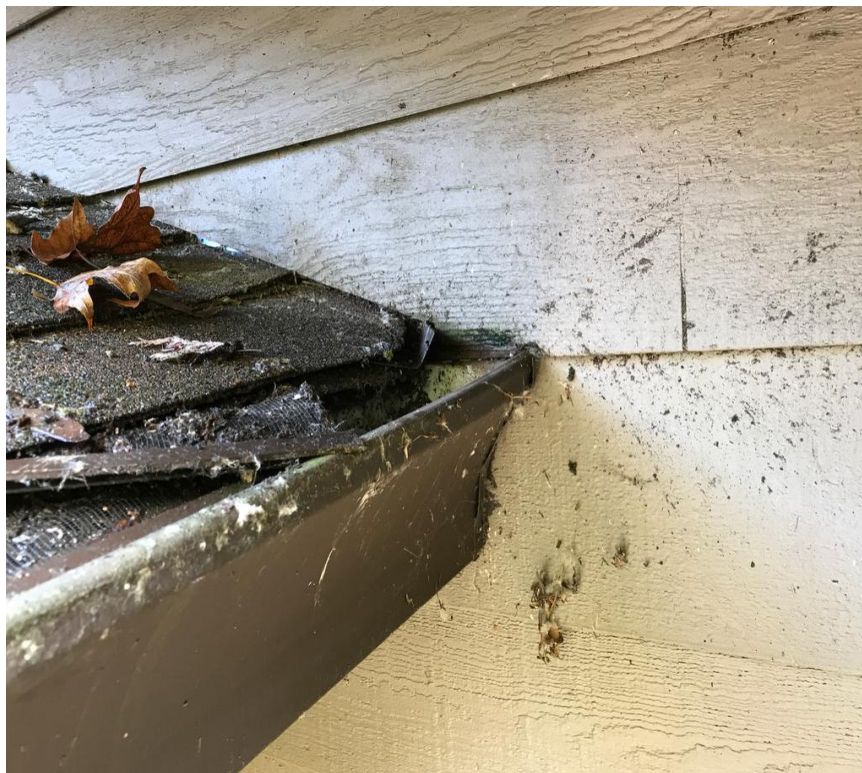
**3.2 – Invasive Opening #3**

Moisture staining and gutter debris are present on the face of the siding adjacent to the gutter termination.

Severity Rating: 4

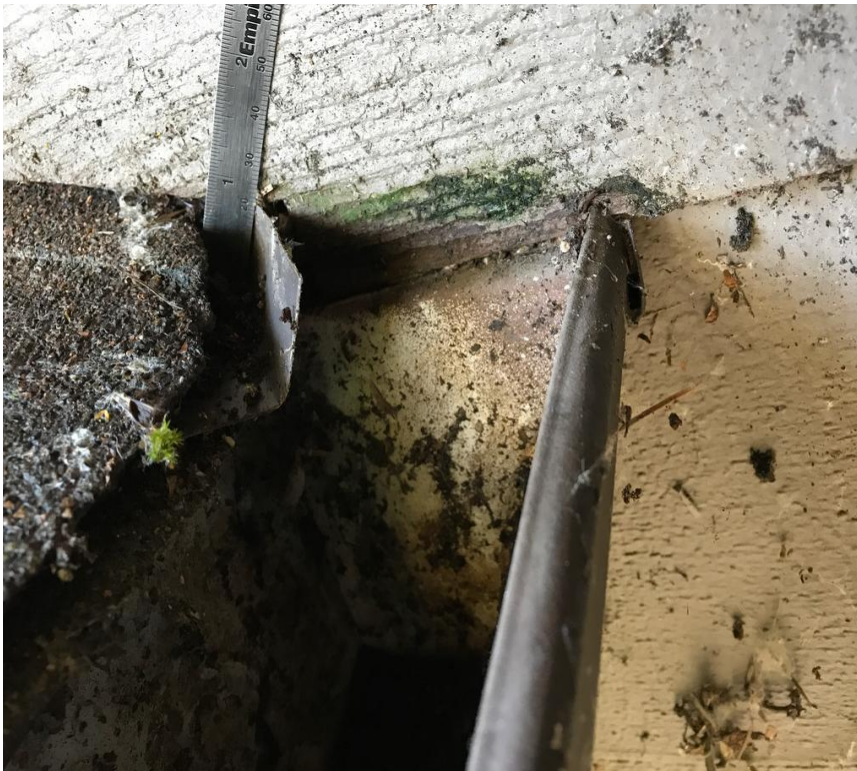
**3.3 – Invasive Opening #3**

The installed sheet metal diverter flashing has an inadequately dimensioned kickout back leg height.

The flashing is not tall enough to divert the roof surface water into the gutter and allows for water infiltration behind the lap siding.

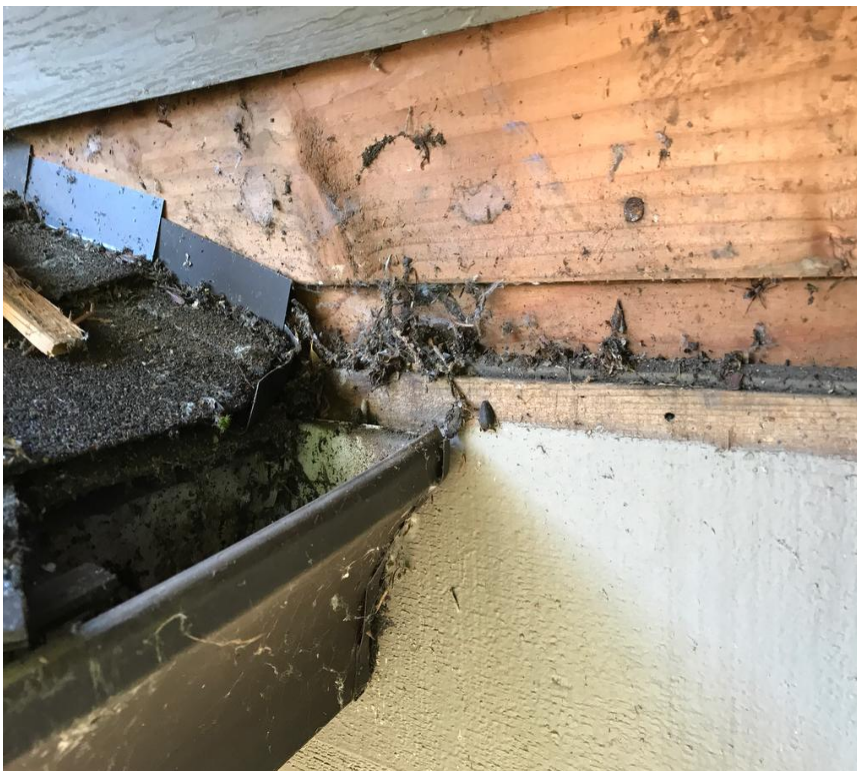
**3.4 – Invasive Opening #3**

Once the cladding was removed, J2 was able to observe the WRB is omitted at this location.

WRB is a code requirement due to the critical nature of water resistance provided to the moisture sensitive structure behind the siding.

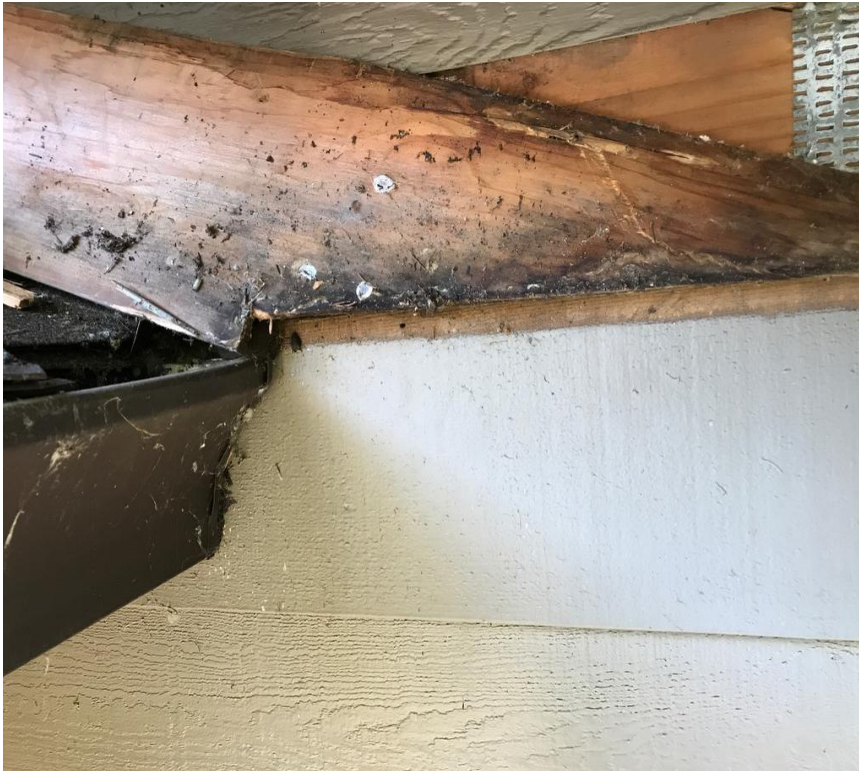
**3.5 – Invasive Opening #3**

The back side of the removed siding board shows signs of moisture staining against the roof shingles where there is inadequate clearance from the roof to the siding.

The siding was also noted to have no primer present at the field cuts or back side of the siding, which limits water absorption.

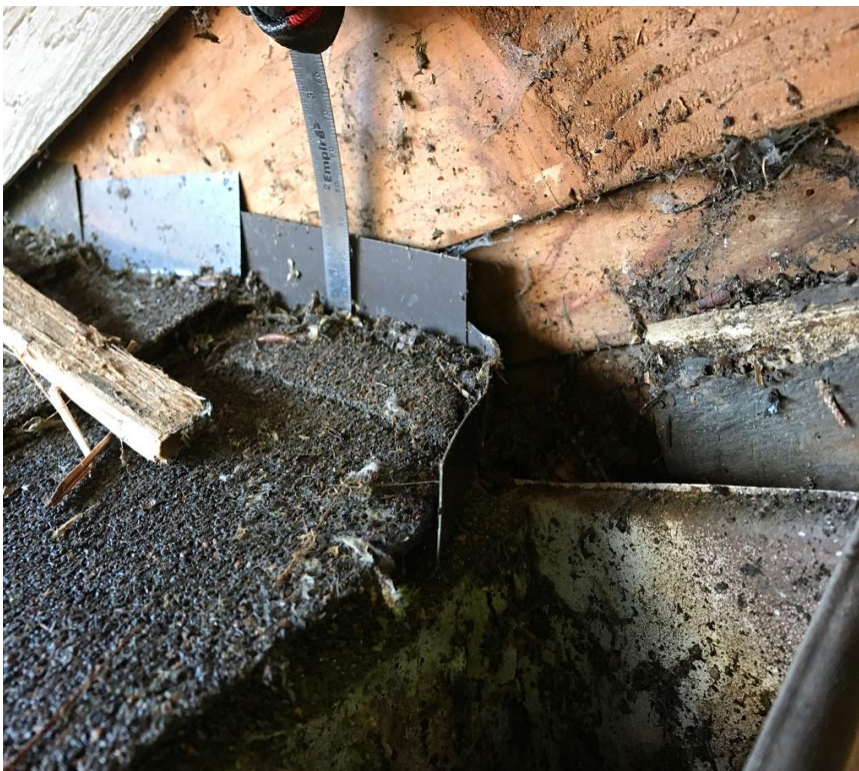
**3.6 – Invasive Opening #3**

The sheet metal “step flashing” was also measured to have an inadequate vertical leg dimension. Although this dimension is taller than the diverter flashing, it still does not meet code minimum. There should be a 2” separation between roof and siding and 2” min. overlap of WRB over step flashing.

Severity Rating: 2

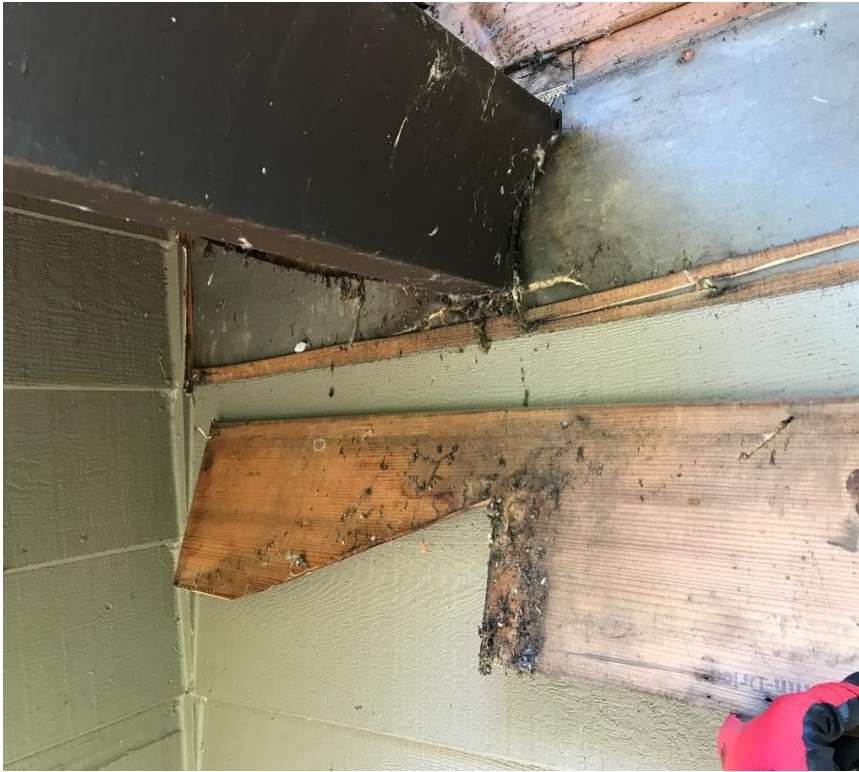
**3.7 – Invasive Opening #3**

J2 observed moisture staining at the exterior gypsum sheathing and the backside of the siding board.

The gutter is also installed without adequate clearance to the adjacent wall.

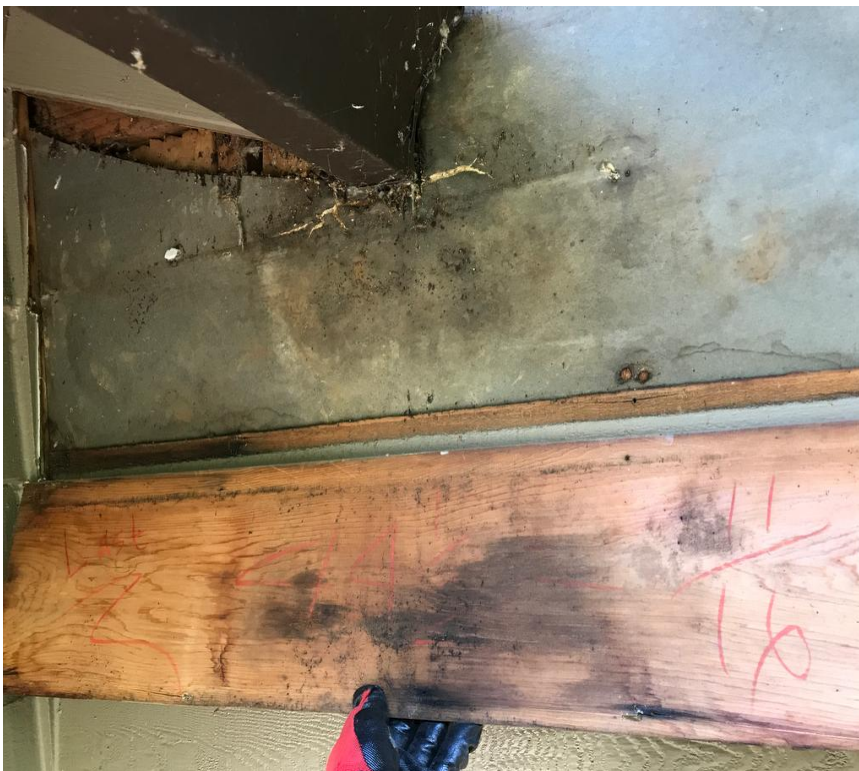
**3.8 – Invasive Opening #3**

Heavy moisture staining, organic growth, and delaminating paper facer on the gypsum sheathing are all evidence of water infiltration into the wall assembly.

Severity Rating: 2

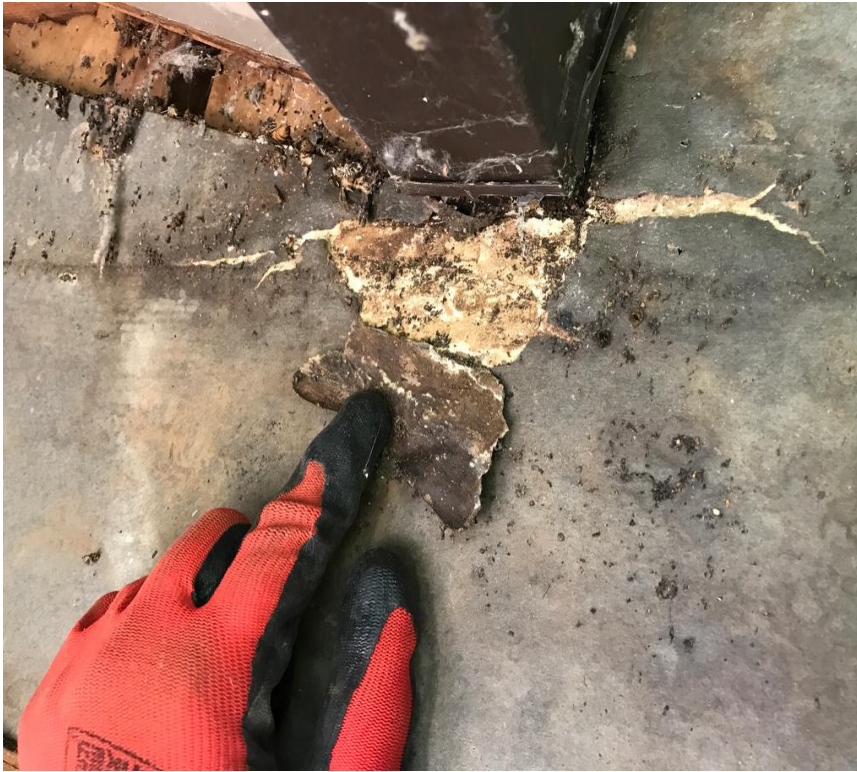
**3.9 – Invasive Opening #3**

Consistent water infiltration has eroded the gypsum core from the exterior sheathing. Although moisture staining and damage was present at the time of J2's review, the moisture readings indicated the gypsum is currently sufficiently dry.

Severity Rating: 2

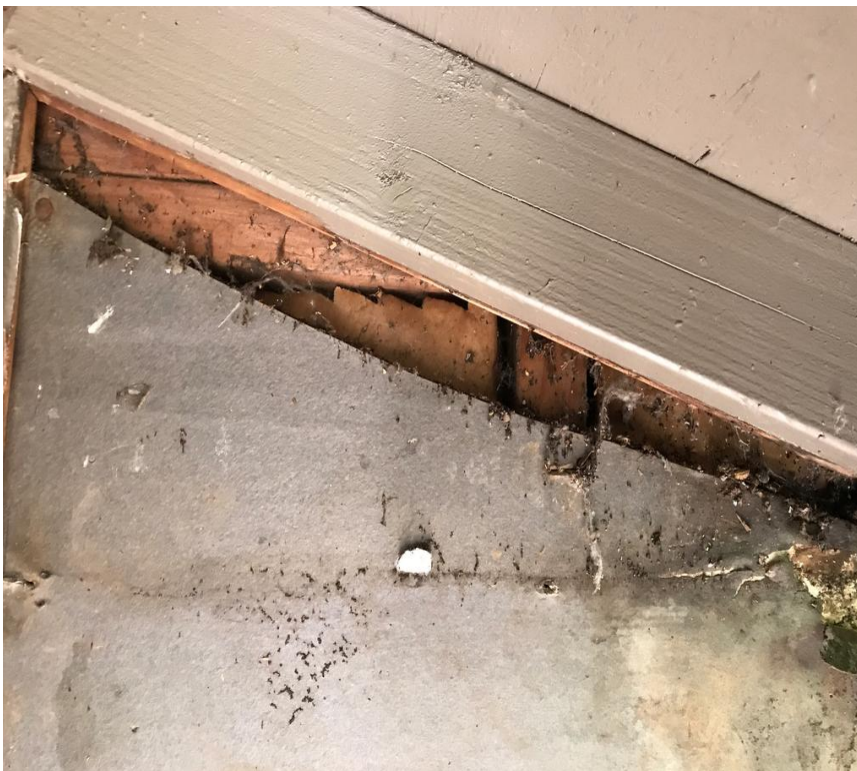
**3.10 – Invasive Opening #3**

The gypsum sheathing boards appear to be installed and inset between the roof rafter tail framing and the inside corner trim. The gypsum sheathing was noted to be discontinuous and short, providing the intended coverage over framing.

Severity Rating: 4

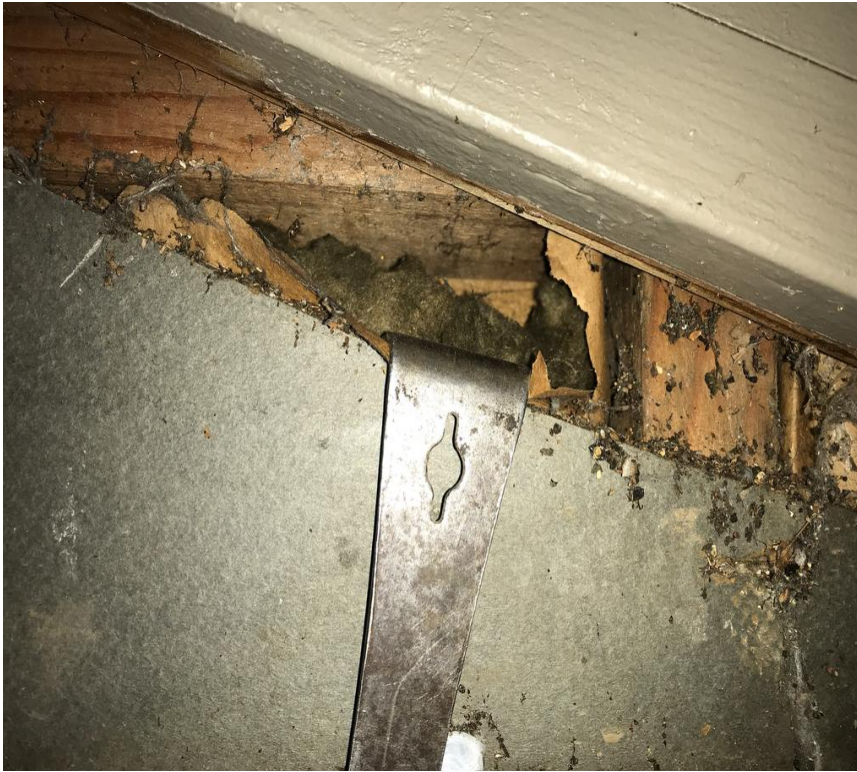
**3.11 – Invasive Opening #3**

The discontinuation of the gypsum sheathing board did allow for confirmation of the presence of batt insulation in the exterior wall cavity. A facer paper was located on the exterior side of the insulation. It was not confirmed if this paper is a vapor retarder or not. A vapor retarder on the outside of the wall can cause moisture issues in the wall cavity.

Severity Rating: 6

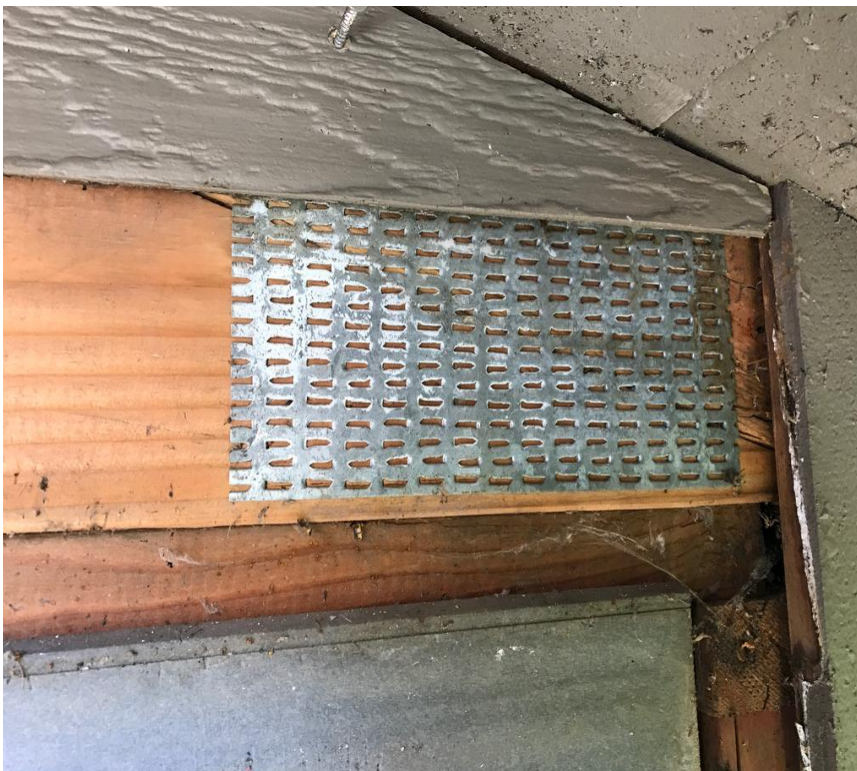
**3.12 – Invasive Opening #3**

J2 observed a roof truss mending plate that is protected from direct weather but exhibiting "white rust" corrosion due to moisture exposure likely due to the general moisture content of the wall assembly.

Severity Rating: 3

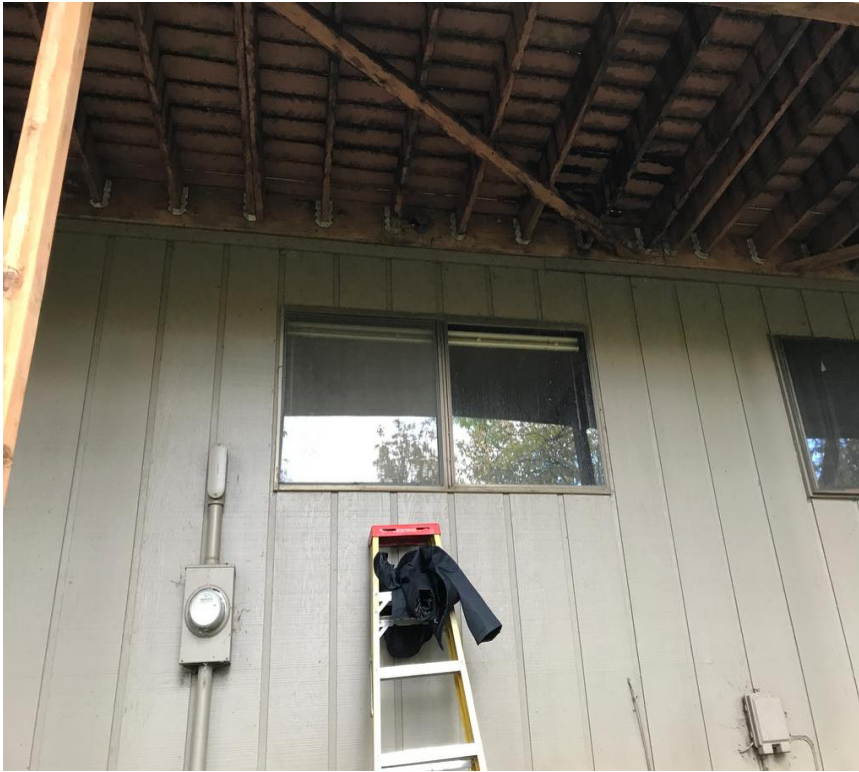
**4.1 – Invasive Opening #4**

Both the deck ledger and the window head did not have sheet metal flashing protecting the horizontal surfaces.

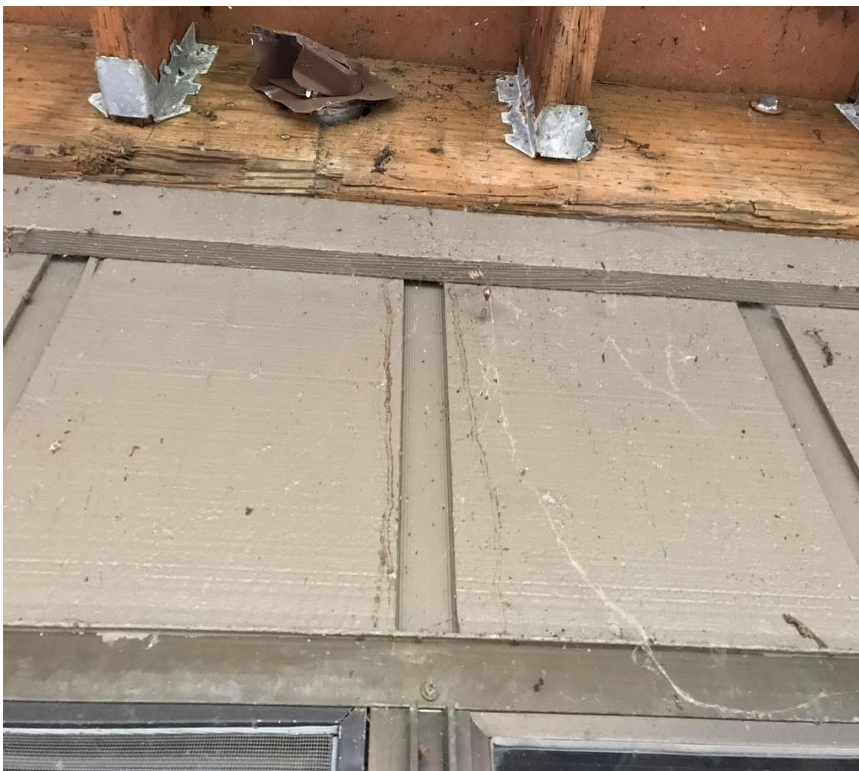
**4.2 – Invasive Opening #4**

J2 observed an exhaust duct hood that was damaged and not properly installed to the ledger.

Moisture staining is also evident below the ledger.

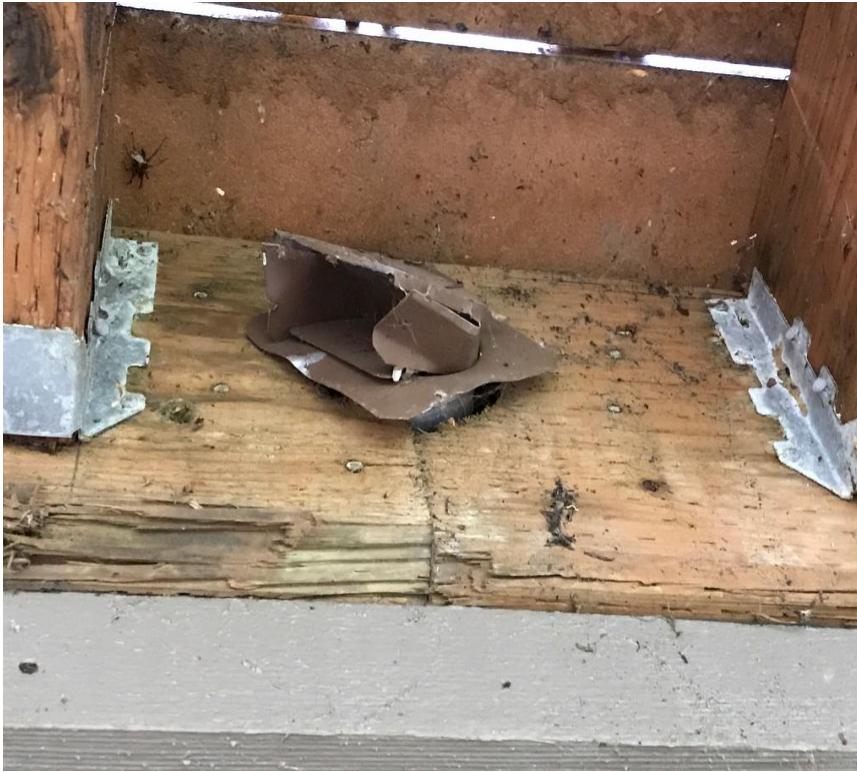
**4.3 – Invasive Opening #4**

The exhaust vent hood could not open to allow for proper exhausting of the ductwork.

The trim band below the deck ledger is not properly lapped by, flashed under, or sealed to the deck ledger and does nothing to prevent water infiltration behind the trim.

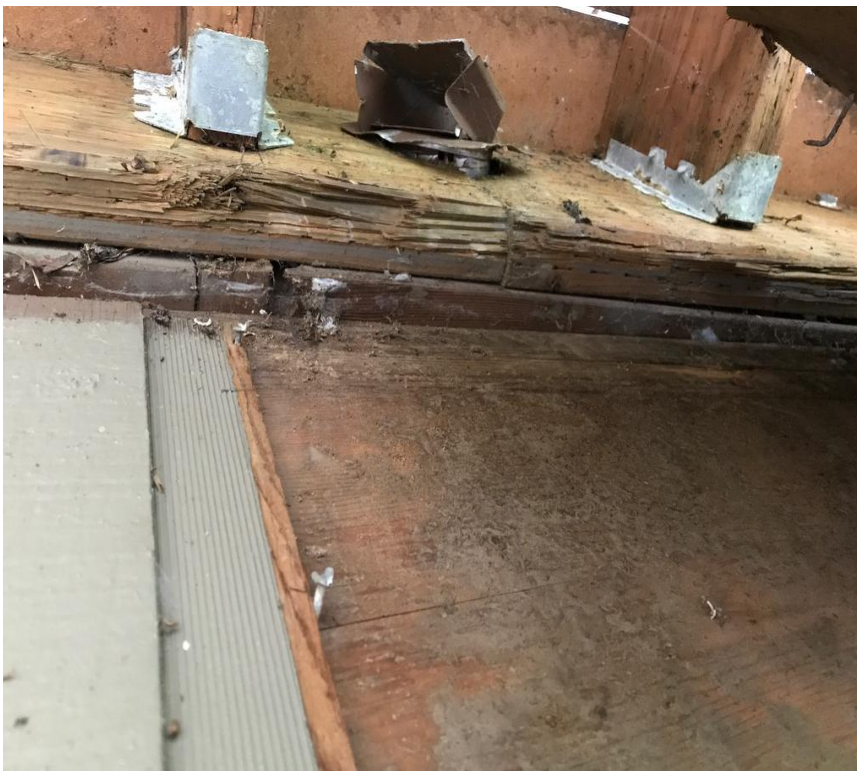
**4.4 – Invasive Opening #4**

Once the panel siding was removed, the wall assembly could be observed to see the code required WRB was omitted.

Severity Rating: 3

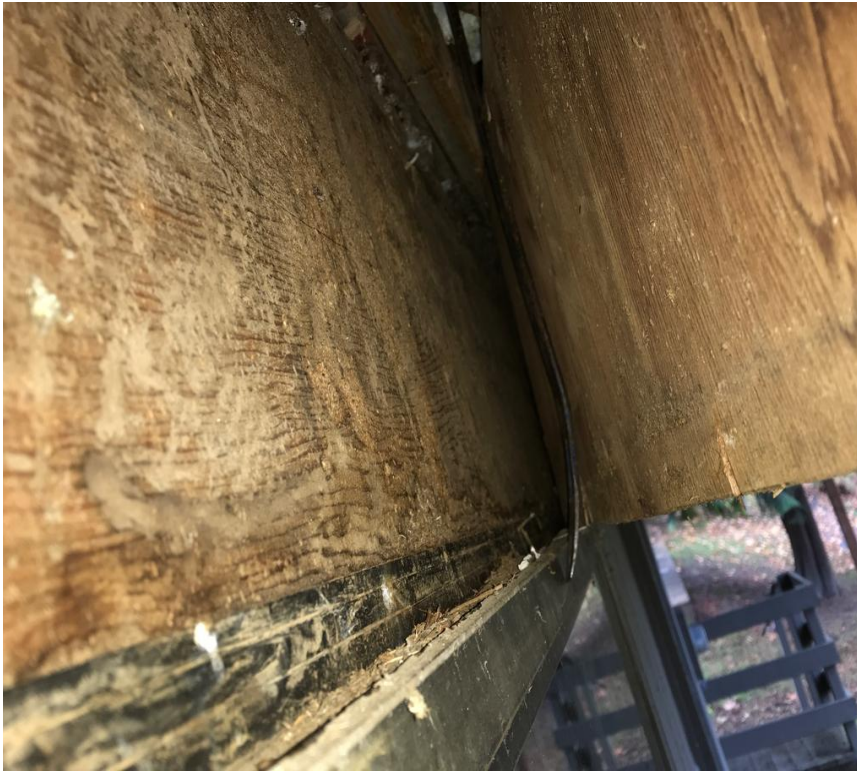
**4.5 – Invasive Opening #4**

Head flange of the aluminum window below the deck ledger. There are no typical and code required components present to limit water infiltration into the wall assembly. No WRB, SAM flashing, sheet metal flashing, or sealant.

Severity Rating: 3

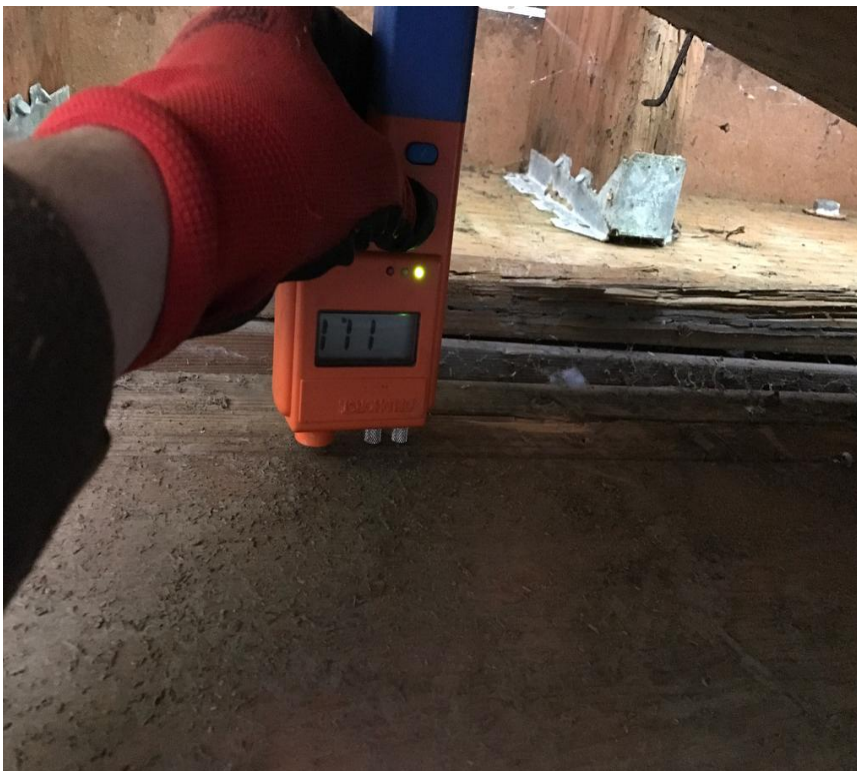
**4.6 – Invasive Opening #4**

The quantity of water infiltrating behind the panel siding has brought debris from the deck surface above. Even with the high volume of water infiltration the moisture content of the wood framing members read sufficiently dry (11.1 mass percent).

Severity Rating: 3
