# **GABRIEL COMMONS**

**3831 – 3897 SW Canby St.  
Portland, OR 97219**

## **PRELIMINARY SIDING ASSESSMENT**

**November 30, 2018**

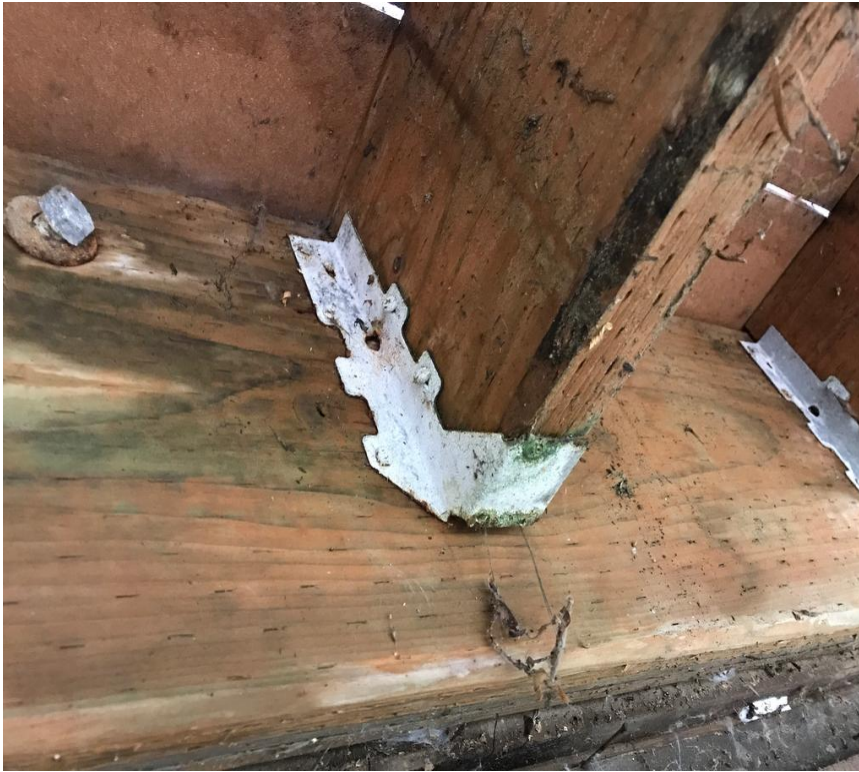
**4.7 – Invasive Opening #4**

All the observed structural hardware and fasteners for the deck ledger were observed to be corroded. The hardware was observed to be a common exterior grade material, but likely incompatible with the specific preservative treatment applied to the ledger.

Severity Rating: 2

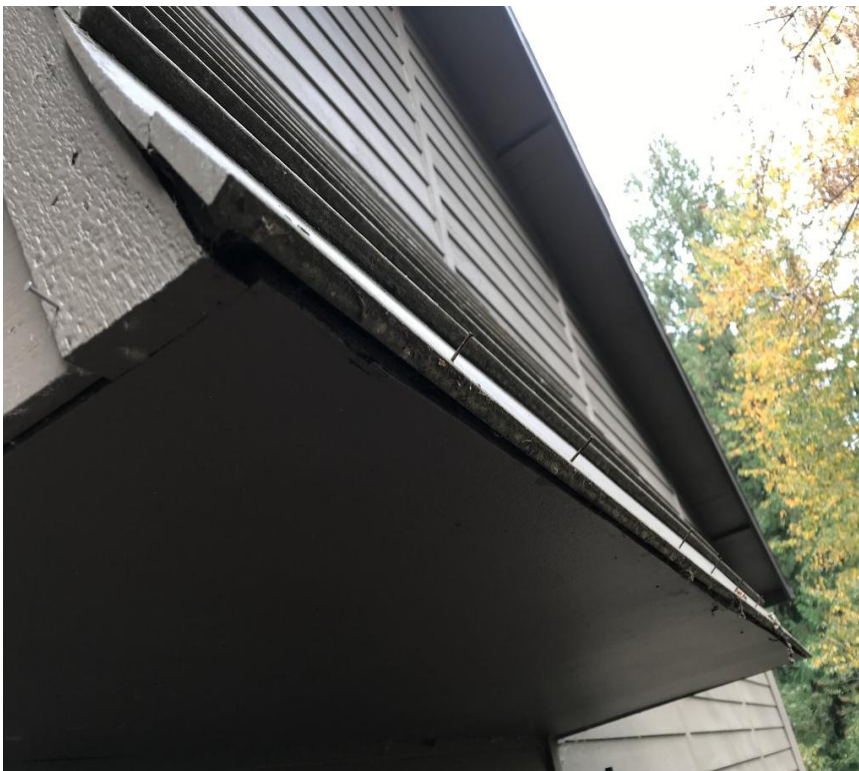
**5.1 – Roof**

There is no drip edge flashing or underlayment extending past sheathing into gutter.

Severity Rating: 4

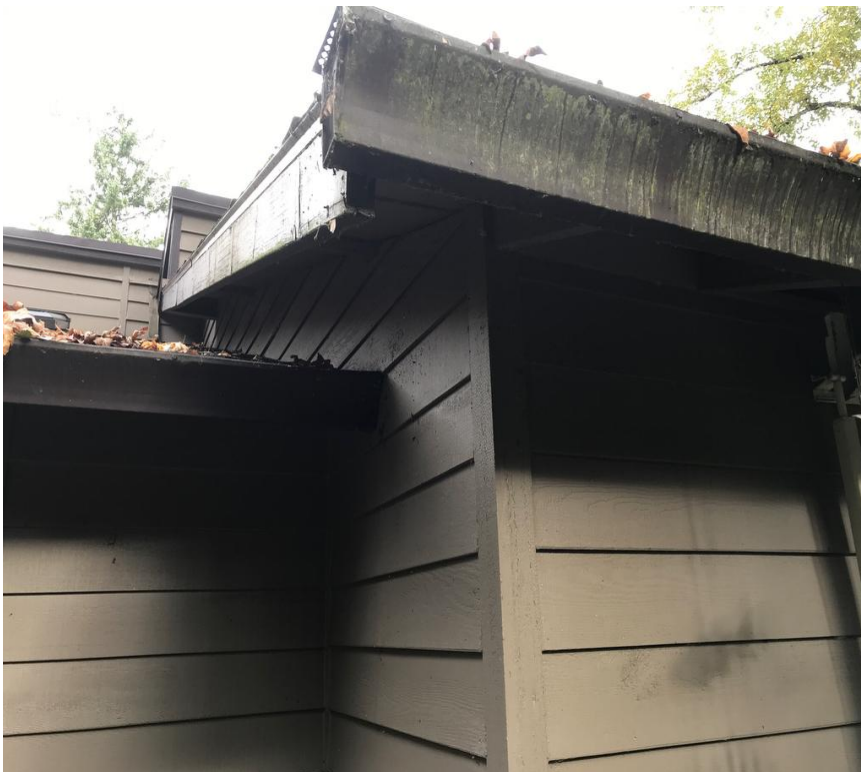
**5.2 – Roof**

Diverter flashing appears to be omitted or inadequately dimensioned.

Severity Rating: 3

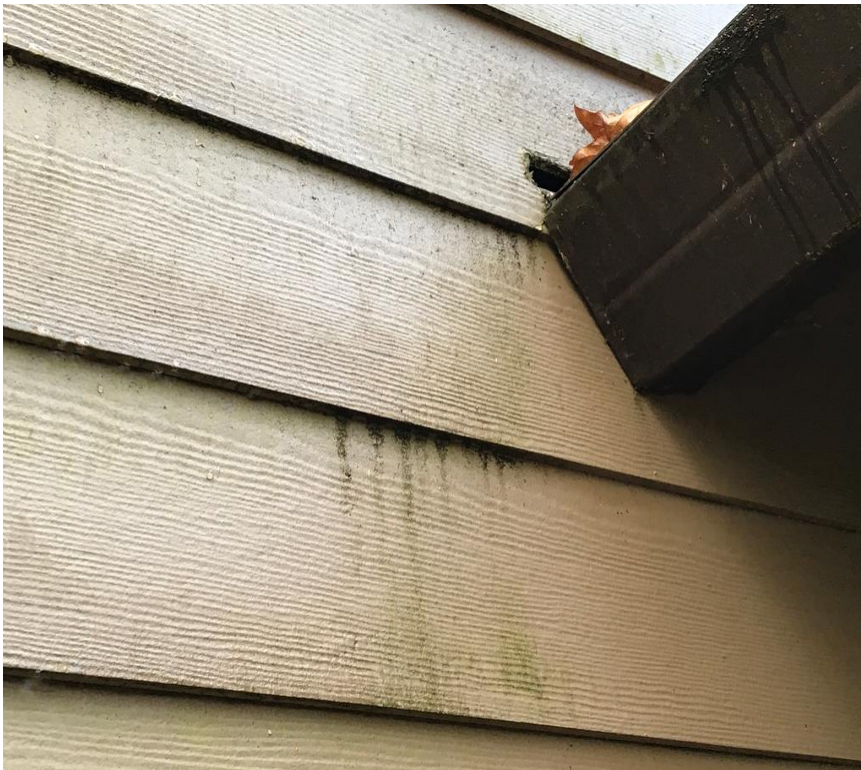
**5.3 – Roof**

Diverter flashing is improperly constructed. The lap siding appears to also be overcut at this location. The siding manufacturer also requires a minimum of 1" clearance between the siding and the end of the gutter.

Severity Rating: 3

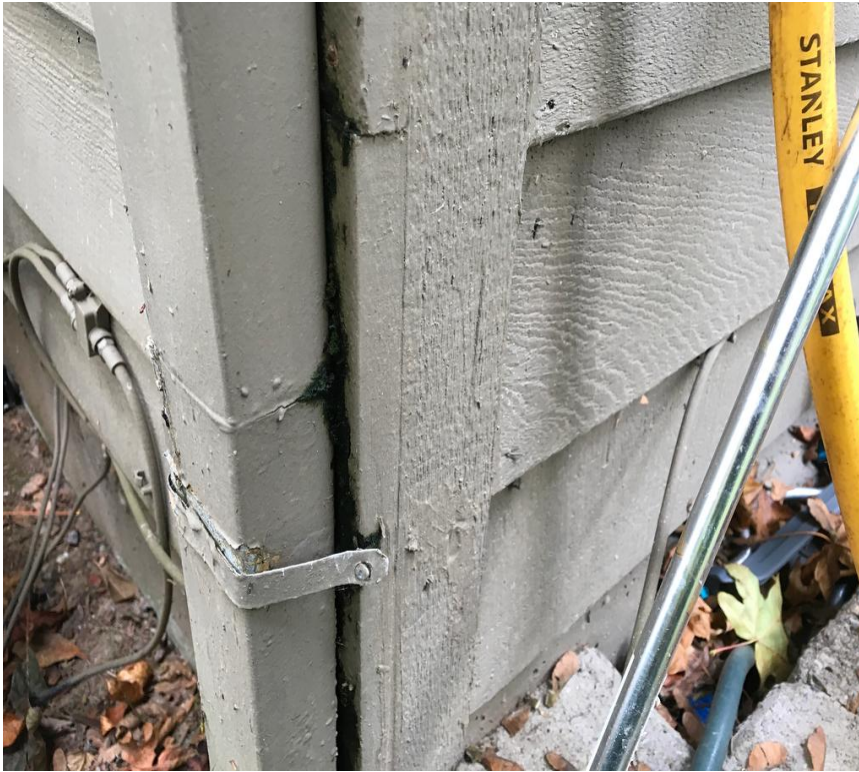
**6.1 – Wall**

Trim is weathered and/or has peeling paint.

Also, note the improper joint in the corner board trim. All vertical joints should be constructed to shed water away from the building.

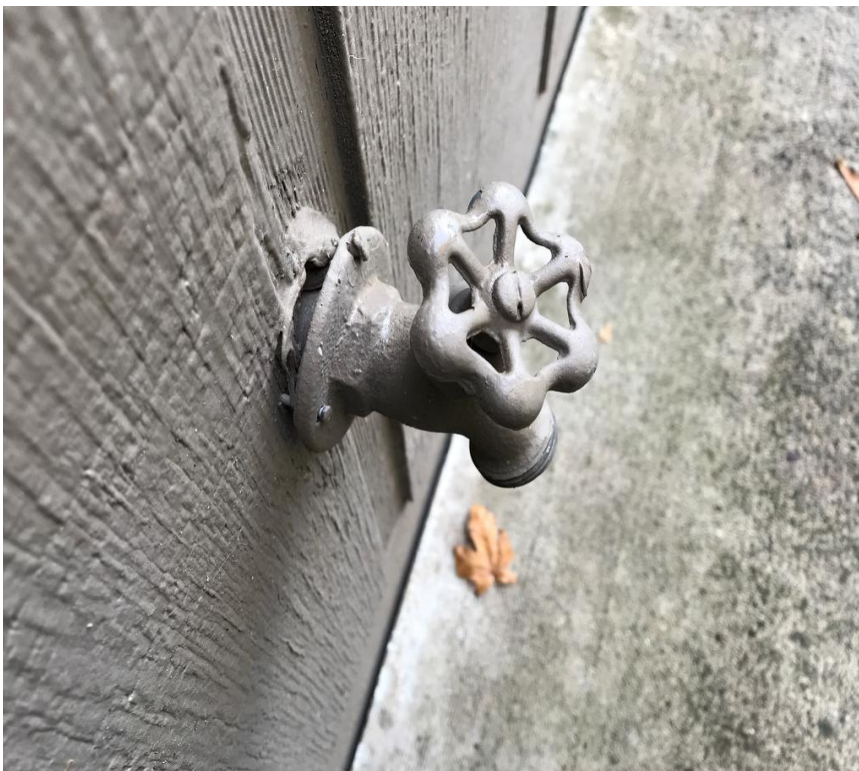
**6.2 – Wall**

Penetrations are not sealed, or are inadequately sealed, to prevent water intrusion.

Severity Rating: 3

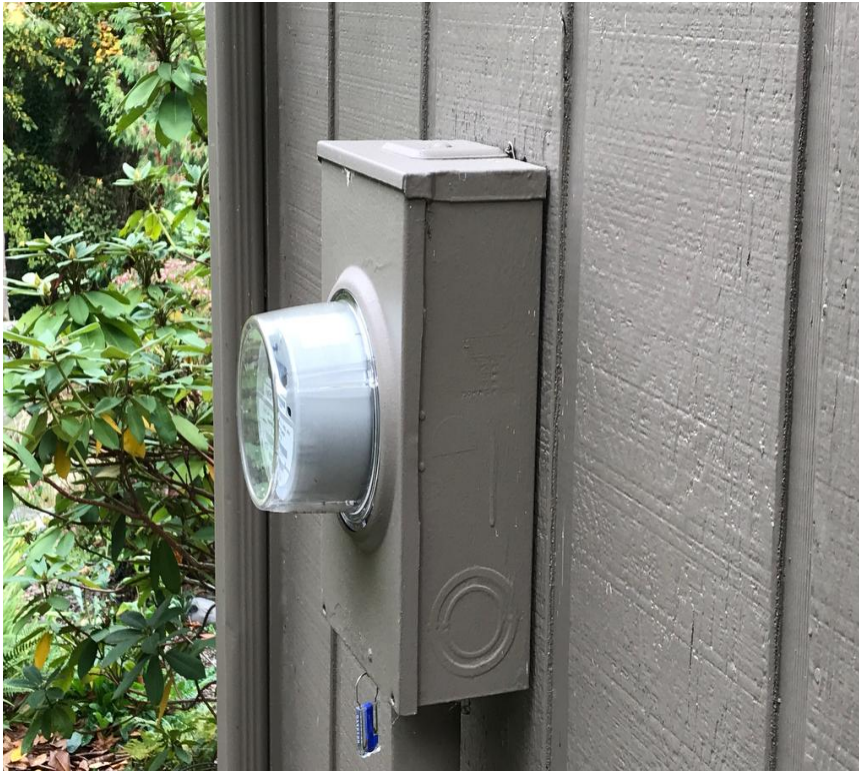
**6.3 – Wall**

Electric meter is installed over siding and without flashing to prevent water intrusion.

Severity Rating: 3

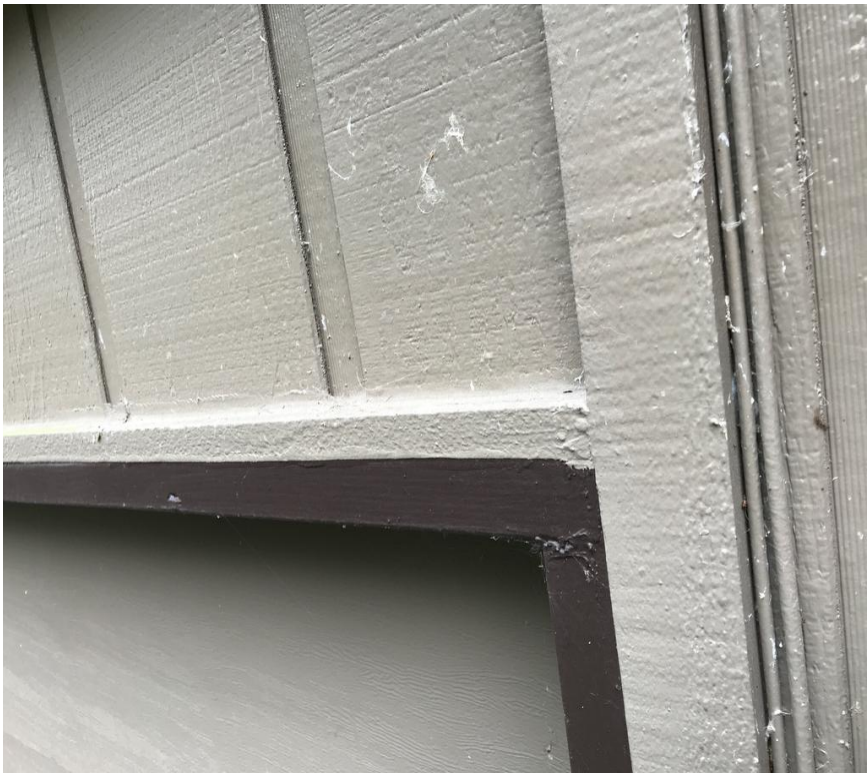
6.5 – Wall

Flashing is omitted, leaving the top of wood trim unprotected.

Severity Rating: 3

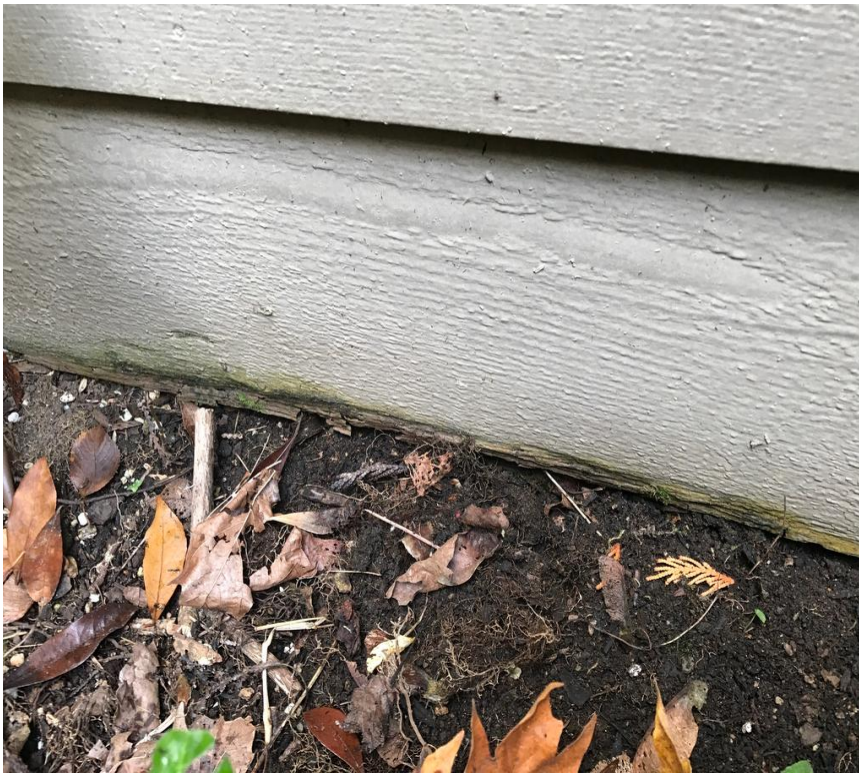
**6.6 – Wall**

Siding is installed less than 6" above grade. Note the bottom edge of deteriorated siding due to soil contact.

Severity Rating: 2

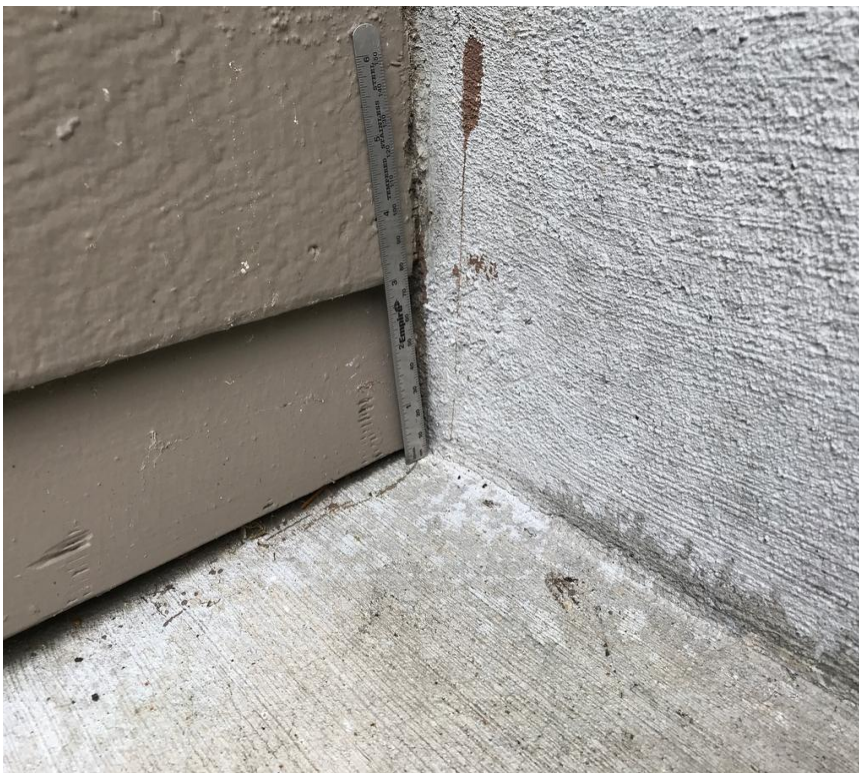
**6.7 – Wall**

Siding is installed less than 1"-2" from horizontal surface.

Severity Rating: 3

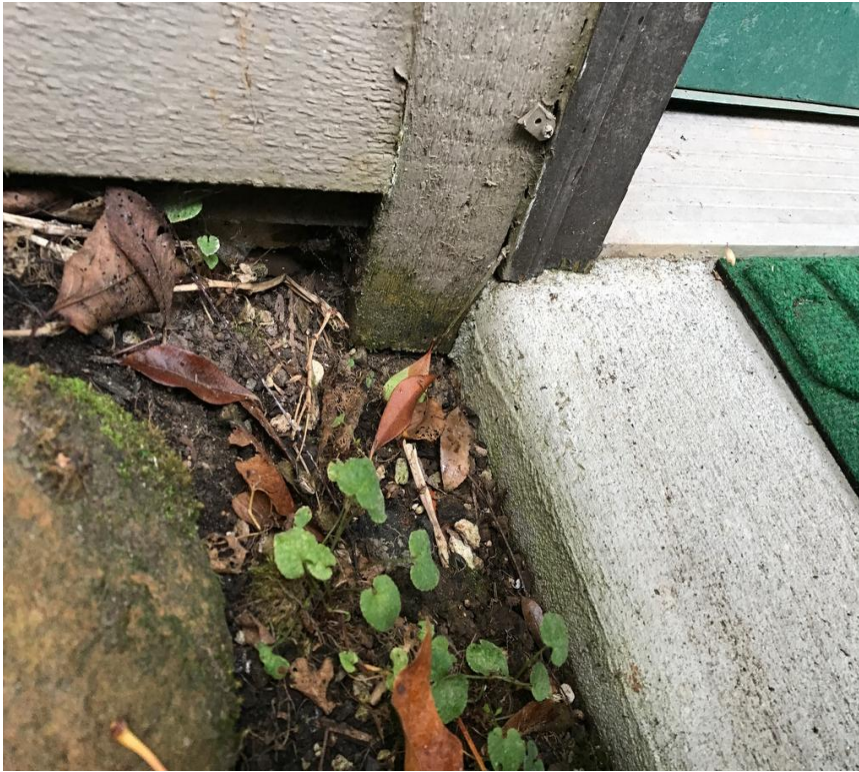
**6.8 – Wall**

Trim is installed less than 6" above grade.

Severity Rating: 3

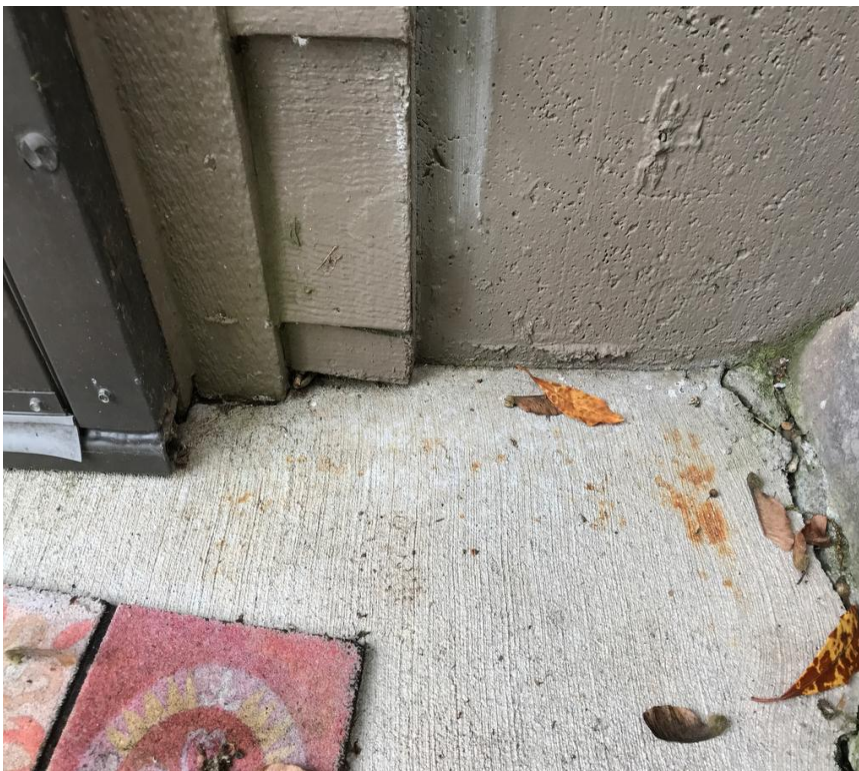
**6.9 – Wall**

Trim is installed less than 1"-2" from horizontal surface.

Severity Rating: 3

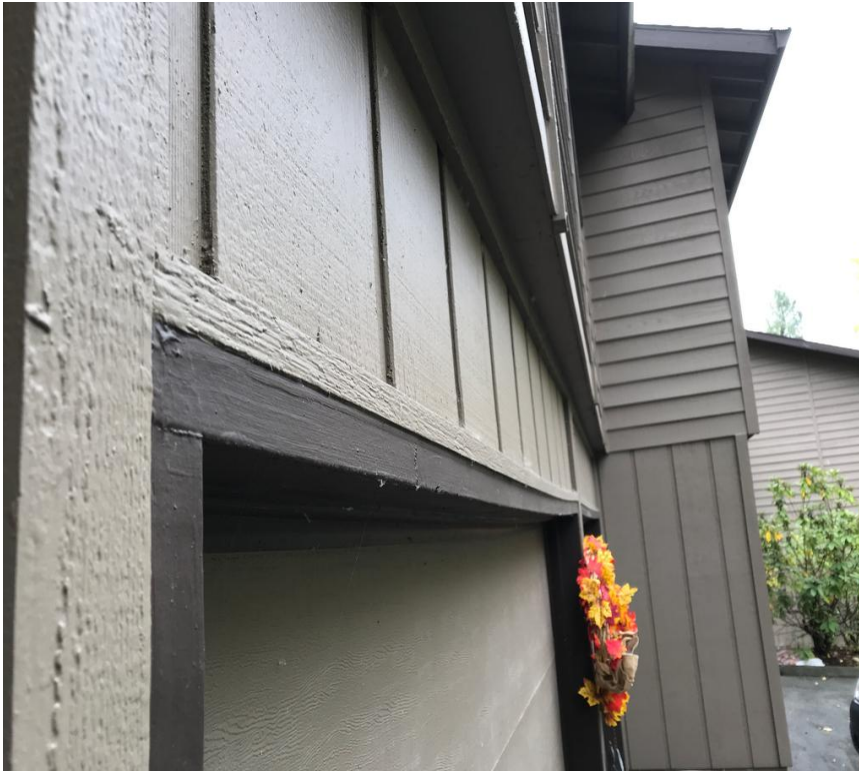
**6.10 – Wall**

Deflection present in garage header beam.

Severity Rating: 6

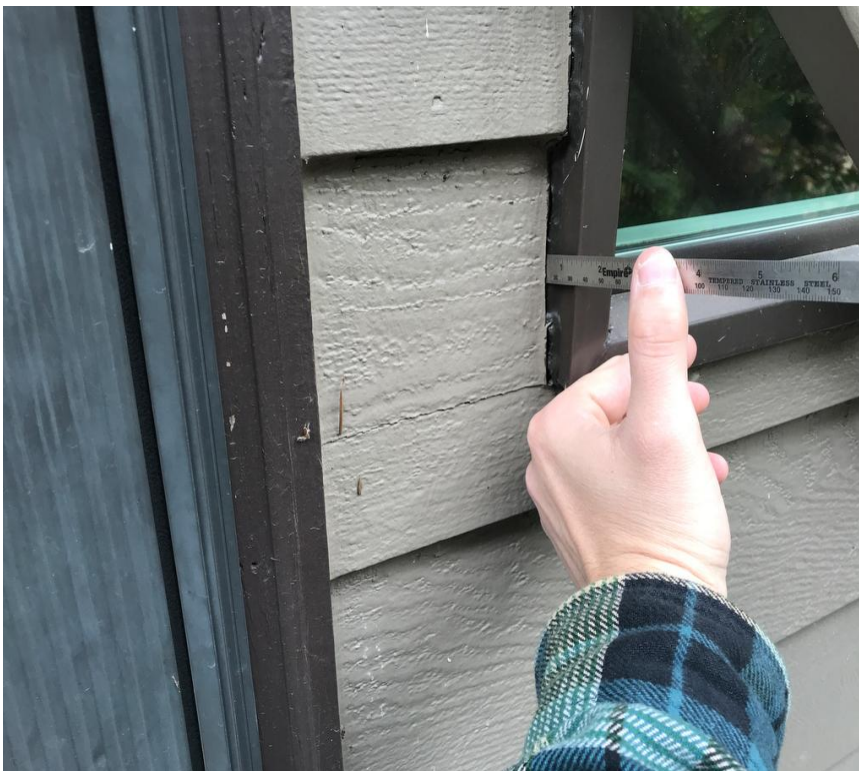
**6.11 – Wall**

Sealant fillet joint has failed due to 3-sided adhesion – not using bondbreaker tape, backer rod, and/or improperly dimensioned joint.

Severity Rating: 3

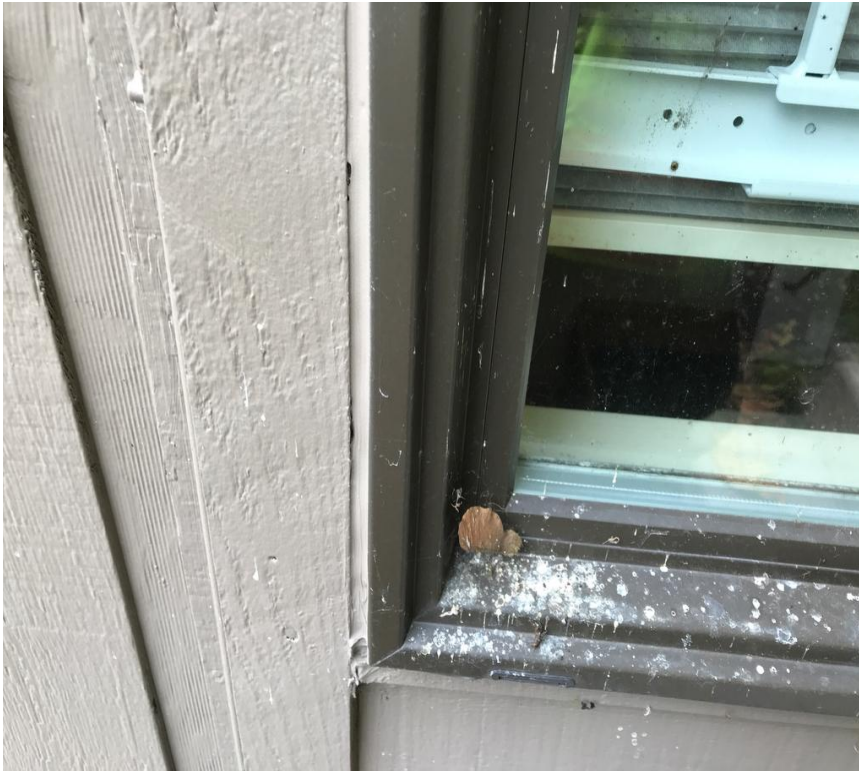
**7.1 – Fenestrations**

Sealant at window has failed.

Severity Rating: 3

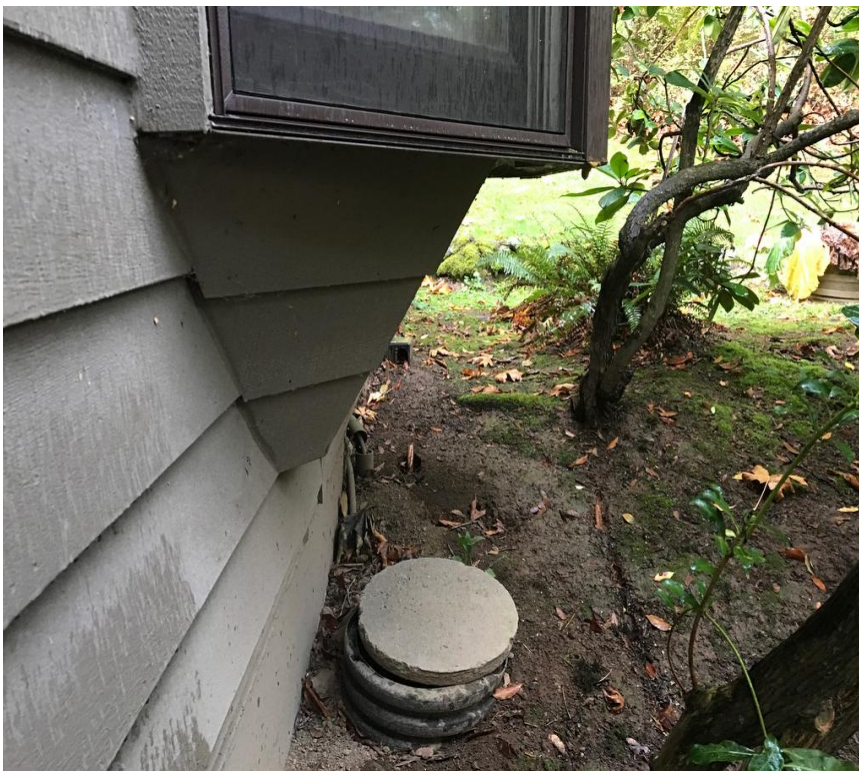
**7.2 – Fenestrations**

Bay window support is questionable.

Severity Rating: 6

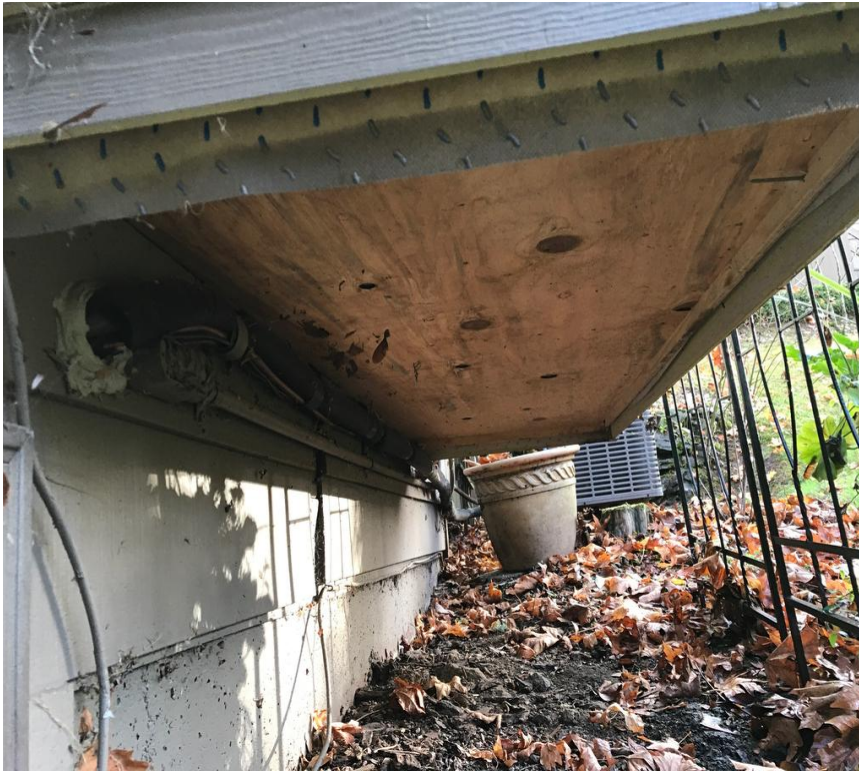
**8.1 – Decks & Landings**

WRB is deteriorated/stained due to excessive water exposure.

Severity Rating: 3

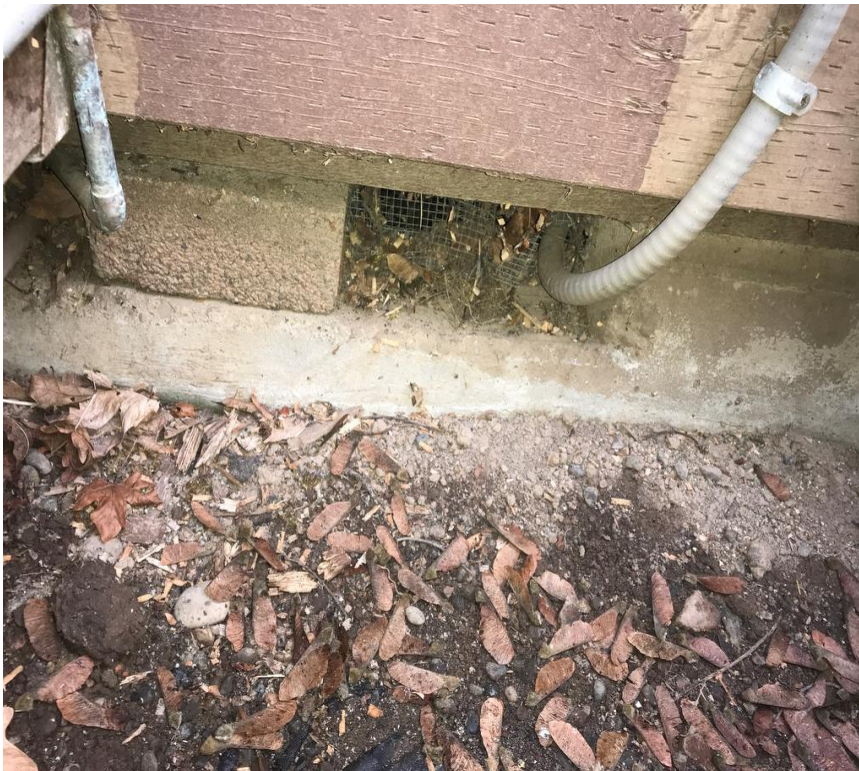
**9.1 – Crawlspace & Below Grade**

Crawlspace appears to be under ventilated.

Most observed crawlspace vents were covered, clogged, or occupied by other components. Note that the rodent screen may be compromised at these locations.
