# Gabriel Commons

## Property Condition Assessment

3831-3897 SW Canby St., Oregon 97216

CBS Ref.: 16-045.00

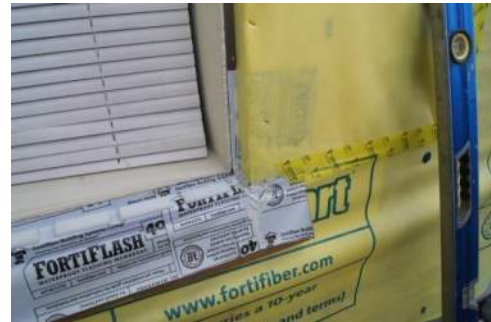
Today's standard practice in new construction or during major renovation is to provide an integrated flashing assembly that turns into the rough openings to provide waterproof "pans" beneath the window and door units (refer to photo). This pan flashing is meant to protect the structure below and drain the incidental water out of the wall system in the event that water leaks around the windows and doors.

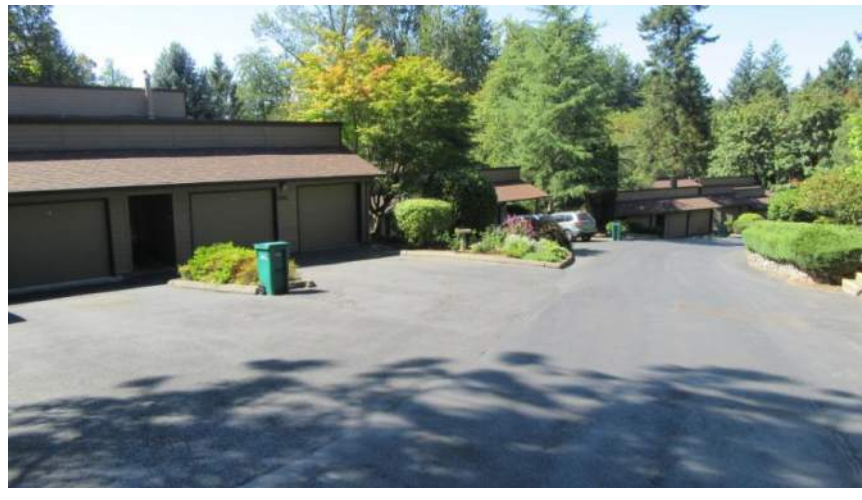
**Photo 1**

Gabriel commons constructed on a gradually sloping site.

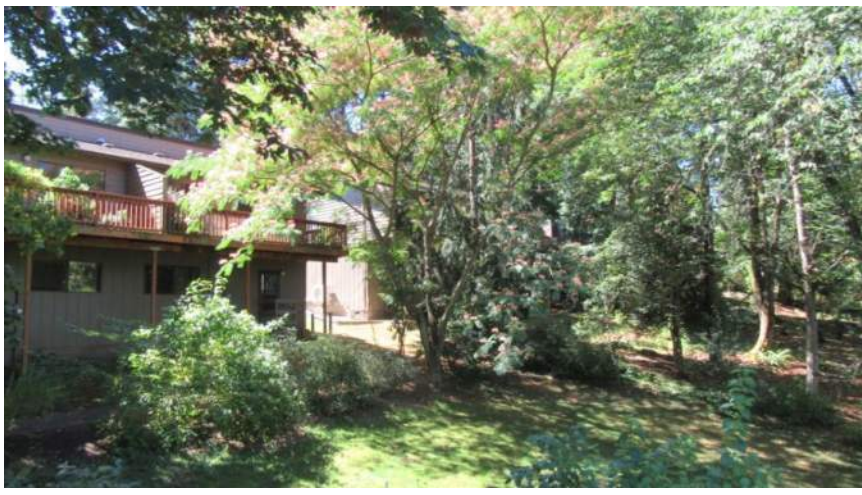
**Photo 3**

Typically, the downhill side of the buildings are 2 stories and the uphill sides are one story.

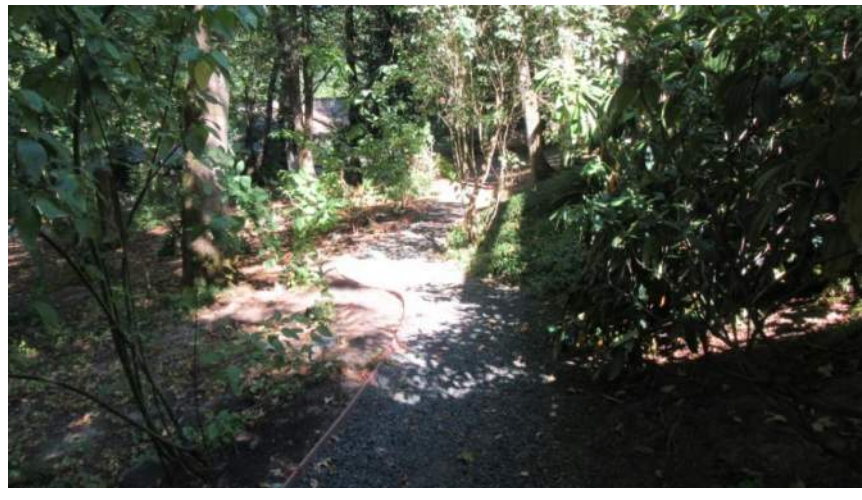
**Photo 4**

The center of the property is heavily wooded, with large mature trees and shrub undergrowth.

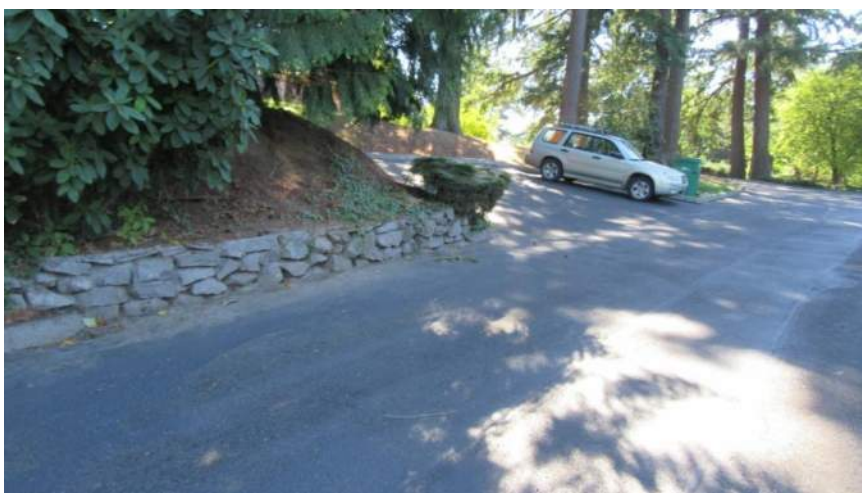
**Photo 5**

Toward the entrance of the property large Douglas firs are present.

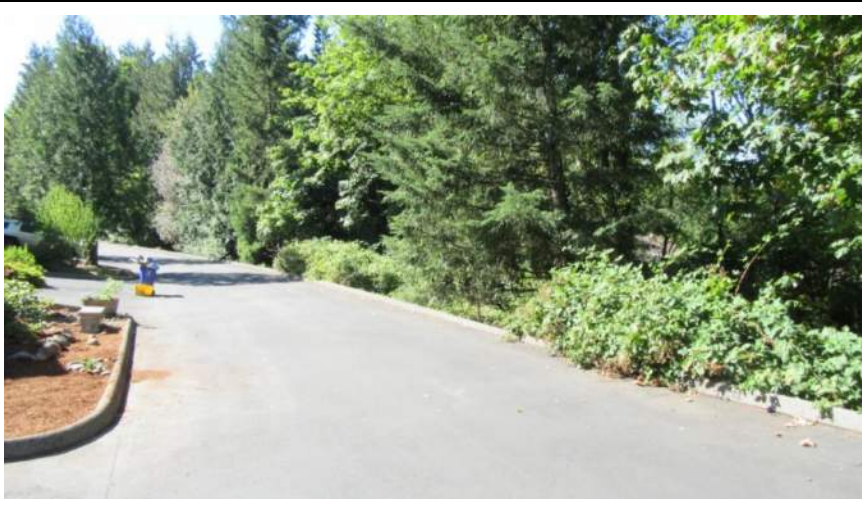
**Photo 6**

Mature trees shaded most of the property, including the landscaped areas, which consisted mostly of small shade-tolerant undergrowth and some areas of grass or shrubs near the sun exposed perimeters. Along the north perimeter of the property, the landscaped areas were beginning to become overgrown with invasive plant species. The trees appeared to be well maintained and pruned to prevent contact or overhanging of most of the roof surfaces. Some trees have begun to encroach on the roof surfaces and buildings, which we recommend get pruned back.

Along the north perimeter of the property large trees line a ravine where a small creek flows.

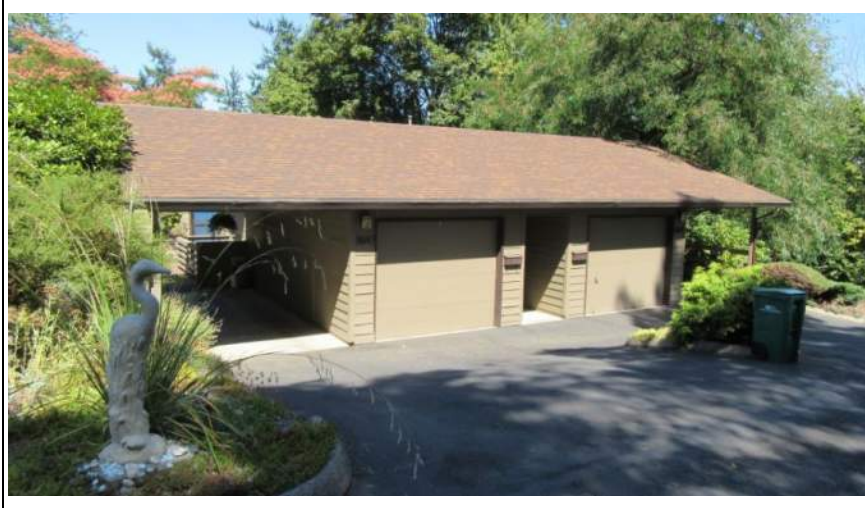
**Photo 7**

Landscaping around the buildings appears to be maintained by the unit owner.

At building perimeters, the plant species and landscaping varied and appear to be maintained by the unit owner. We recommend plants be maintained in a manner that prevents contact with the building exteriors or overhangs the roof surfaces, and that irrigation does not directly spray the buildings or cause pooling water to develop along the foundation wall.

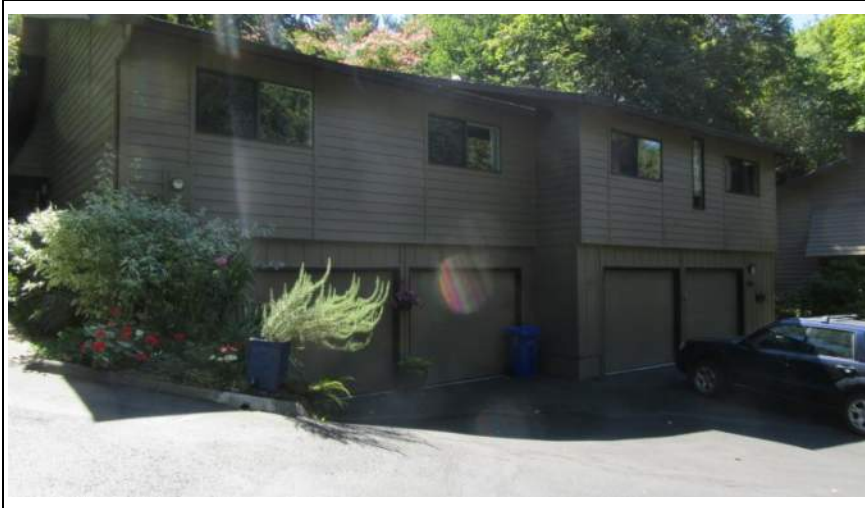
**Photo 8**

Typical landscaping at the building perimeters.

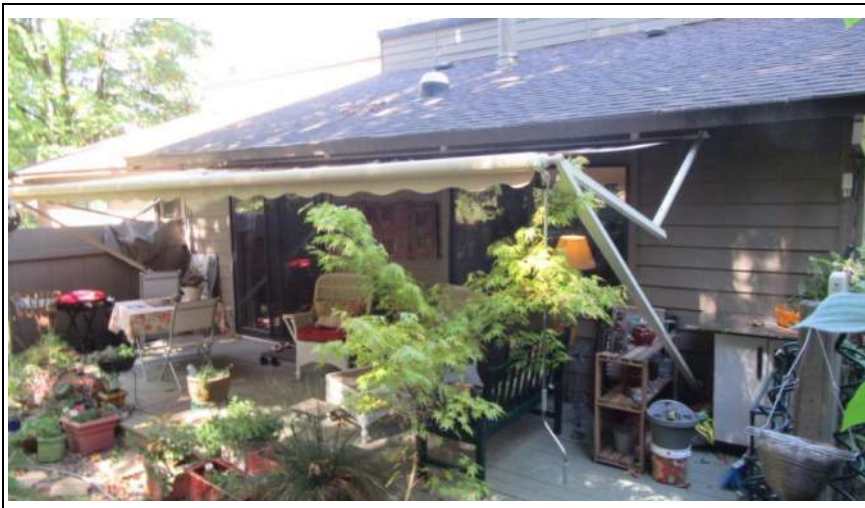
**Photo 9**

Private landscaping.

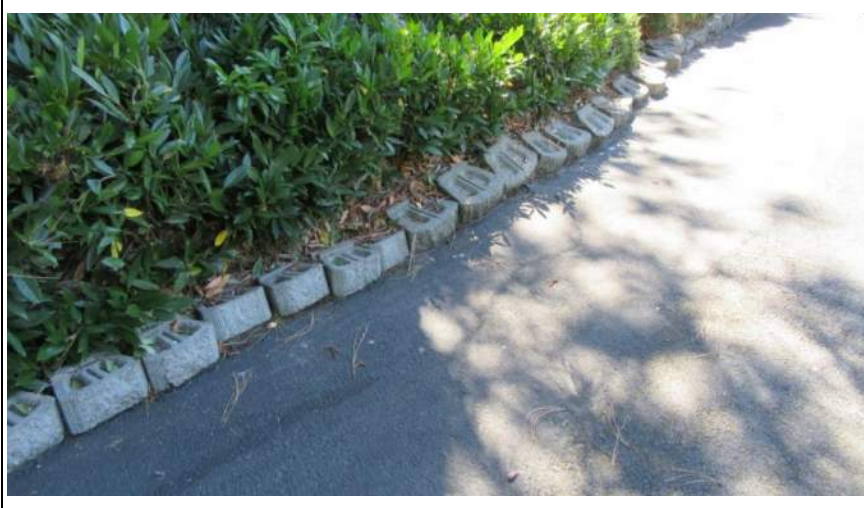
**Photo 10**

As curbs have eroded, they have been replaced with CMU pavers.

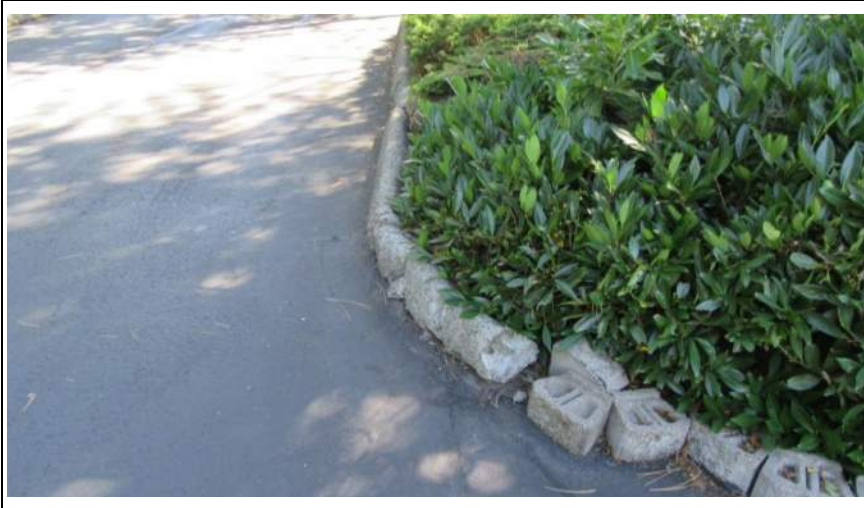
**Photo 11**

Concrete curbs, sidewalks, and flatwork exist throughout the site. Concrete curbs are the most prominent concrete feature, boarding the roads and planter beds near the road. Concrete curbs were in fair condition, with several areas in need of repair.

Concrete curbs have deteriorated and are being replaced with CMU blocks.

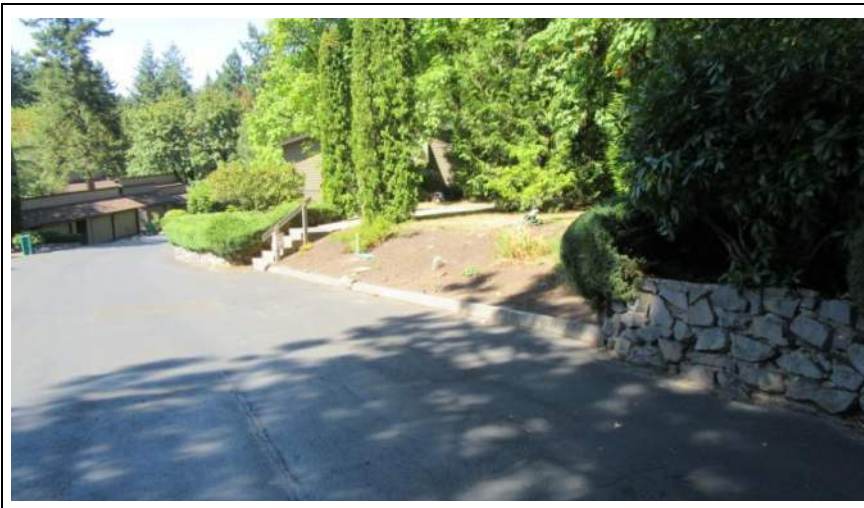
**Photo 12**

Concrete curbs line the perimeter of the street and some planter beds near the street.

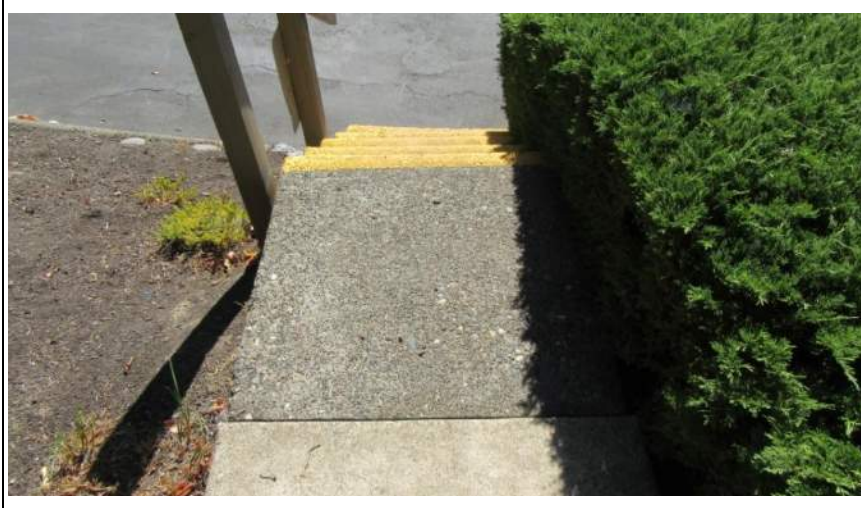
**Photo 13**

Concrete stain providing access to the pool area.

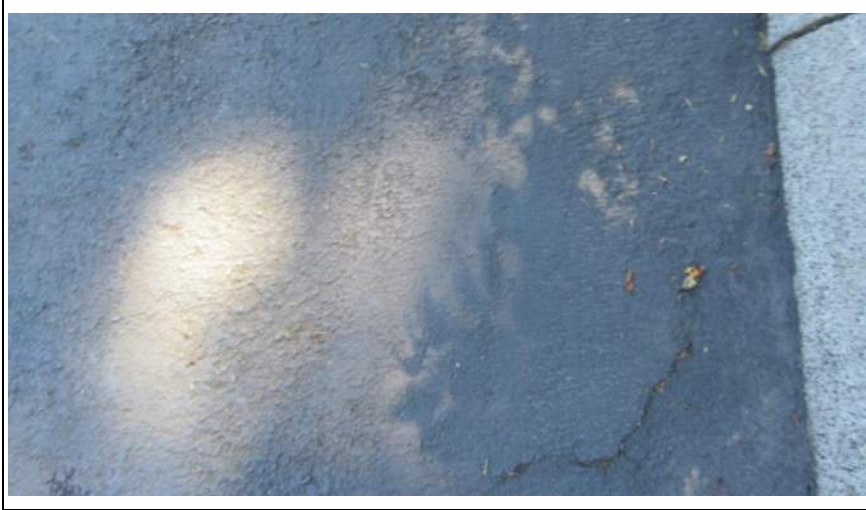
**Photo 16**

A continuous asphalt surface formed the roadway through the complex as well as the off-street parking and driveways. The asphalt surface appeared to be well maintained. We observed one major pot-hole, marked by a cone; otherwise, we did not observe any significant deterioration of the surface. Cracks in the surface were observed, and appeared to have been previously sealed. At some locations, the cracking has redeveloped, which we recommend having sealed. The surface coat is in fair condition and likely has 1-2 years until reapplication is necessary.

Asphalt surface was in generally good condition. Some minor crack sealing is needed.

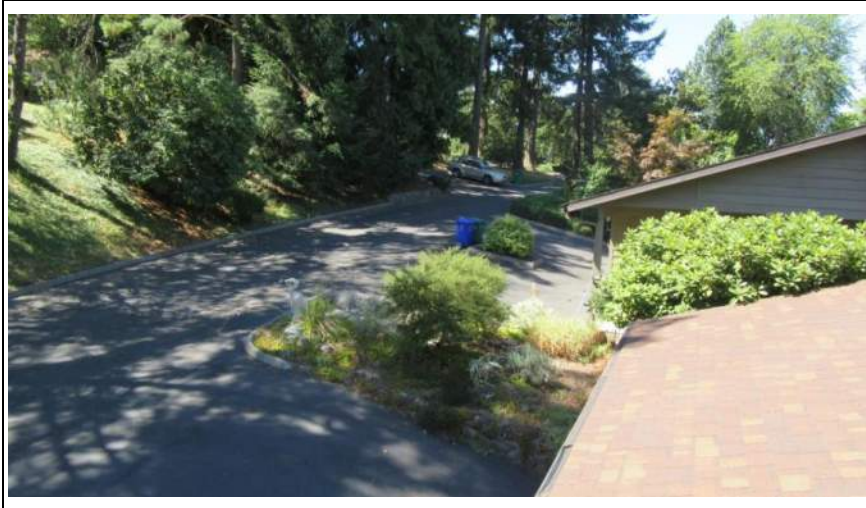
**Photo 17**

Overall of drive surface looking west toward the entrance.

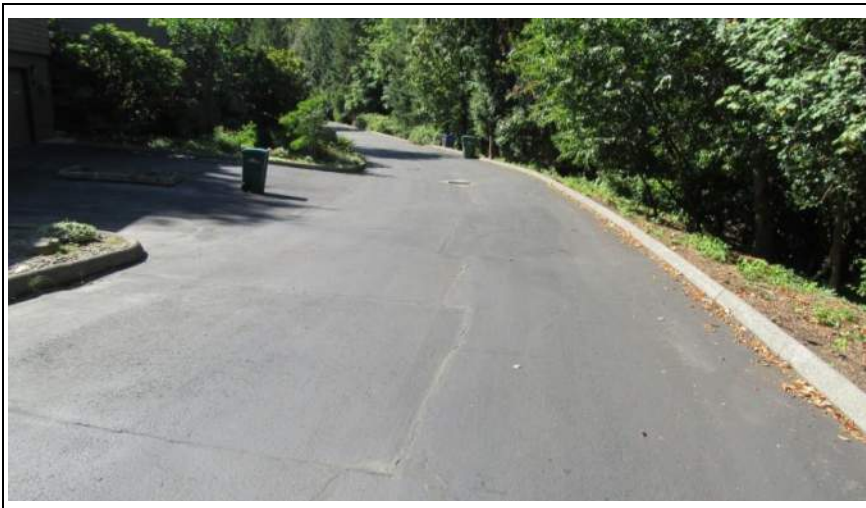
**Photo 18**

The drive surface looking west at the north perimeter of the property.

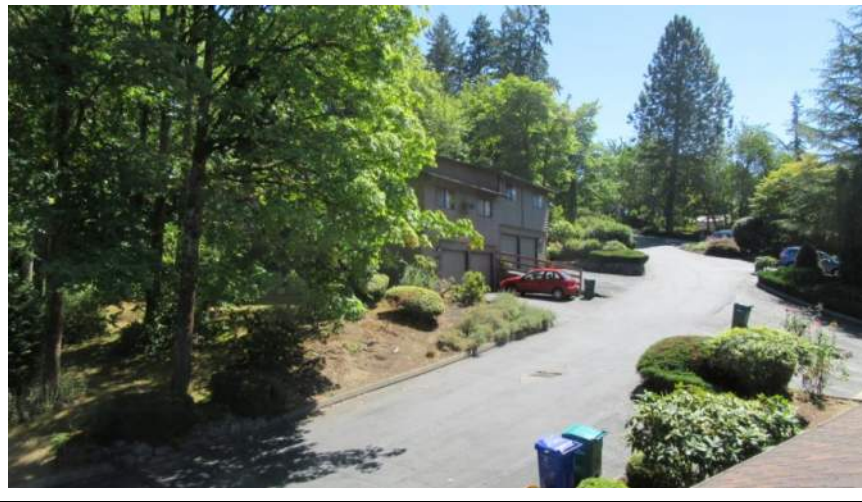
**Photo 19**

The drive surface looking south at the northwest corner of the property.

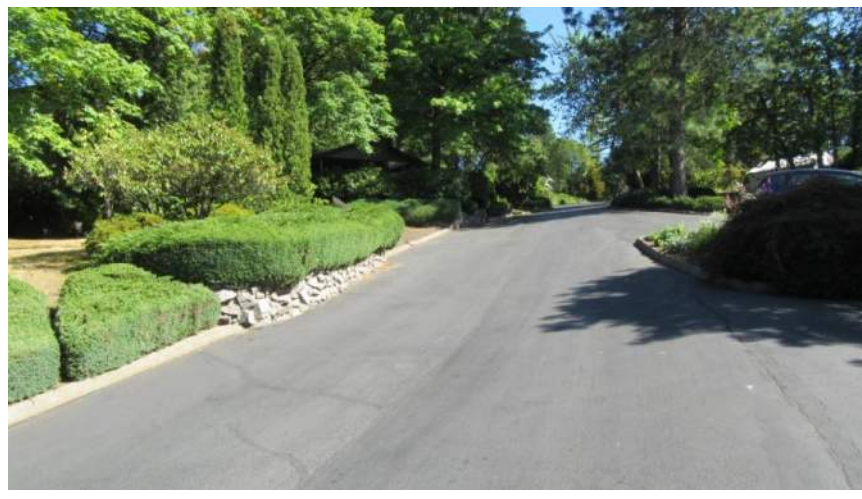
**Photo 20**

The driving surface looking east toward the entrance of the property.

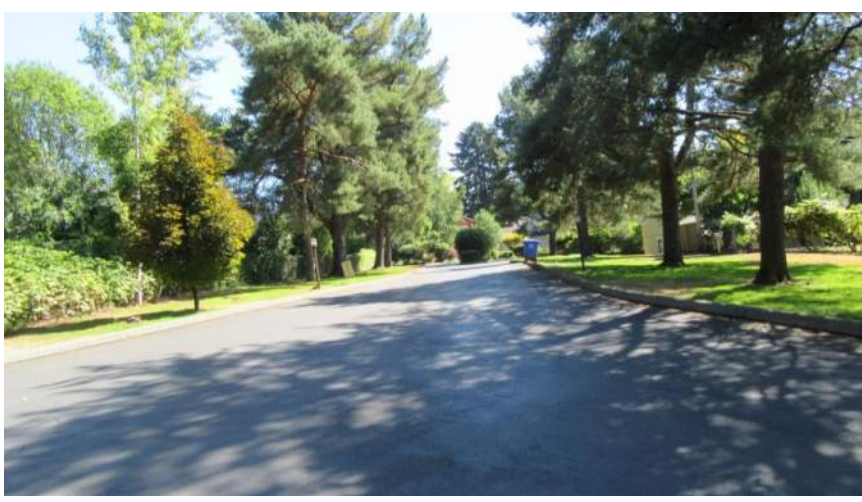
**Photo 21**

Looking south down the arterial drive connecting the loop to the city street.

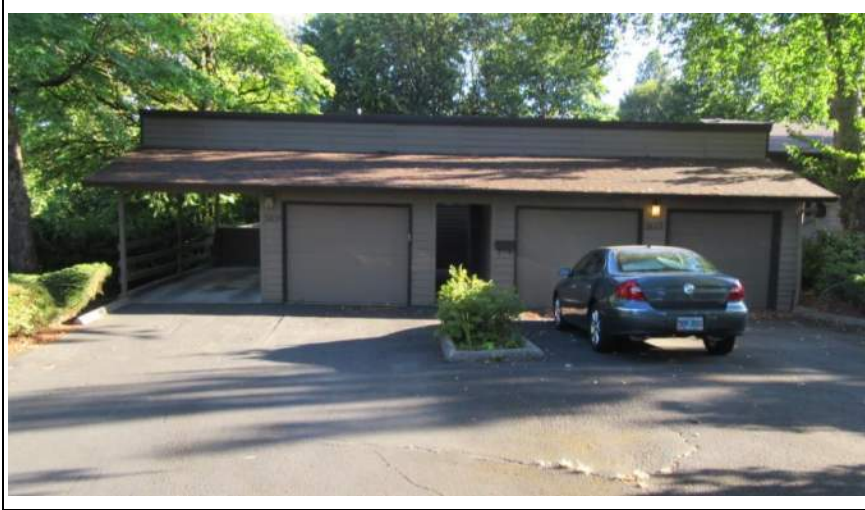
**Photo 22**  
Type 1 building.

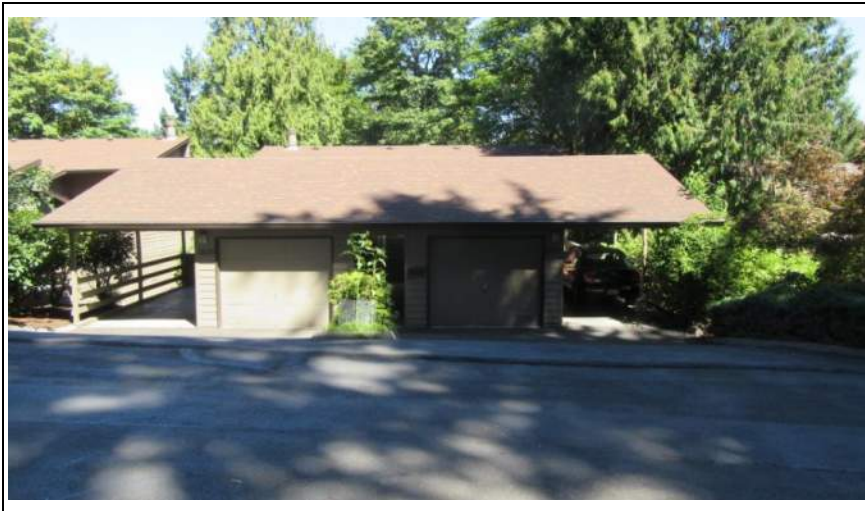
**Photo 23**  
Type 2 building.

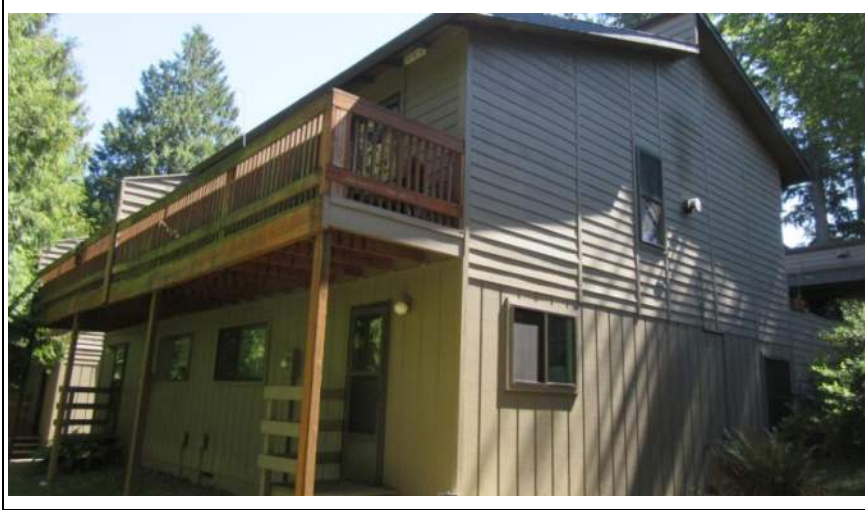
**Photo 25**

Typical side and rear elevation of a type 1 and type 2 building.

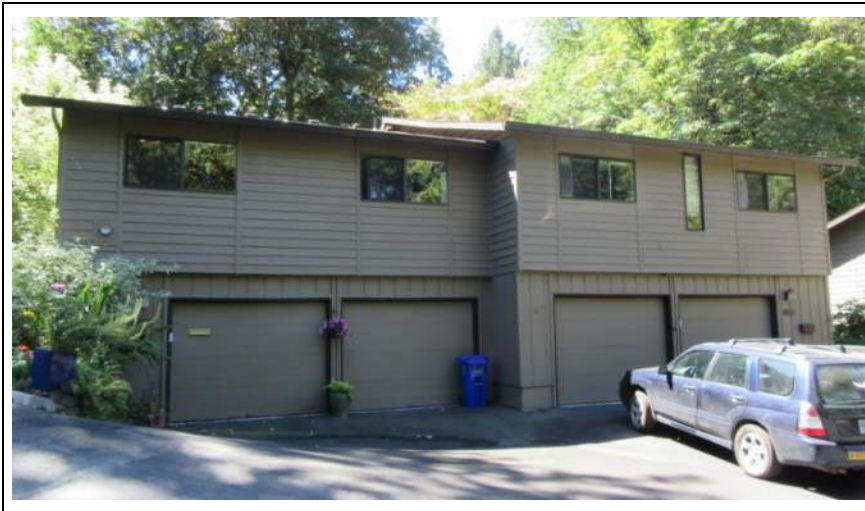
**Photo 26**

Type 3 building.

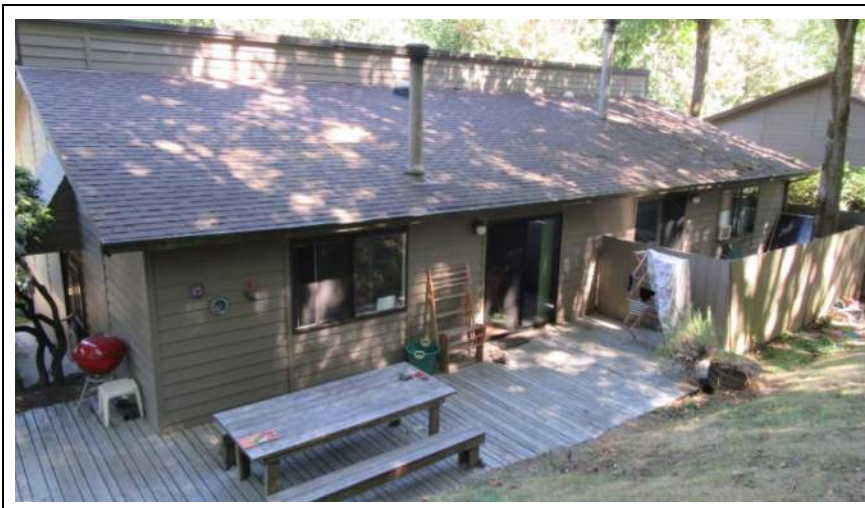
**Photos 27**

Rear and side elevation of the typical type 3 building.

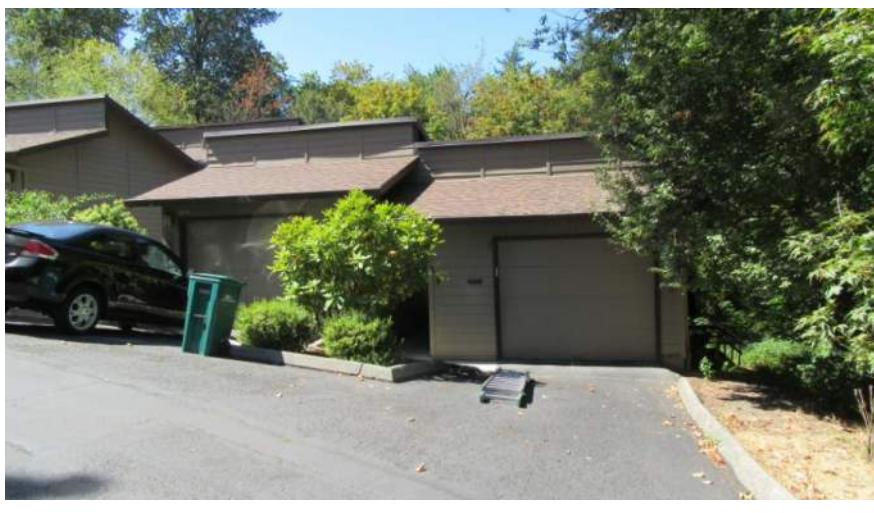
**Photo 28**

Type 4 building.

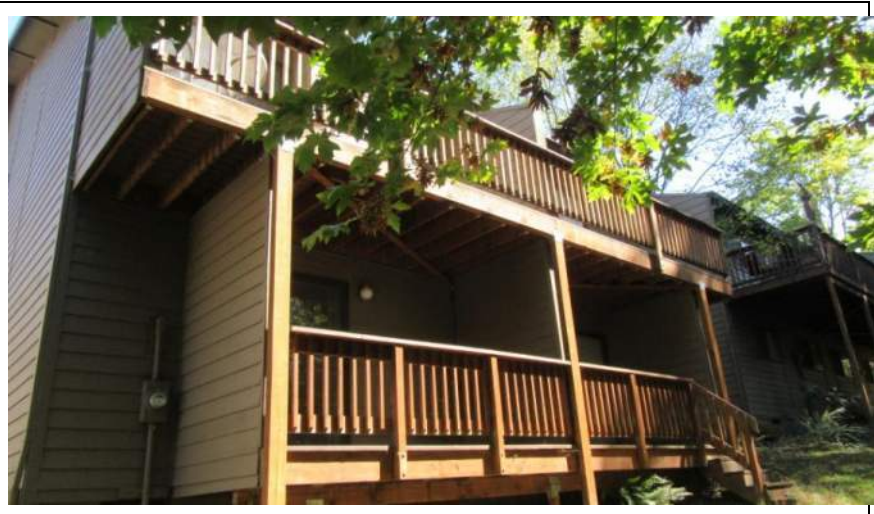
**Photo 30**

Type 4 buildings have a bottom and top level wood framed balcony.

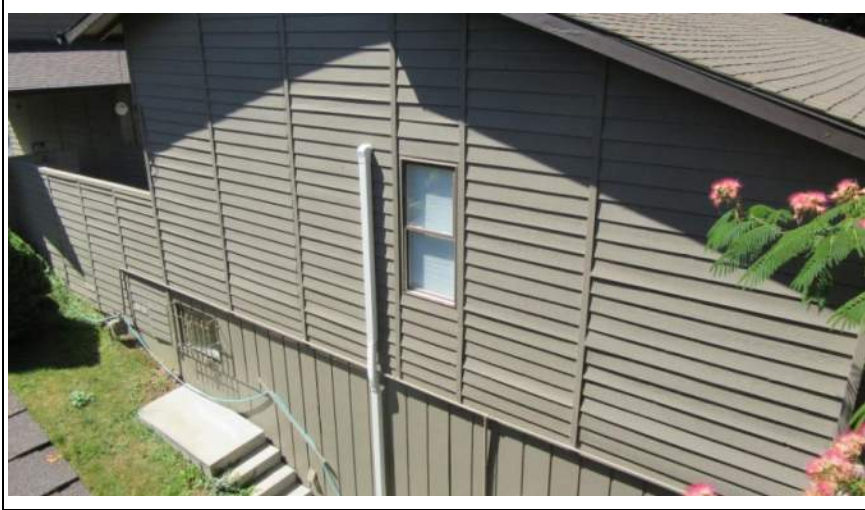
**Photo 31**

Typical cedar lap siding wall configuration. Cupping and warping in the siding are visible by the irregularities in the surface..

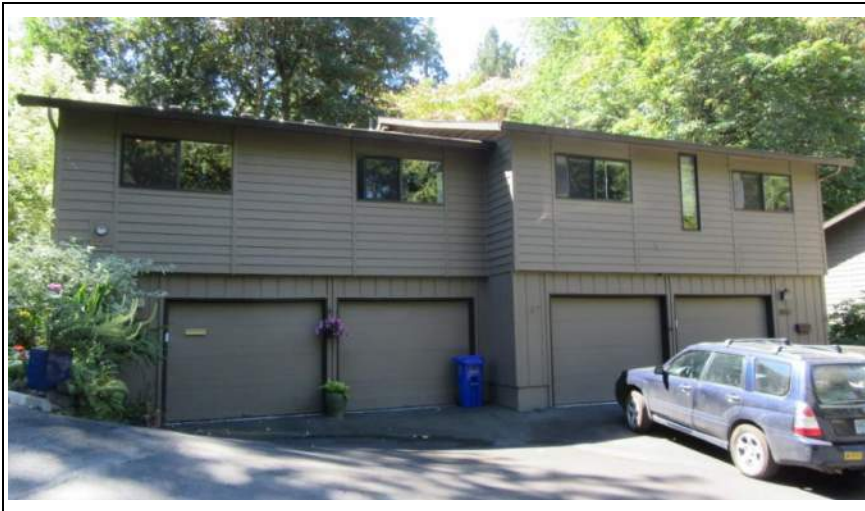
**Photo 32**

Cedar lap siding at the upper level and T1-11 at the lower level.

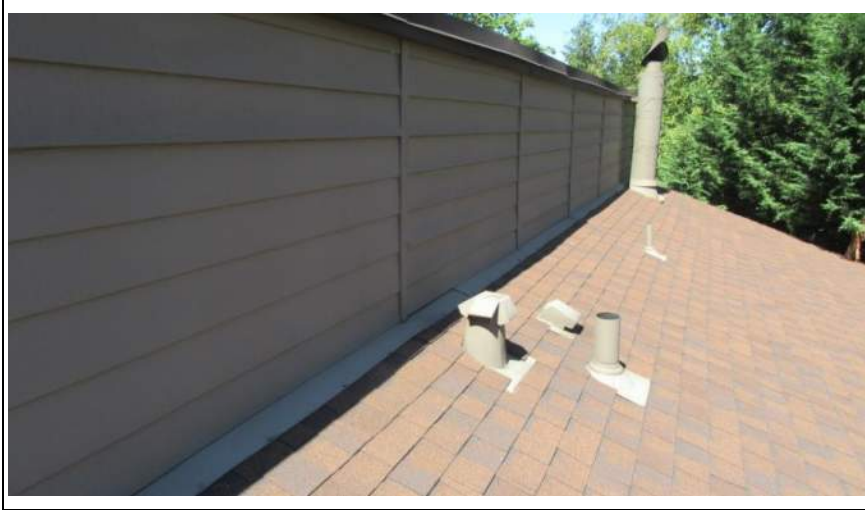
**Photo 34**

Typical head wall configuration.

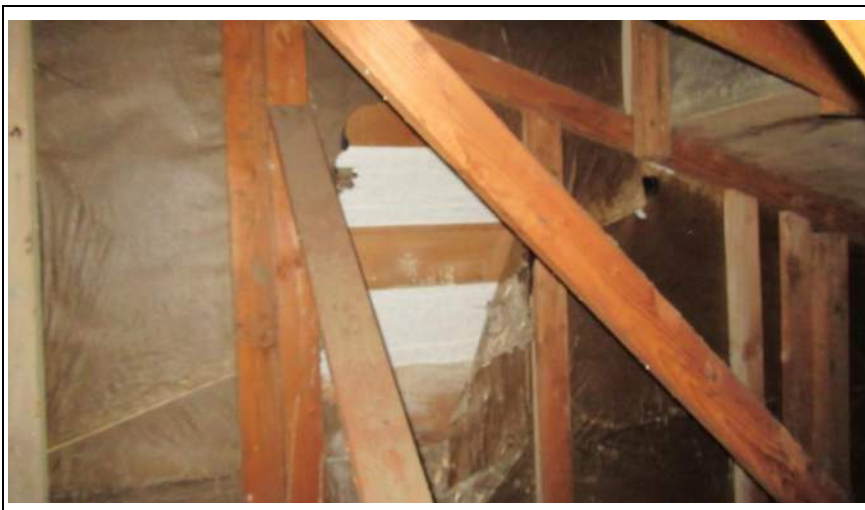
**Photo 36**

Gable walls, lap siding is installed as single-wall construction. The weather barrier was often damaged or deteriorated.

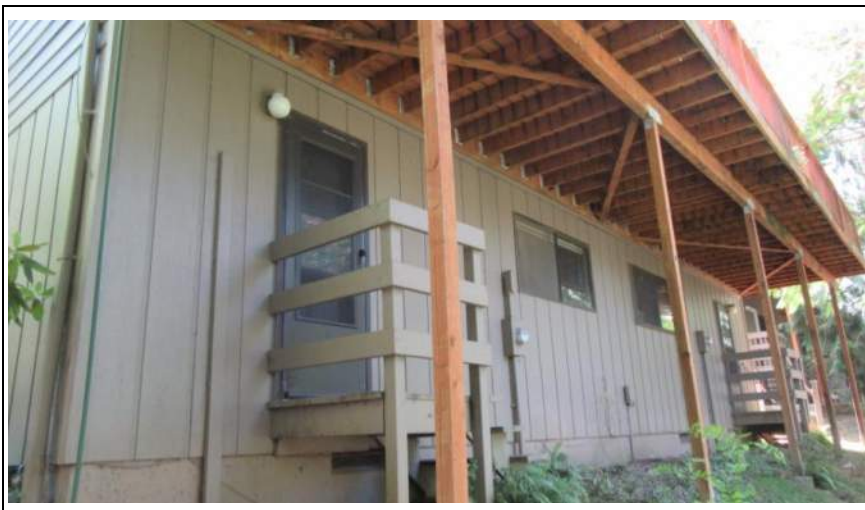
**Photo 39**

T1-11 siding installed at the bottom level of type 1 and type 2 buildings. Often the ledger was mounted directly over the siding and was not flashed to prevent water ingress.

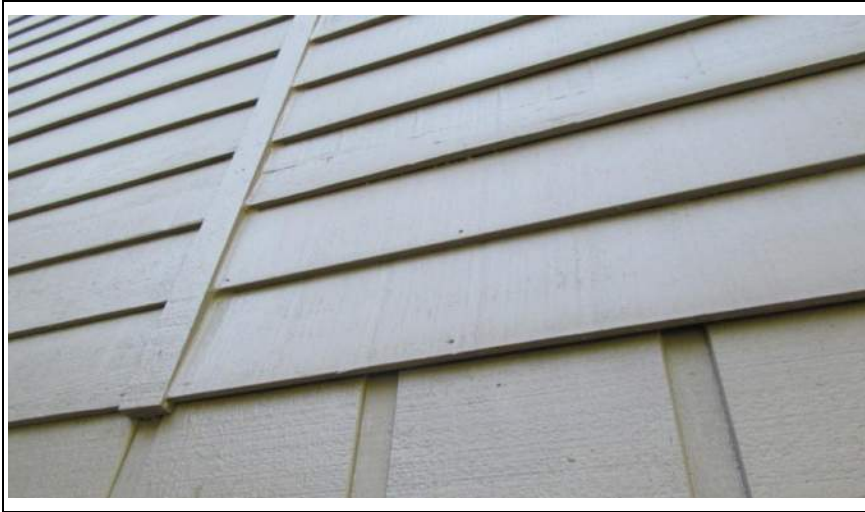
**Photo 40**

At side walls, T1-11 siding was lapped under the lap siding above to project the leading edge.

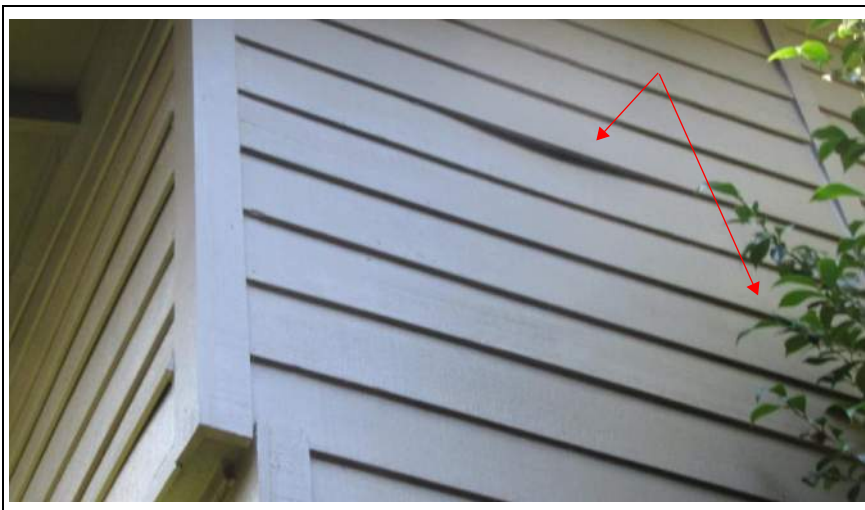
**Photo 42**

Warping of siding is creating open voids that can allow water ingress, which will further deteriorate the cladding.

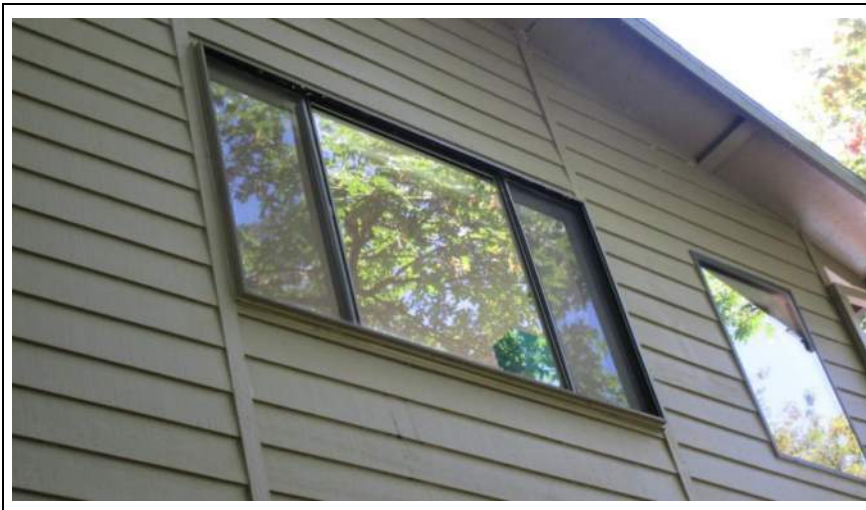
**Photo 55**

Door openings are not flashed and are entirely sealant dependent.

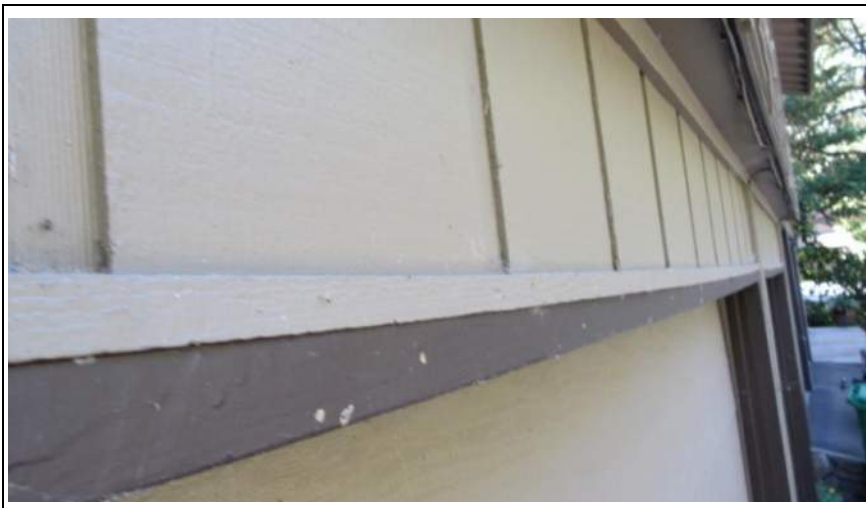
**Photo 56**

Typical jump-framed assembly.

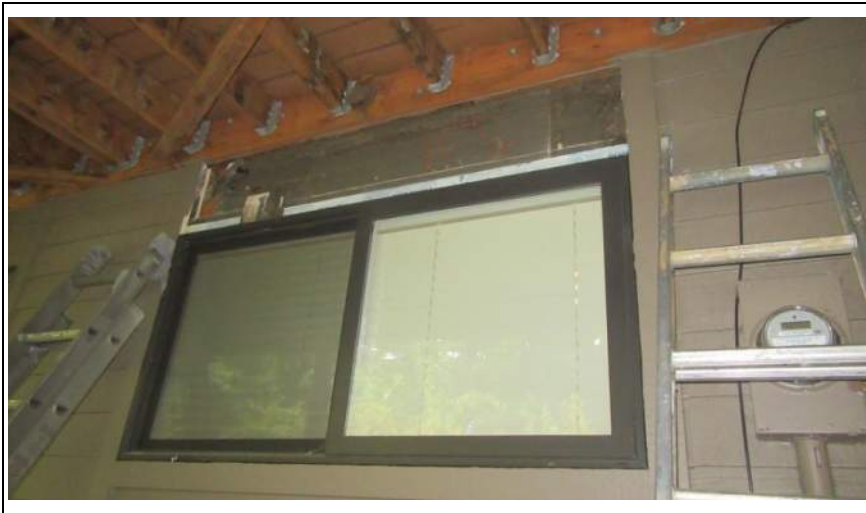
**Photo 67**

Window opening is not wrapped with membrane flashing. No weather barrier was present.

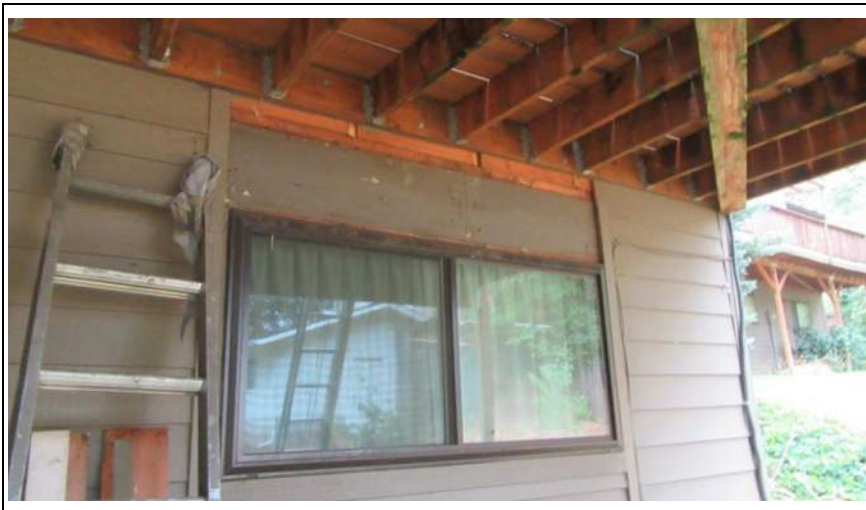
**Photo 68**

No visible weather barrier. Membrane flashing applied to the window frame only.

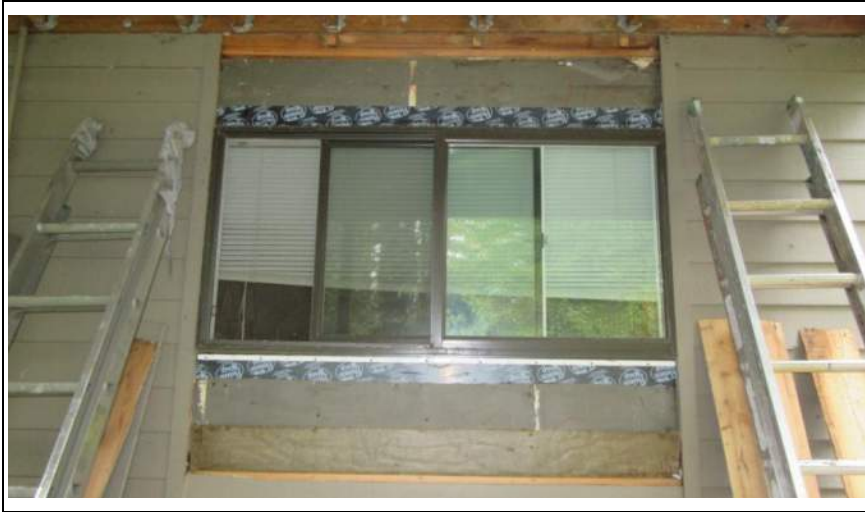
**Photo 69**

Weather barrier and membrane flashings omitted.

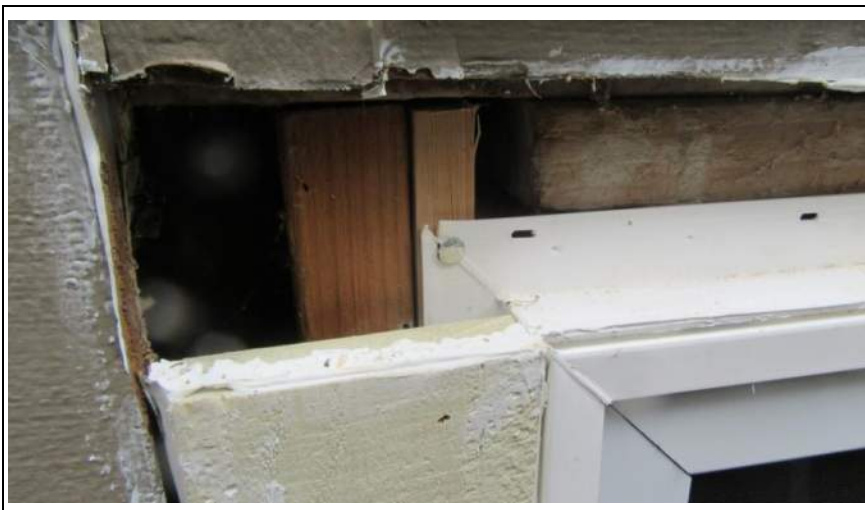
**Photo 71**

Partially applied weather barrier is heavily damaged due to prolonged exposure to moisture.

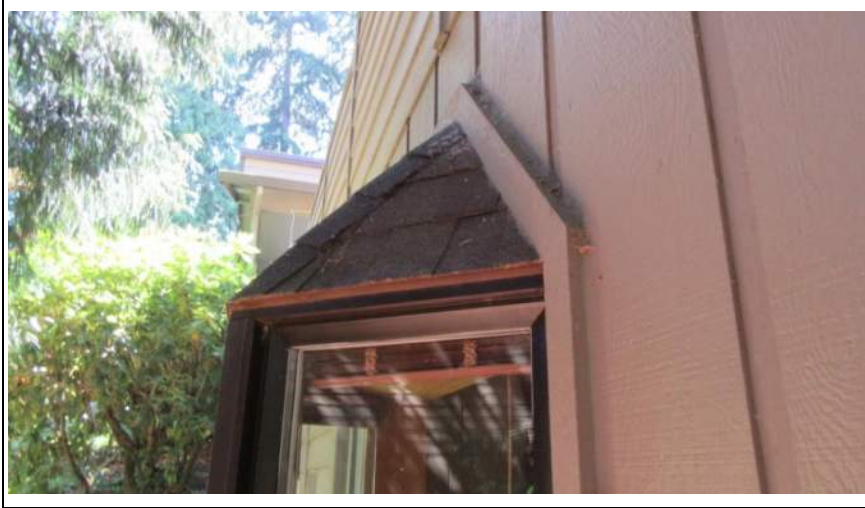
**Photo 72**

Weather barrier and membrane flashings omitted. Wall sheathing is also missing at this location.

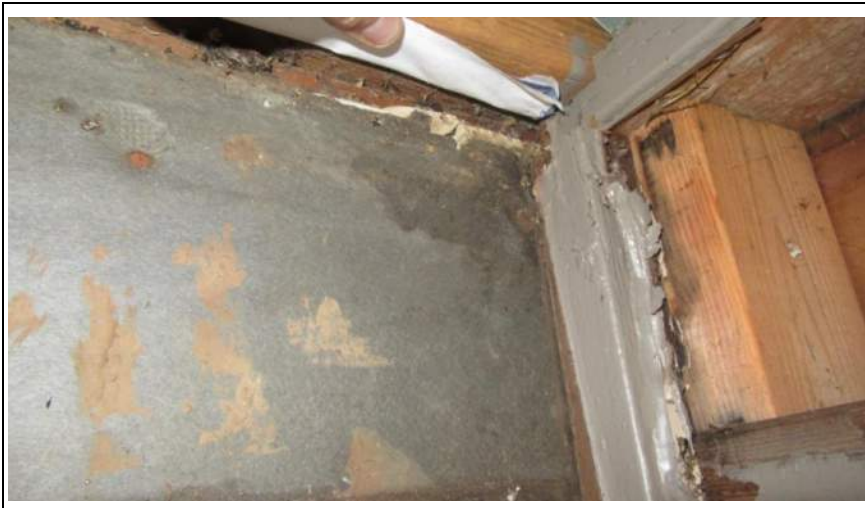
**Photo 80**

Water damaged gypsum sheathing and visible organic growth at original window installation.

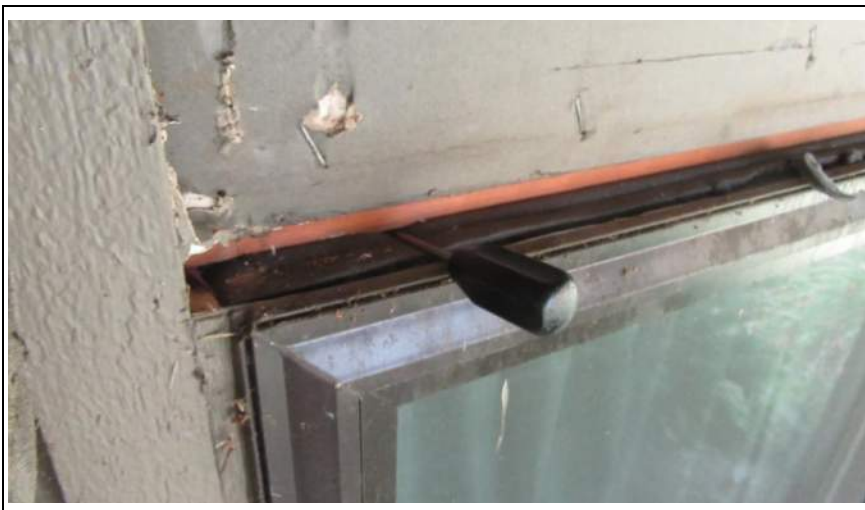
**Photo 83**

Vinyl flanged window not installed to mitigate air leakage.

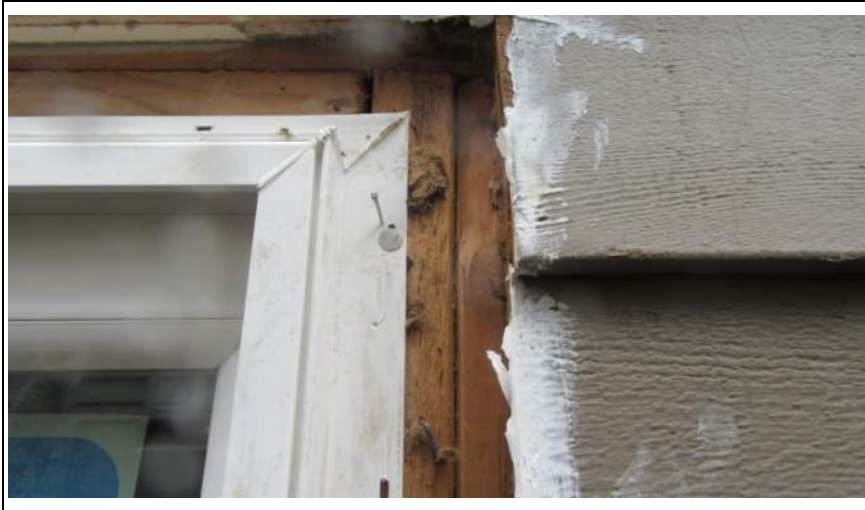
**Photo 84**

Vinyl flangeless window not installed to mitigate air leakage.

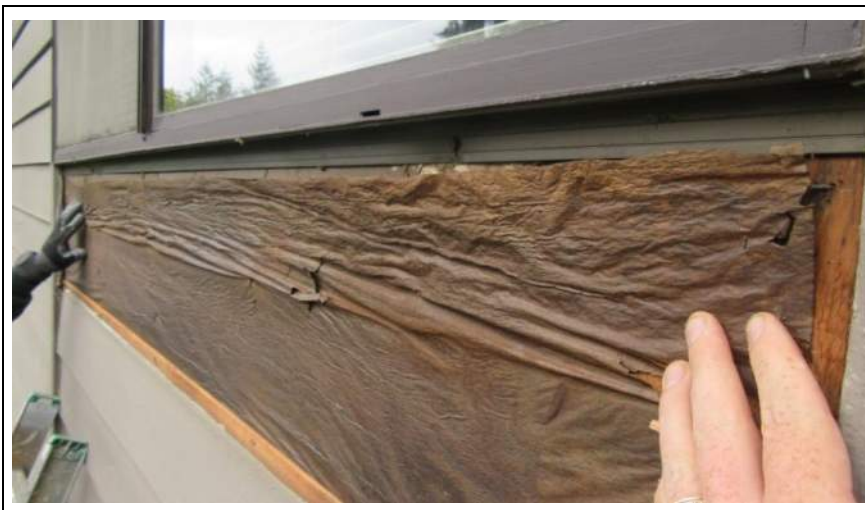
**Photo 86**

Through-wall penetrations not installed to mitigate air leakage.

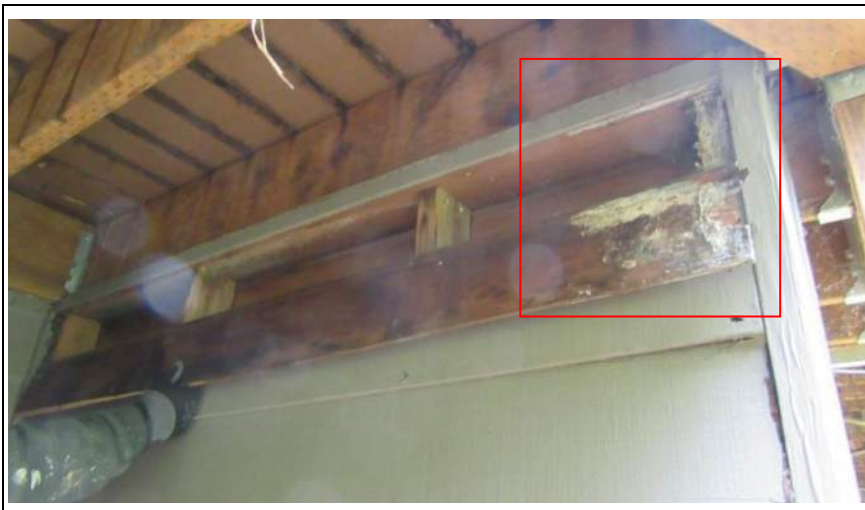
**Photo 95**

View into a stud cavity. Staining on the underside of the beveled siding is indicative of water intrusion.

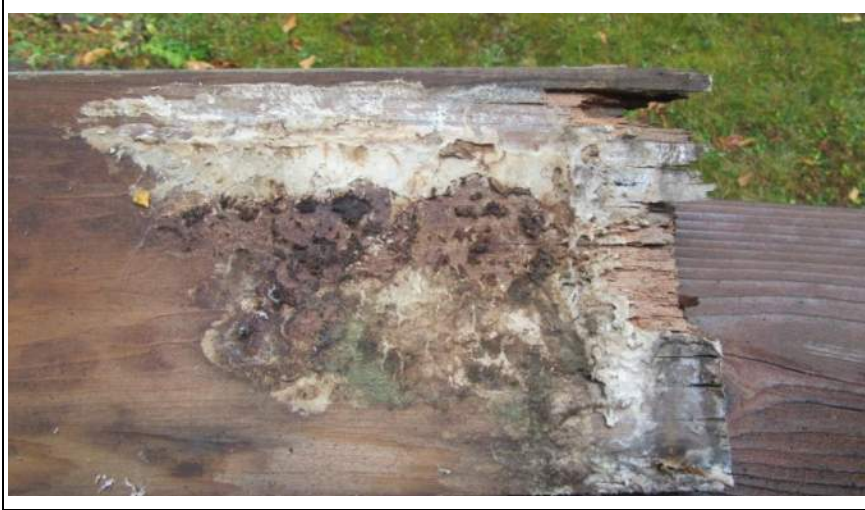
**Photo 96**

At invasive opening 8, water damage to siding and stud framing was observed.

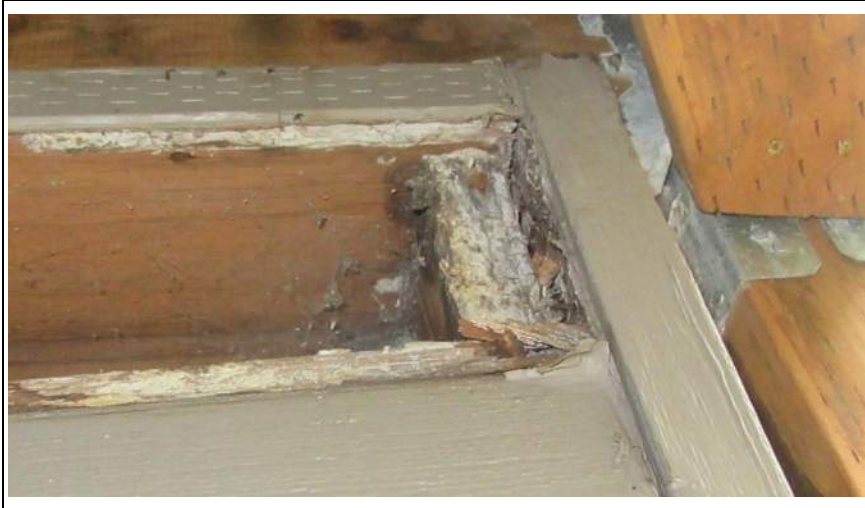
**Photo 97**

Water damaged siding at guard wall.

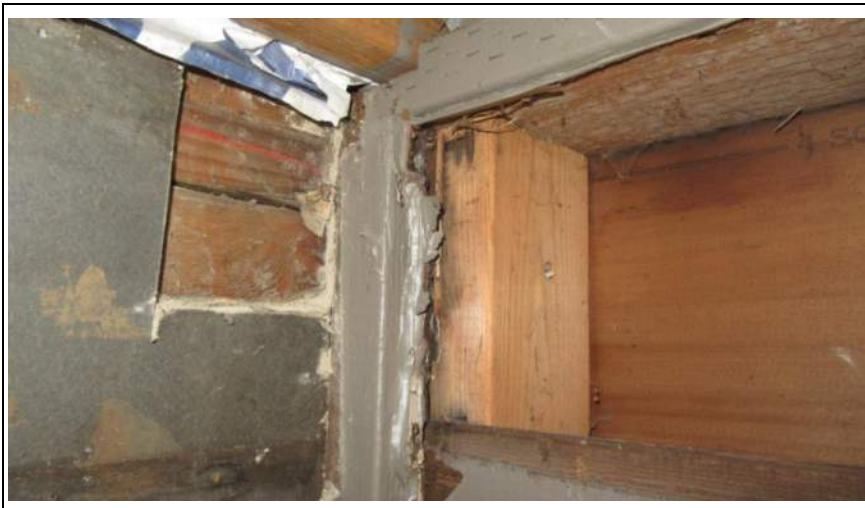
**Photo 98**

Water damaged stud framing at guard wall.

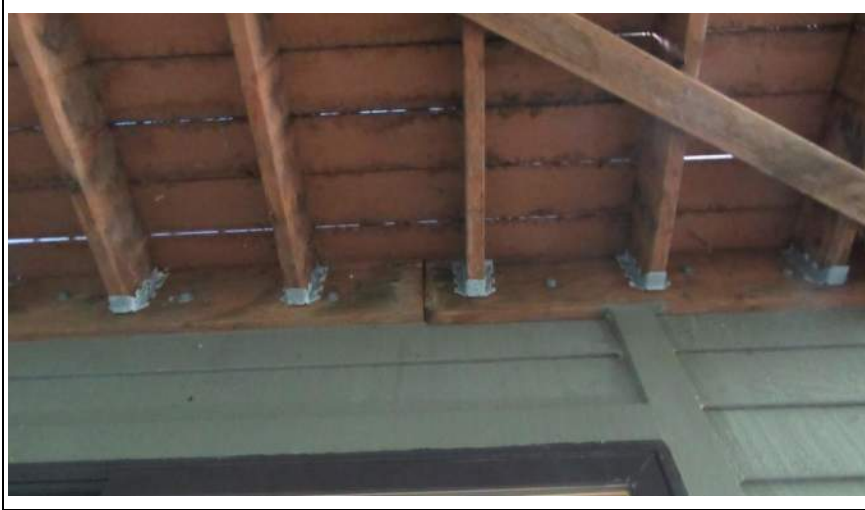
**Photo 99**

Water intrusion at guard wall impacting building wall.
