# Gabriel Commons

## Property Condition Assessment

3831-3897 SW Canby St., Oregon 97216

CBS Ref.: 16-045.00

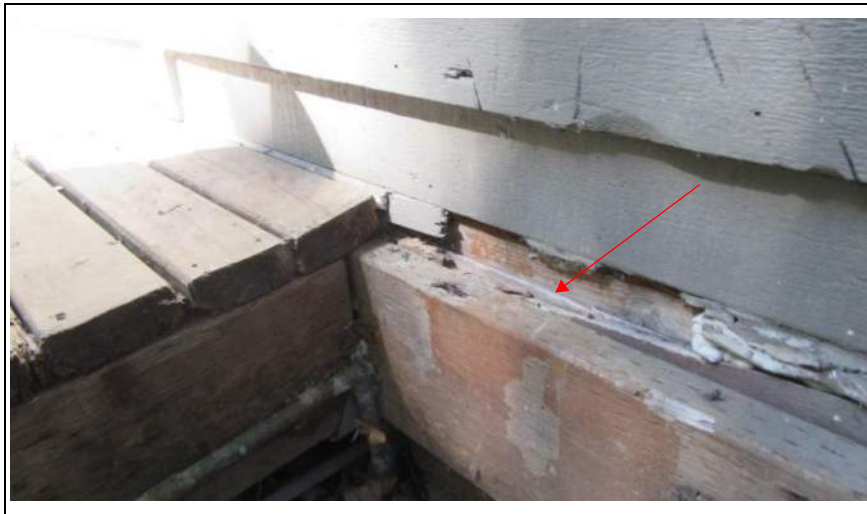
**Photo 103**

South elevation under unit 49.

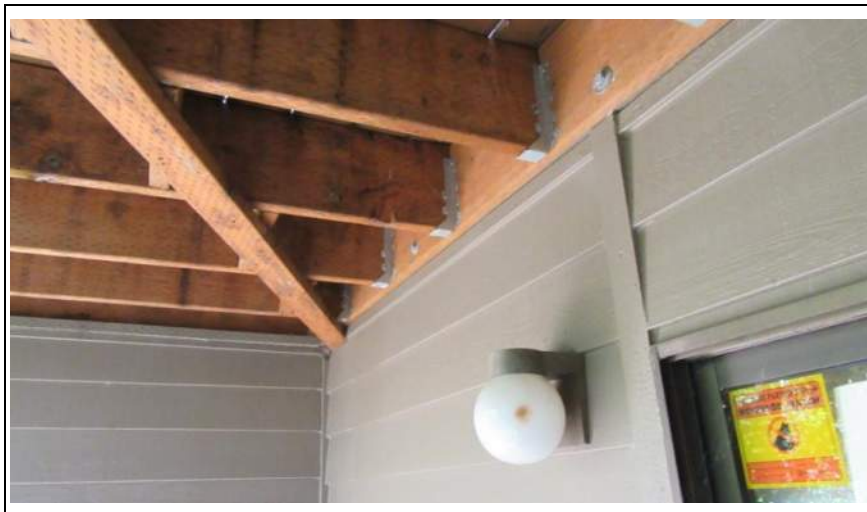
**Photo 104**

Deck ledger anchored to framing and T1-11 siding without adequate flashing.

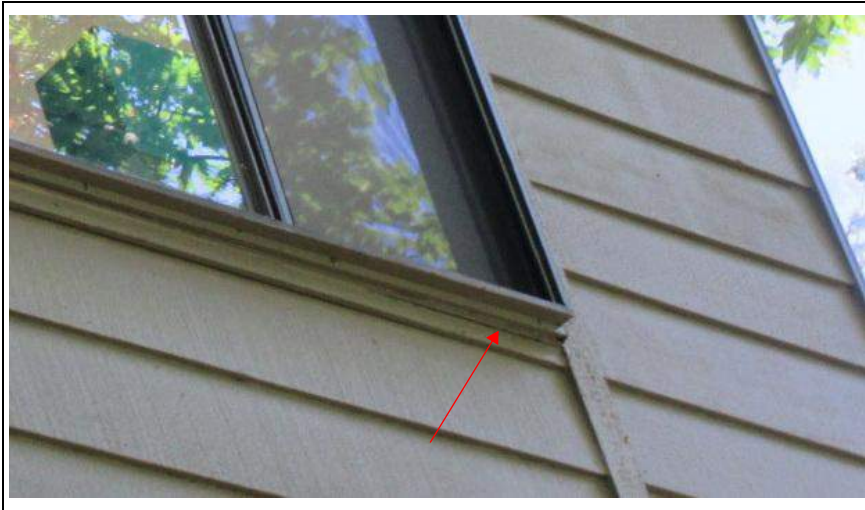
**Photo 108**

Painting was generally in good condition, though there were obvious locations where paint had been applied over siding in poor condition. Additionally, there were numerous locations where sealant repairs have been made in the interim time between painting.

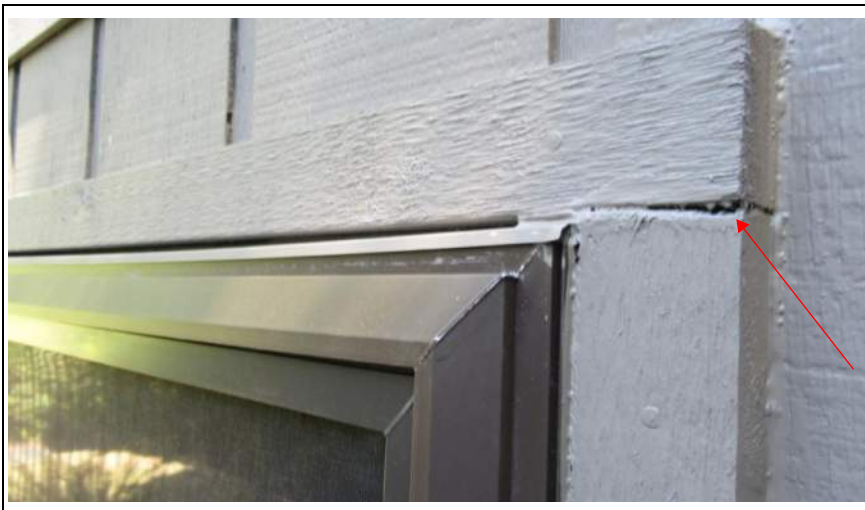
**Photo 110**

Failed sealant at unflashed projecting wood trim was observed.

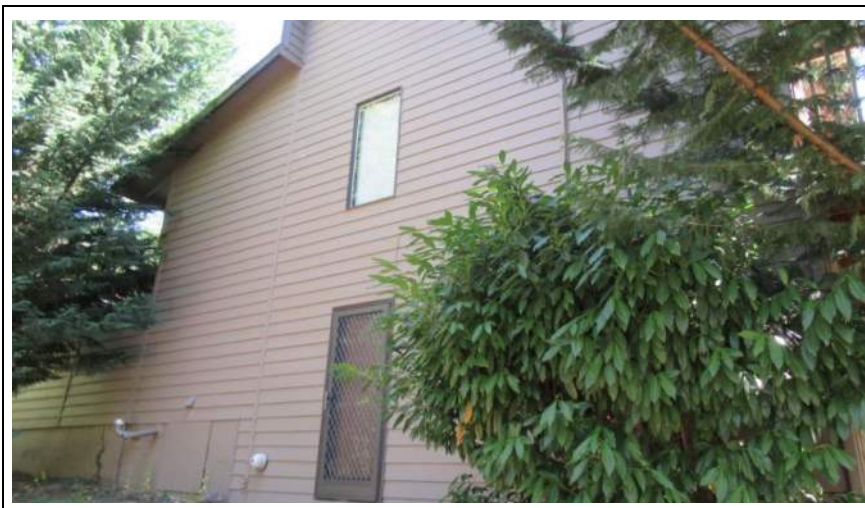
**Photo 113**

At numerous locations, the original aluminum window frames are still in service.

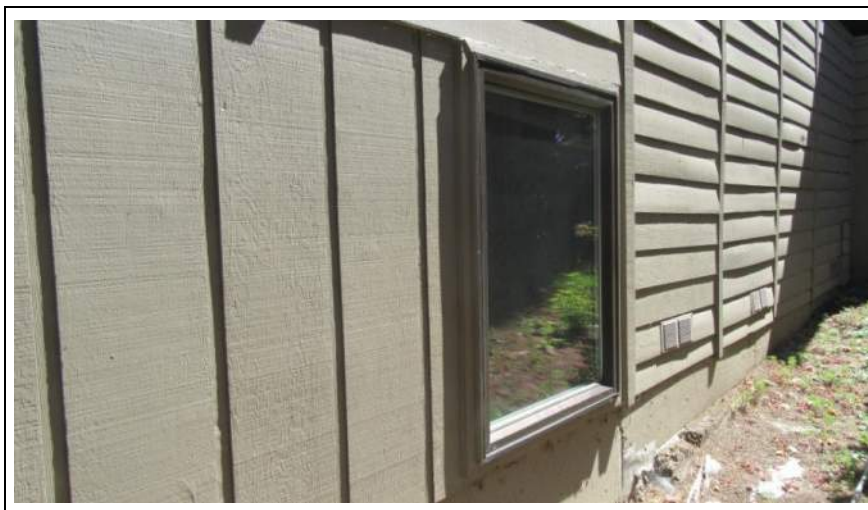
**Photo 119**

Original aluminum windows are still in service within the T1-11 siding.

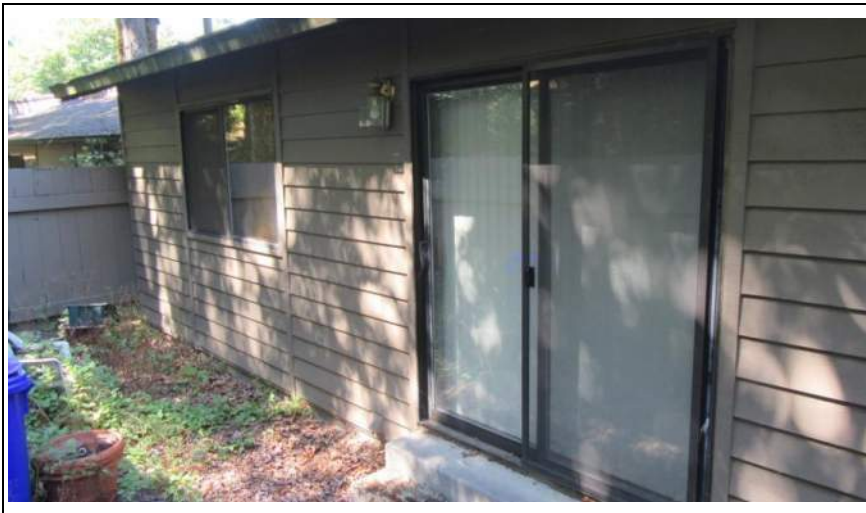
**Photo 121**

Another example of a jump-framed window installation.

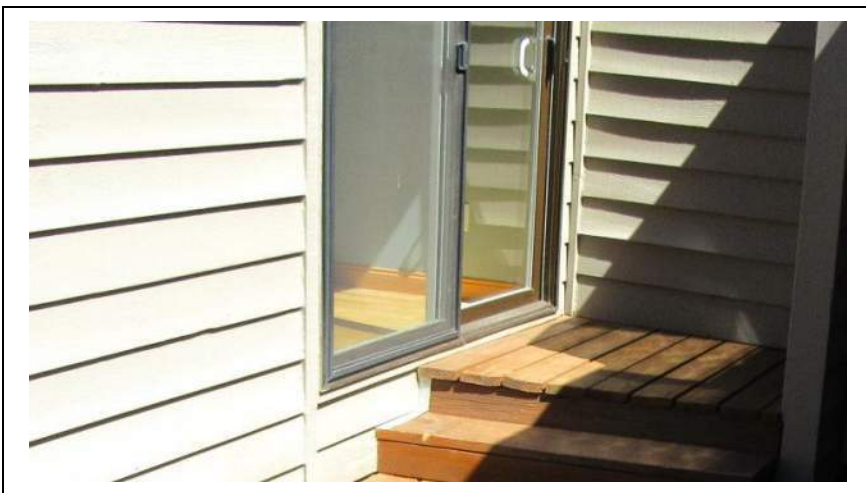
**Photo 122**

Many aluminum sliding glass doors are still in service.

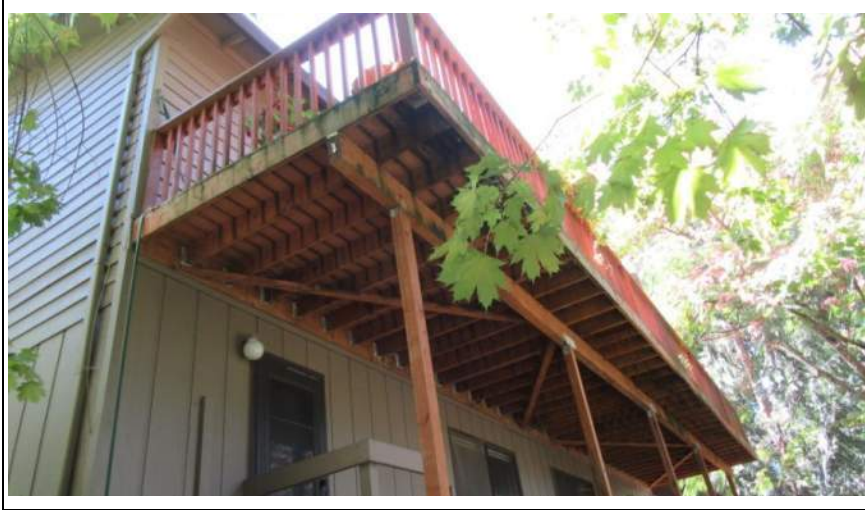
**Photo 123**

The thresholds of sliding glass doors do not appear to have been flashed to allow for the egress of incidental moisture.

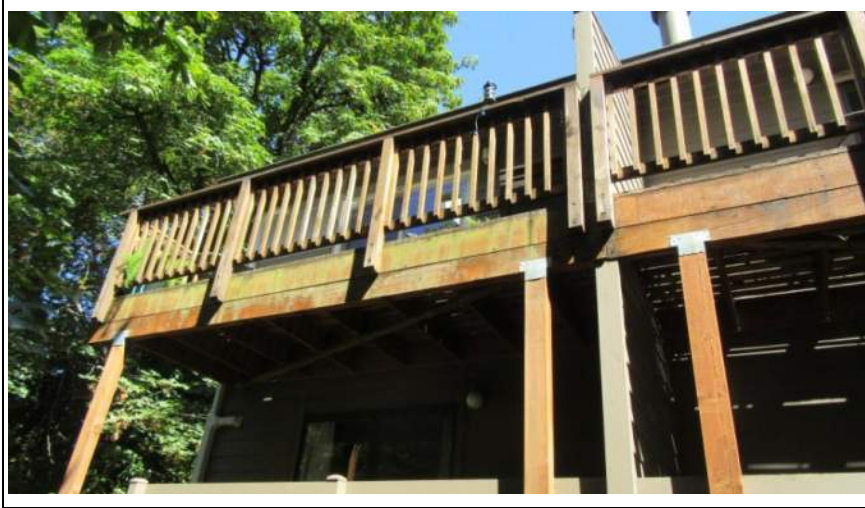
**Photo 138**

Typically, a pressure treated ledger has been installed over the original rim joist, which supports the balcony joists with sheet metal hangers.

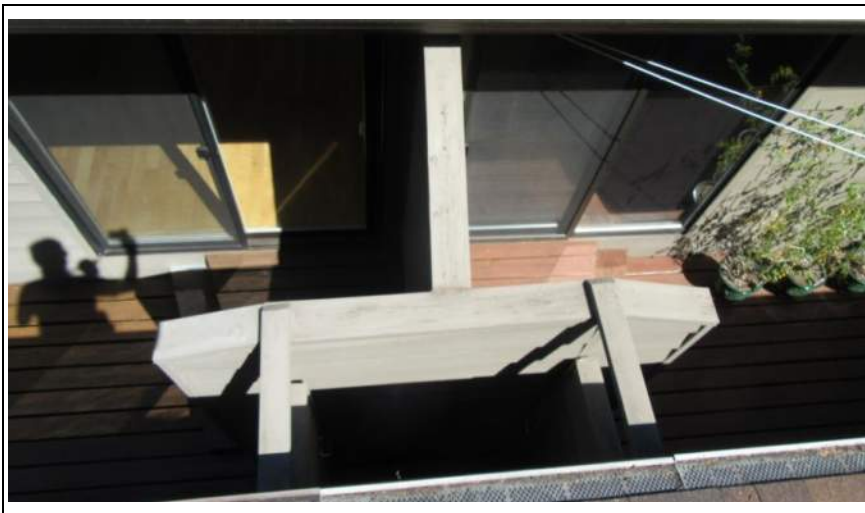
**Photo 139**

Typical balcony railing system. Guard walls separate the private balconies. Typically, the guard walls are not flashed to mitigate water entry on the top exposed edger.

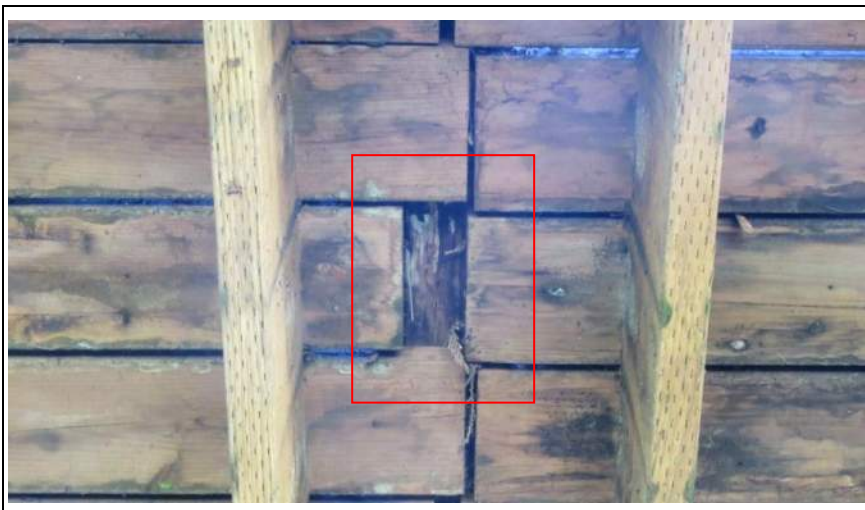
**Photo 143**

Guard walls on balconies are often in adequately supported.

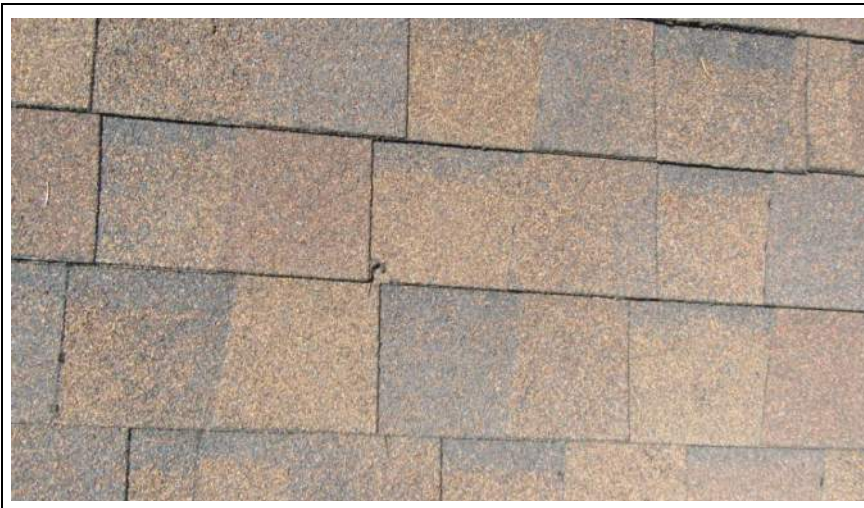
**Photo 149**

Generally, the roof surface are in good condition.

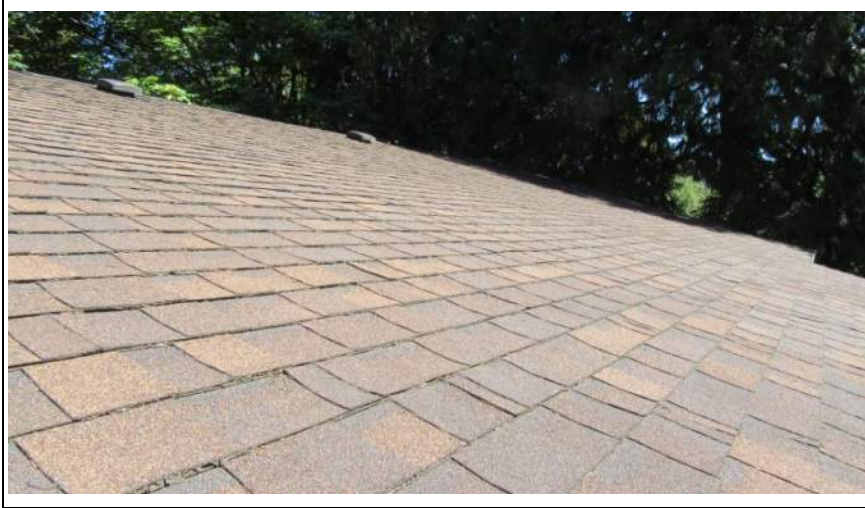
**Photo 150**

Normal granular loss for the age of the shingle.

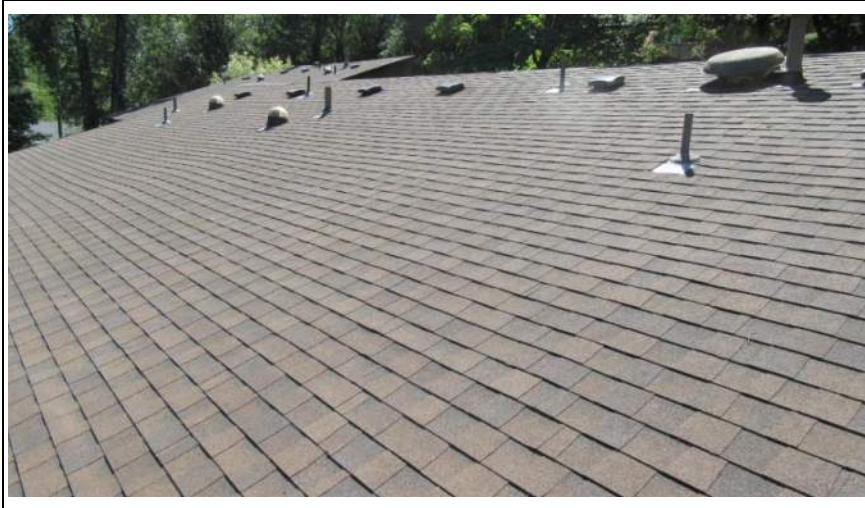
**Photo 151**

Minor cupping was observed on the shaded elevations.

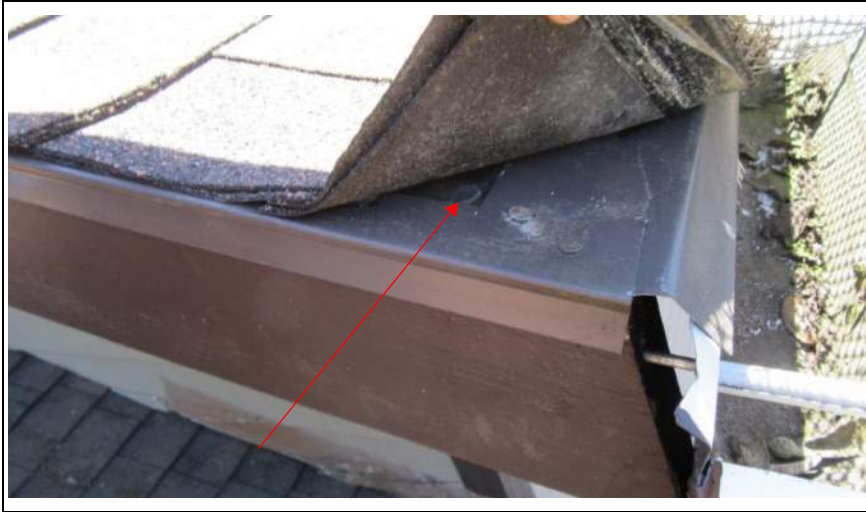
**Photo 153**

Generally, the roof surface were in good condition.

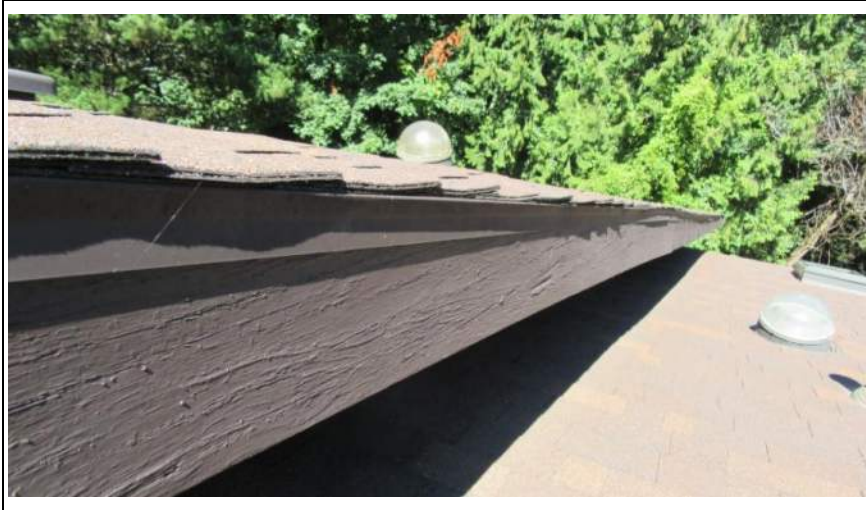
**Photo 154**

Gutter flashing is incorrectly sequenced with the roofing underlayment.

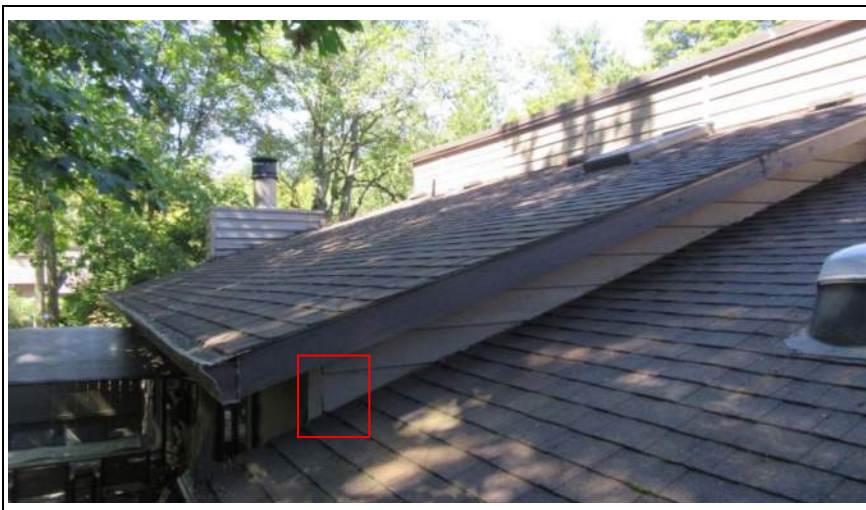
**Photo 158**

Siding in contact with the roofing. Siding does not appear to have been disturbed during the roof replacement.

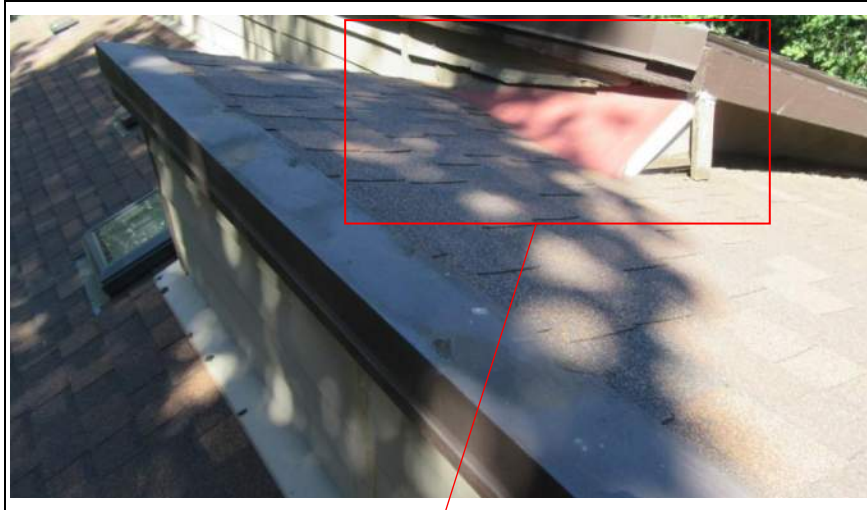
**Photo 160**

Sheet metal flashing has been installed at this offsetting roofline.

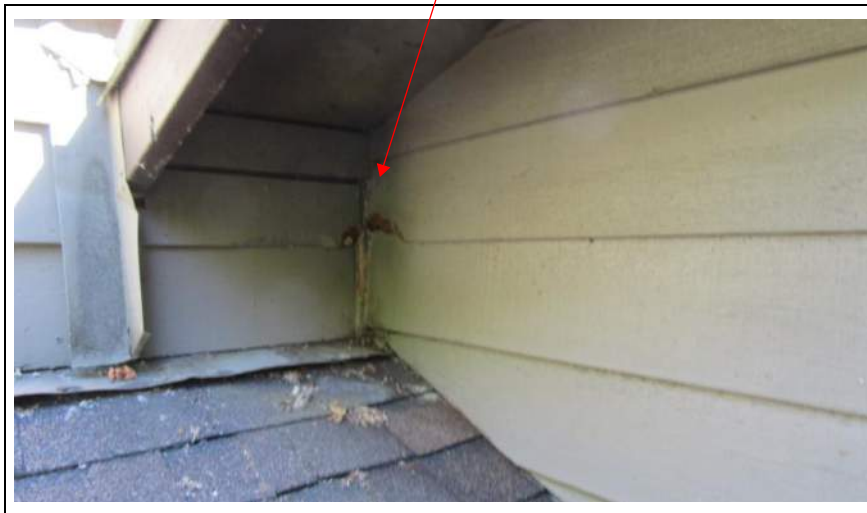
**Photo 161**

Evidence of water intrusion was observed in the soffit. Further investigation is recommended.

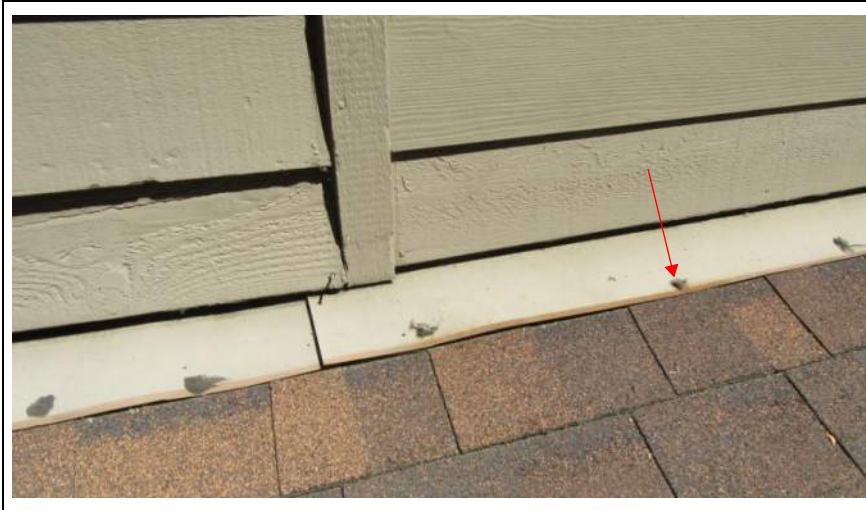
**Photo 163**

Fasteners are poorly sealed or not sealed at all.

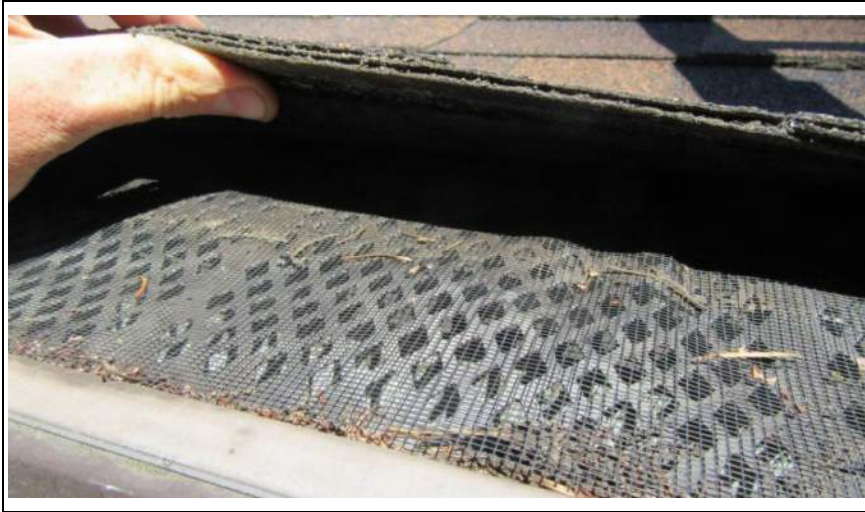
**Photo 166**

Gutter guard covers require removal to clean out fine debris periodically.

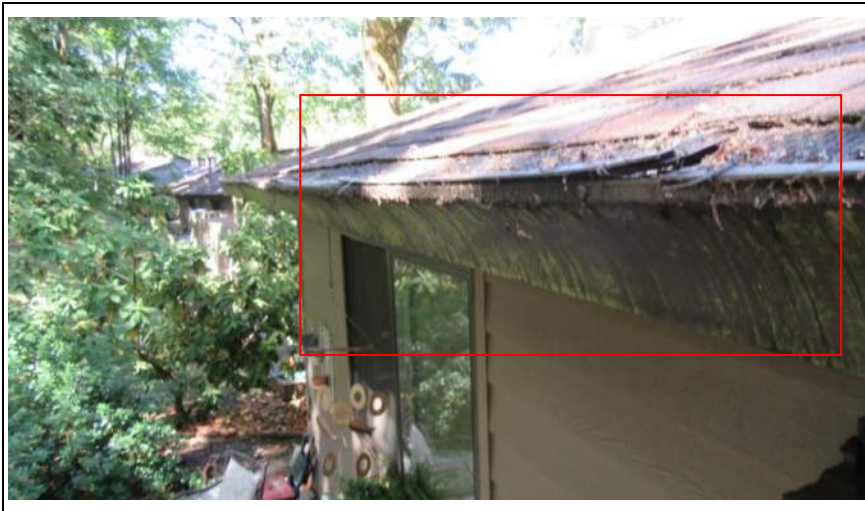
**Photo 167**

At some locations gutters appeared to have over flowed.

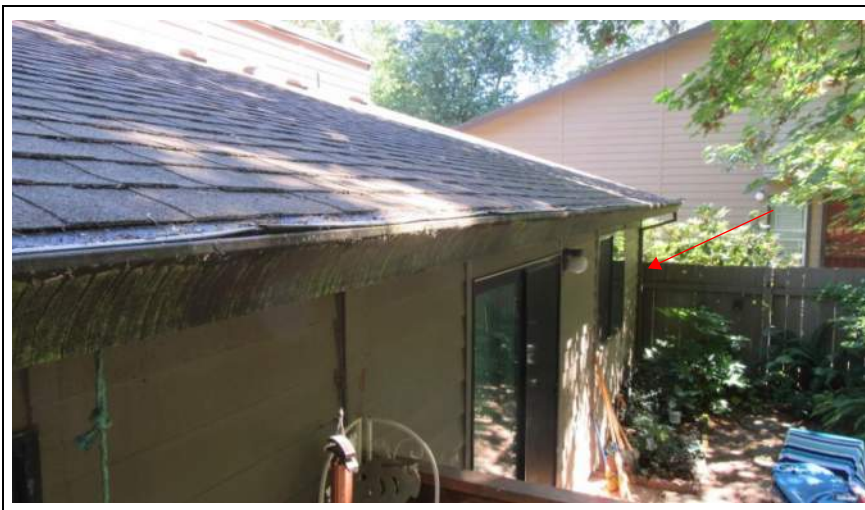
**Photo 168**

Gutters only have a single downspout for the entire length of the building, which is allowing the system to become overwhelmed.

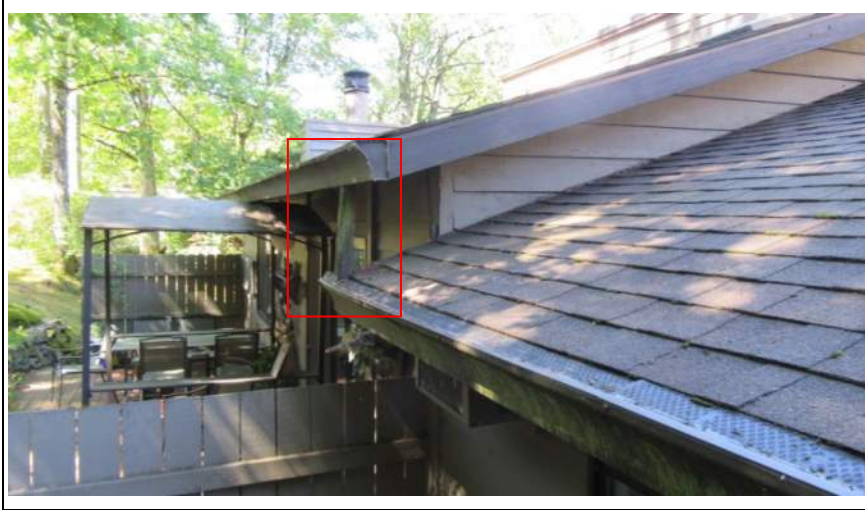
**Photo 169**

Additionally, where gutters drain into gutters below, this slows drainage and increases the likelihood that overflowing may occur.

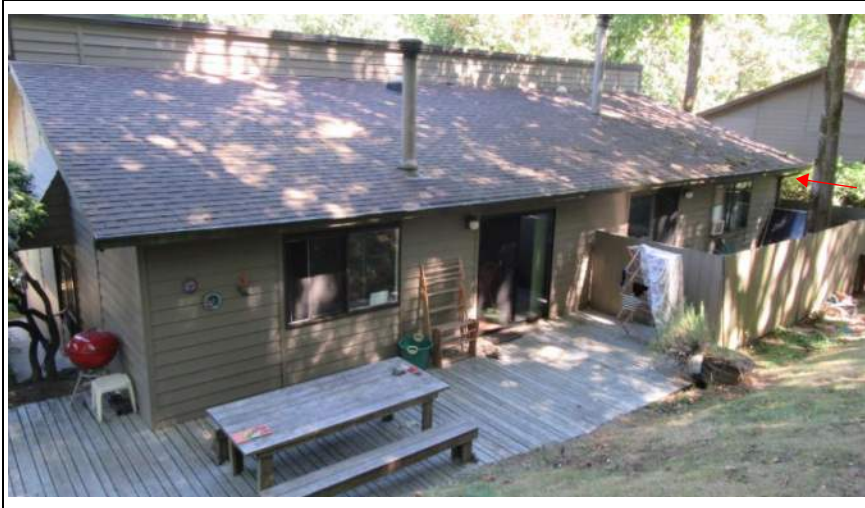
**Photo 170**

Typical building with single downspout to drain half of the roof surface.

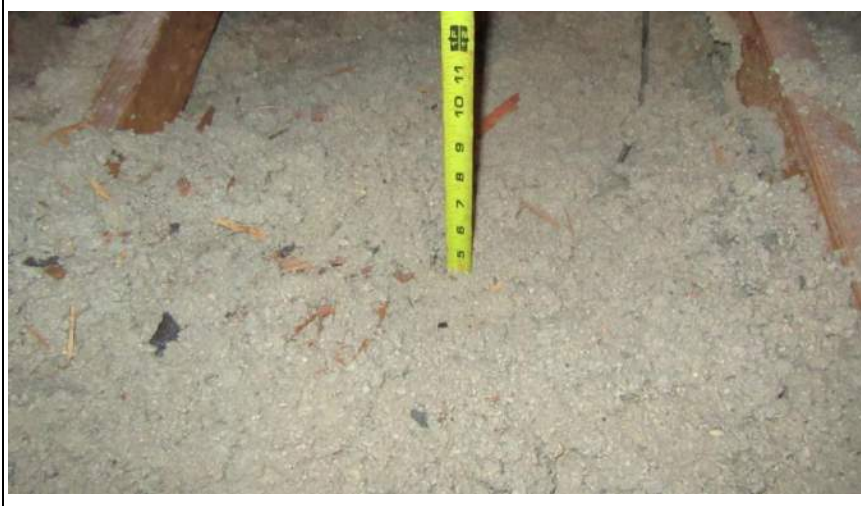
**Photo 172**

Generally, attic insulation is insufficient. Current building code requires 15.5 in. of blown in insulation.

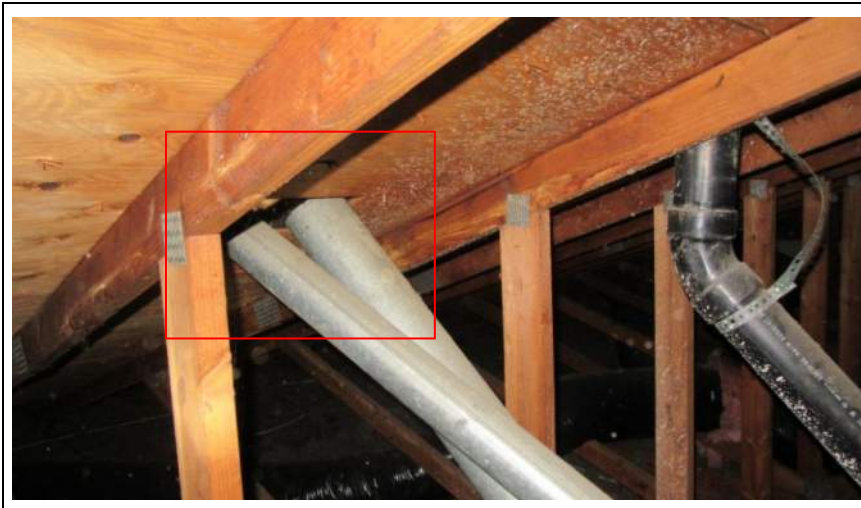
**Photo 173**

Sheet metal exhaust ducts are inadequately supported and are not properly flashed to the exterior of the building.

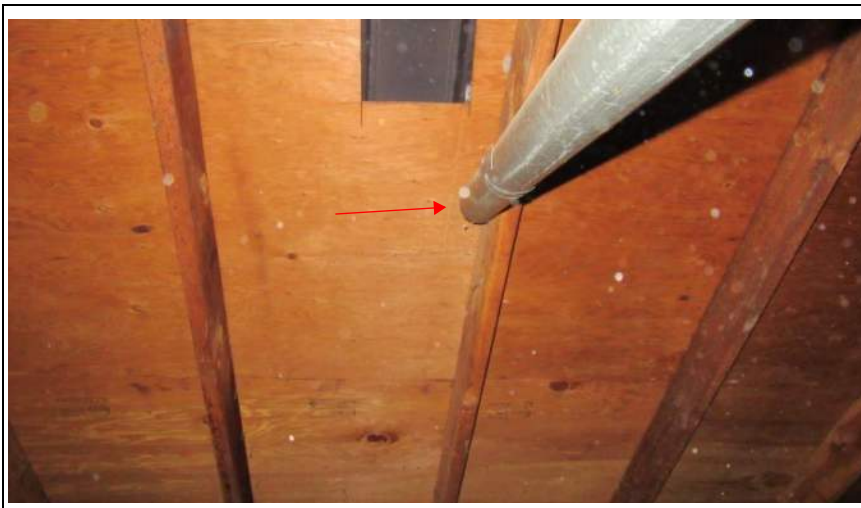
**Photo 174**

In most cases, ductwork was directed at a roof opening, but not sealed to prevent air leakage within the attic.

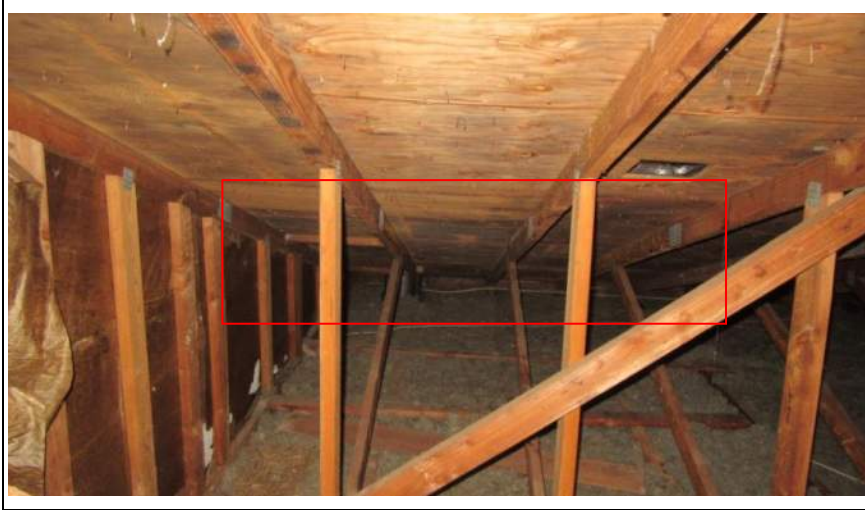
**Photo 175**

Visible condensation on the roof sheathing was observed throughout the complex.

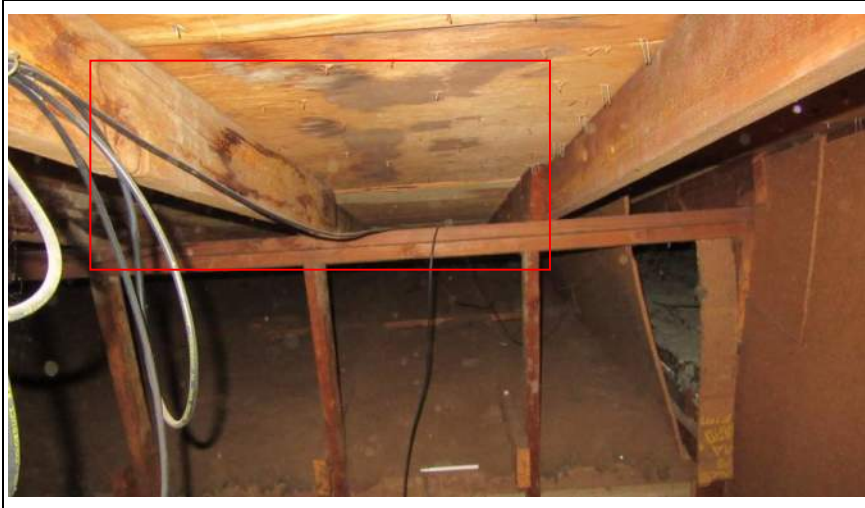
**Photo 176**

Staining on roof sheathing due to accumulation of moisture latent interior air.

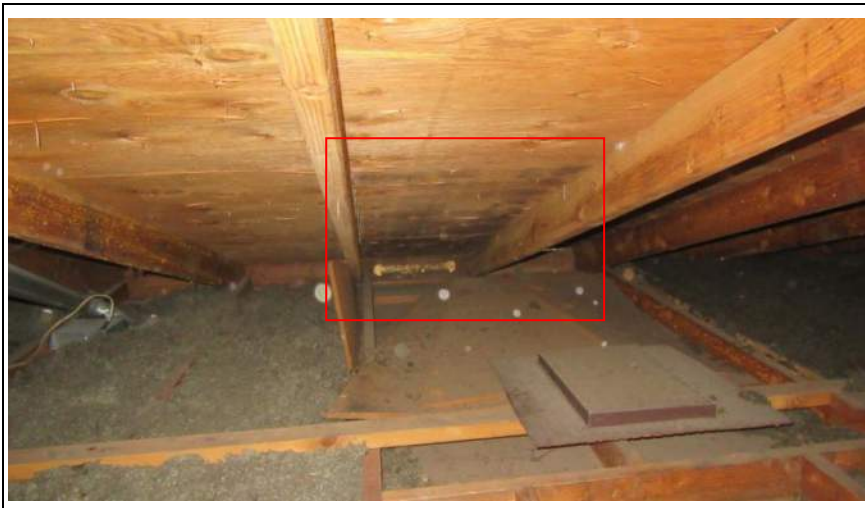
**Photo 177**

Typical condensation staining at the perimeter of the building.

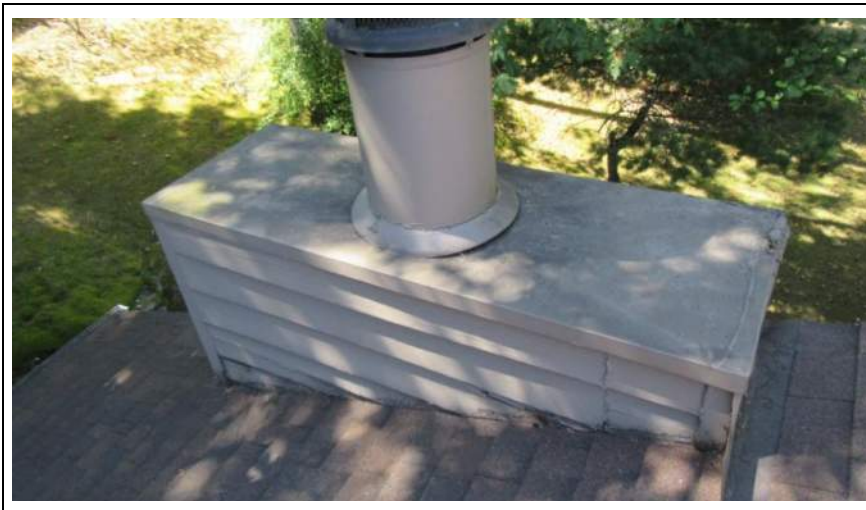
**Photo 179**

Ponding water and open joints appear to be an issue at the chimney cap.

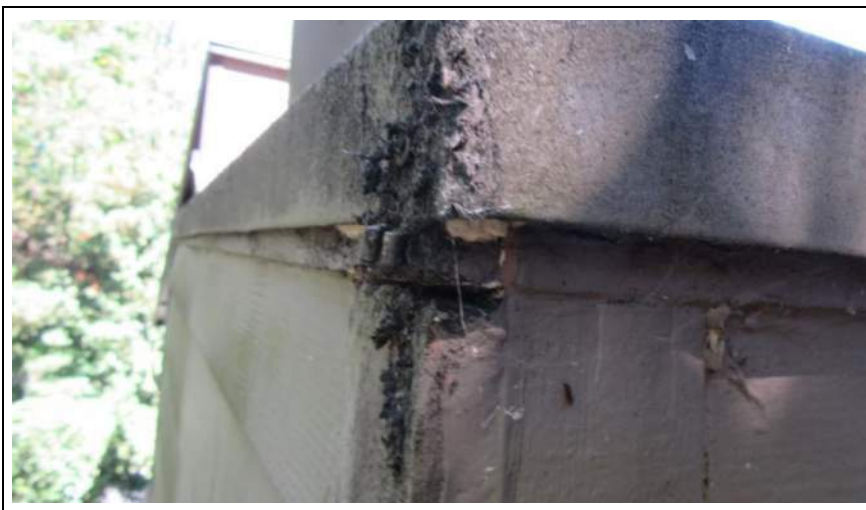
**Photo 180**

Water entering failed seams appears to be entering behind the cladding at this chimney. Further investigation is recommended.

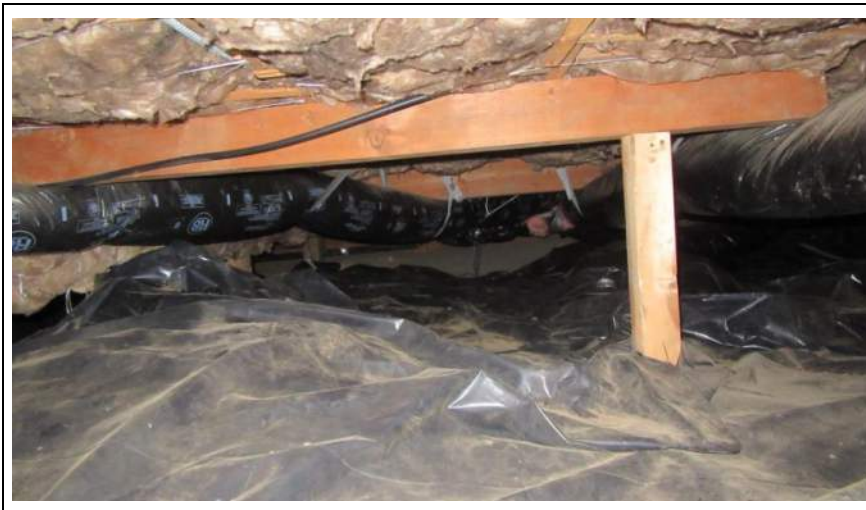
**Photo 182**

Below floor insulation and vapor barrier in tact.

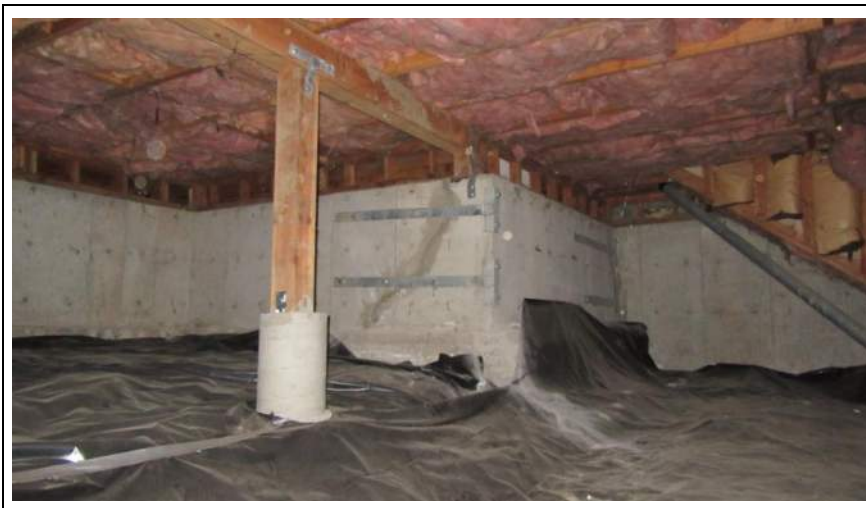
**Photo 183**

Structural improvements have been made.

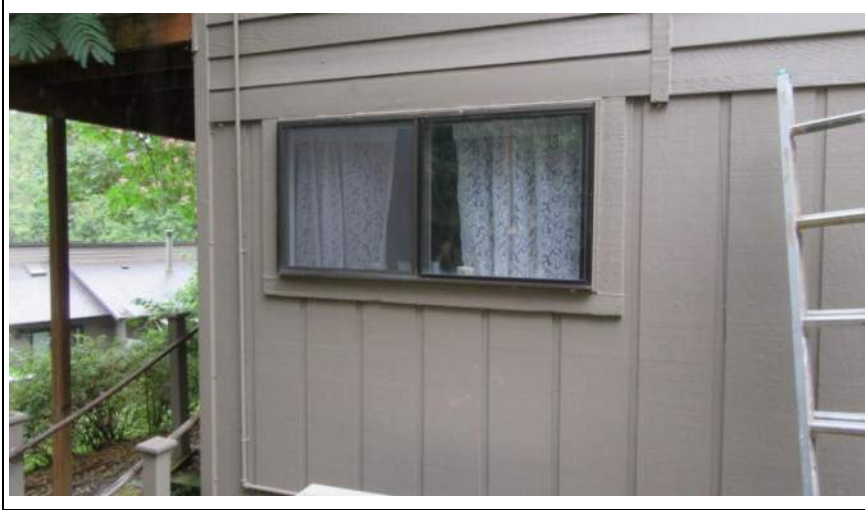
**Photo 1**

Opening 1 - Unit 47:  
Trim was removed around the  
basement window.

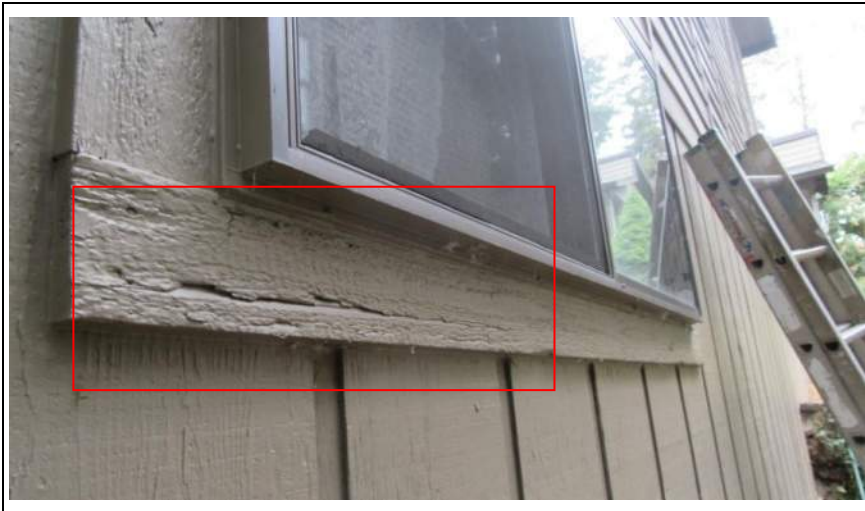
**Photo 2**

Opening 1 - Unit 47:  
Water damaged trim has been  
painted over.

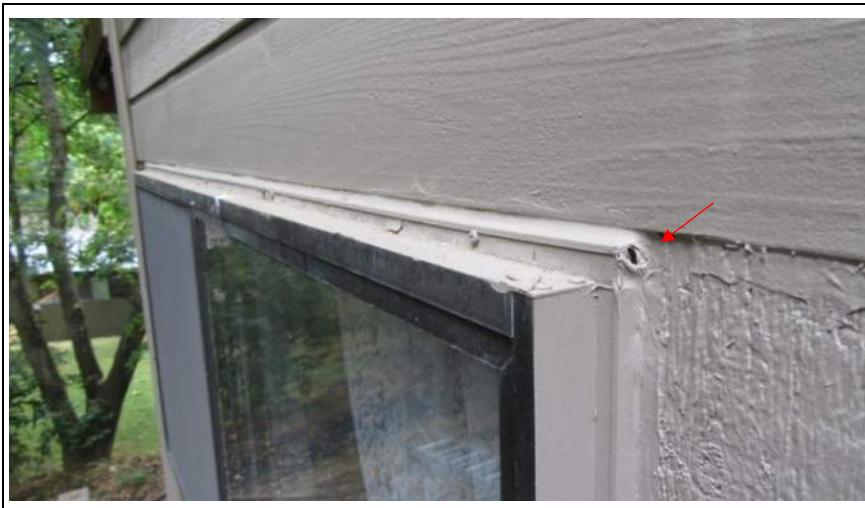
**Photo 3**

Opening 1 - Unit 47:  
Window head is not flashed and  
voids are present in the sealant.

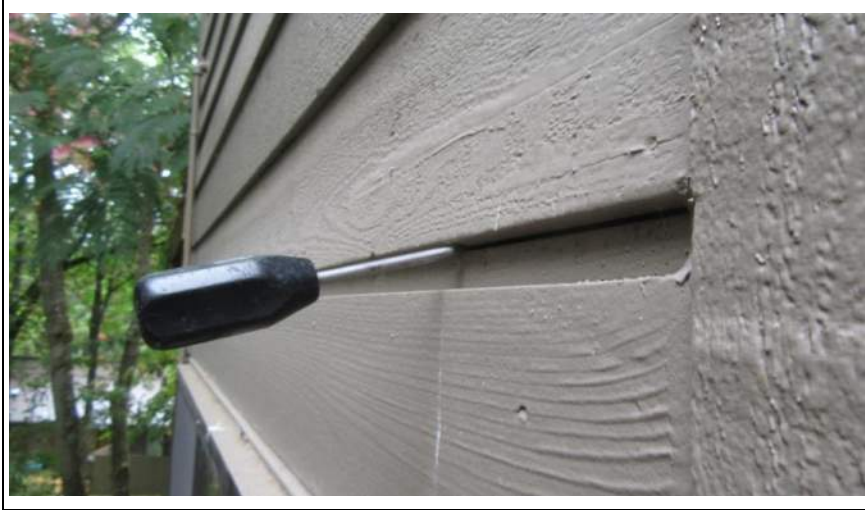
**Photo 4**

Opening 1 - Unit 47:

Gaps in the siding remain, where siding was apparently removed to facilitate the installation of the window.

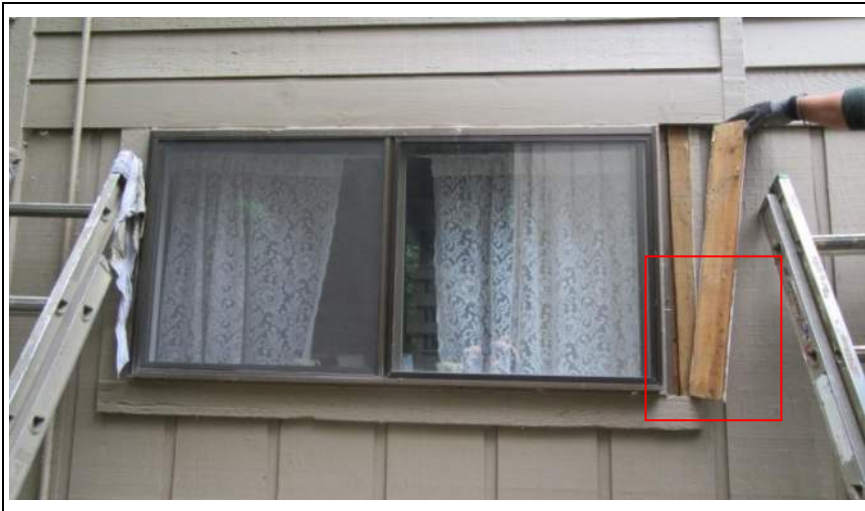
**Photo 5**

Opening 1 - Unit 47:

Water staining is visible on the back side of the jamb trim.

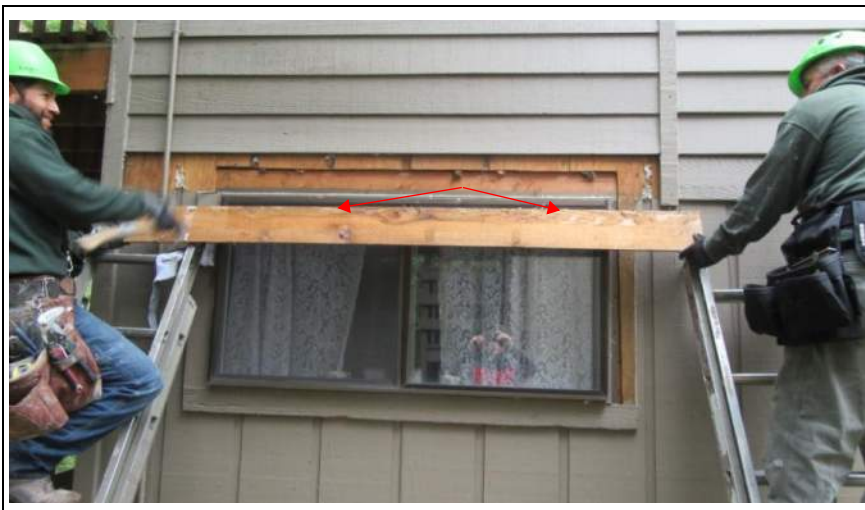
**Photo 6**

Opening 1 - Unit 47:

Staining on the bottom side of the interior face of the trim is indication that water is pooling on the window frame behind the cladding.

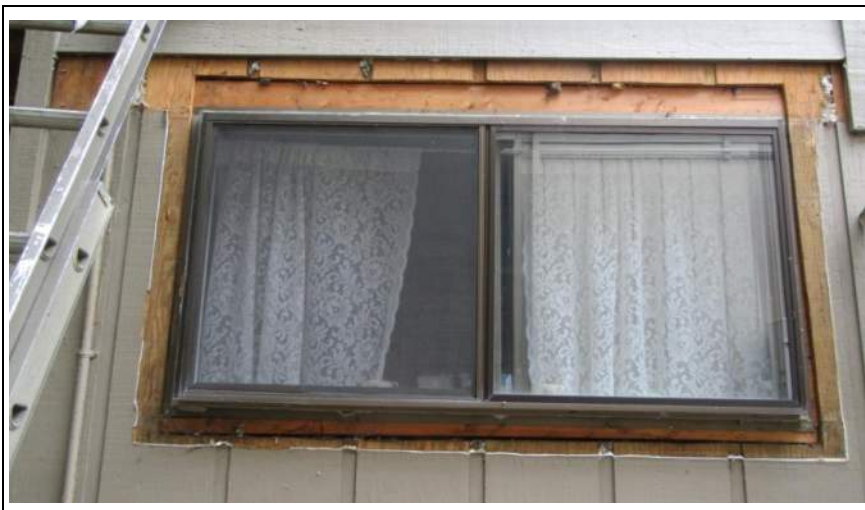
**Photo 9**

Opening 1 - Unit 47:  
Overall of window opening. Jump-framed window installed onto wood framing. Building paper or membrane flashings are not present.

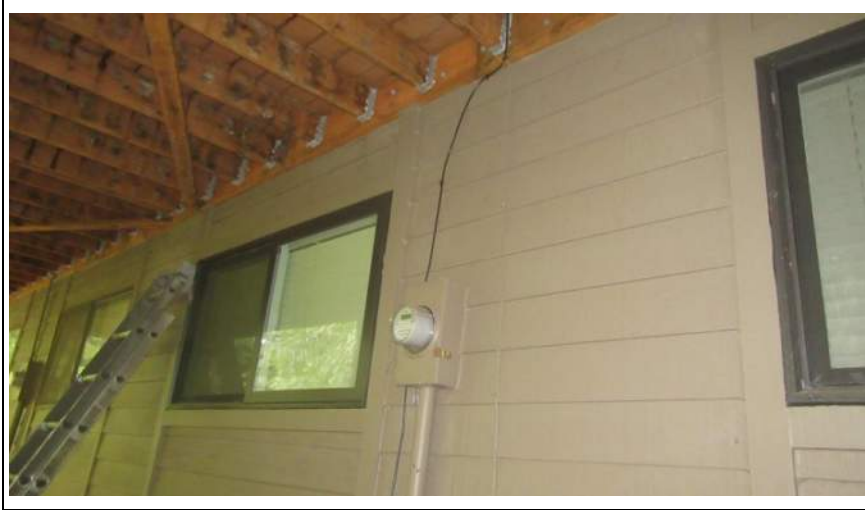
**Photo 13**

Opening 2 - Unit 31:  
Siding removed below balcony  
ledger and above vinyl window.

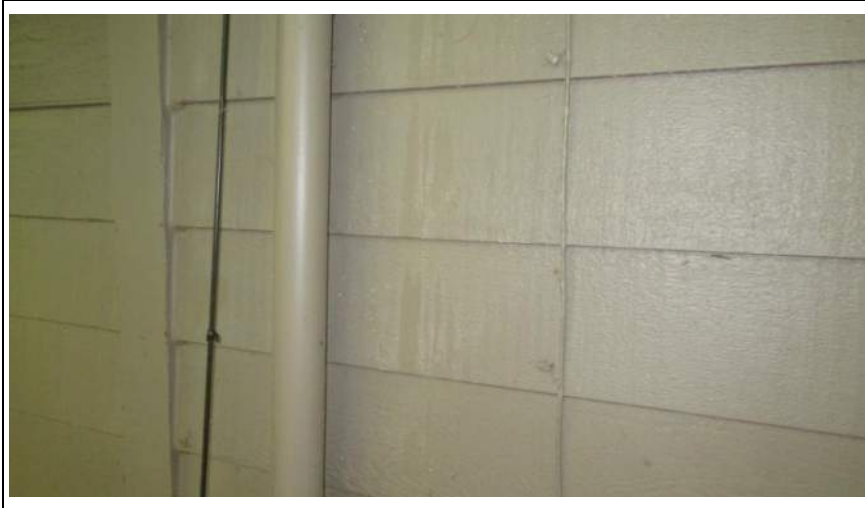
**Photo 14**

Opening 2 - Unit 31:  
Water stains on siding, indicating  
bulk water flow down siding.

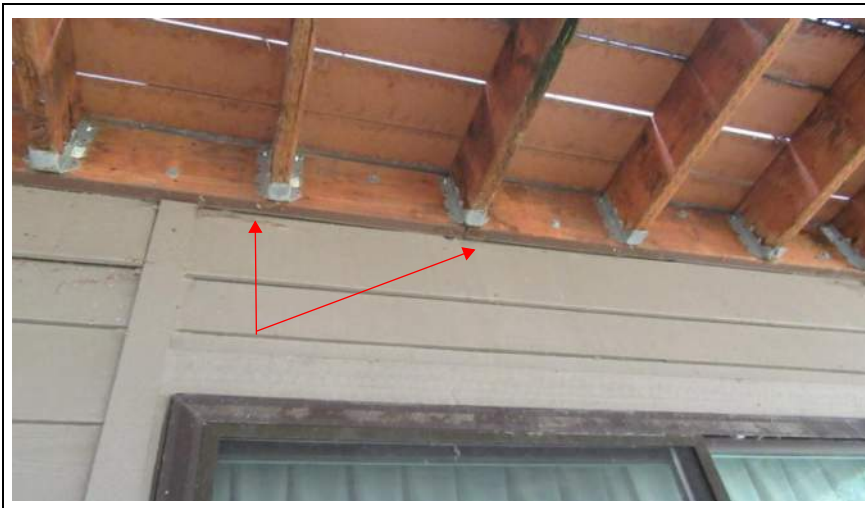
**Photo 15**

Opening 2 - Unit 31:  
Open joint between the siding and  
underside of the balcony ledger.

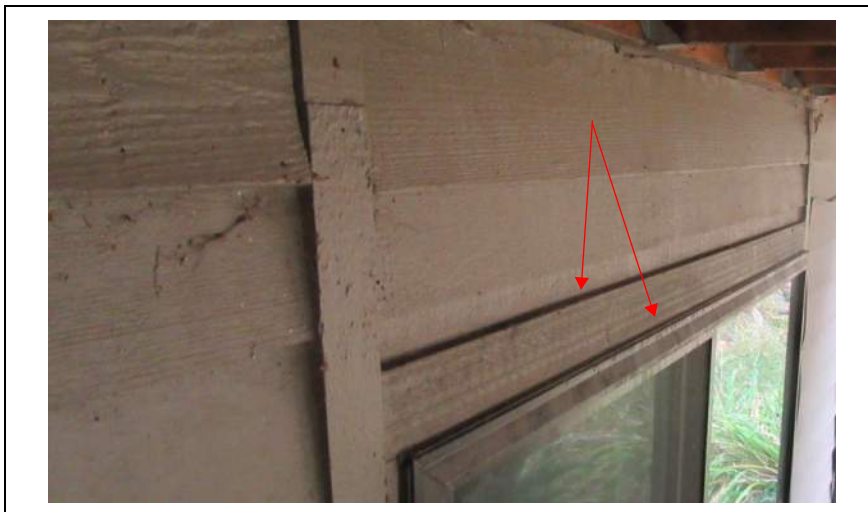
**Photo 17**

Opening 2 - Unit 31:  
Sheet metal flashing is not provided  
above projecting wood trim.

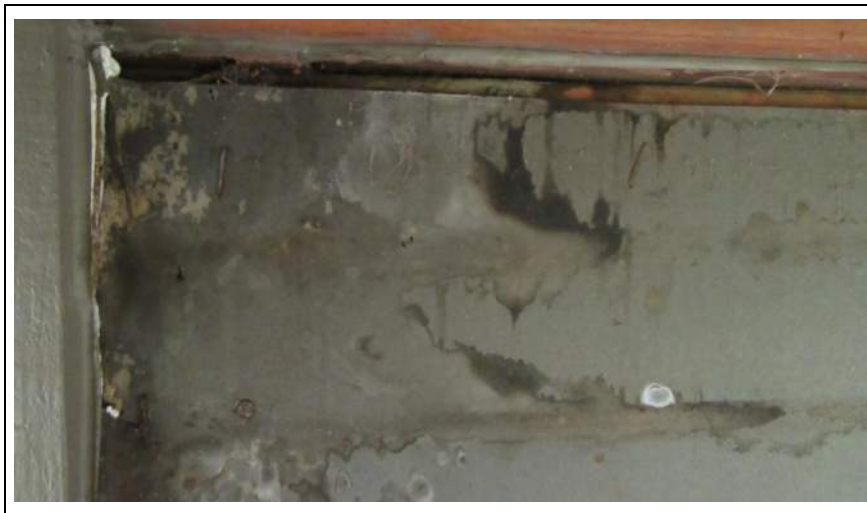
**Photo 20**

Opening 2 - Unit 31:

Water damage and organic growth present on wall sheathing.

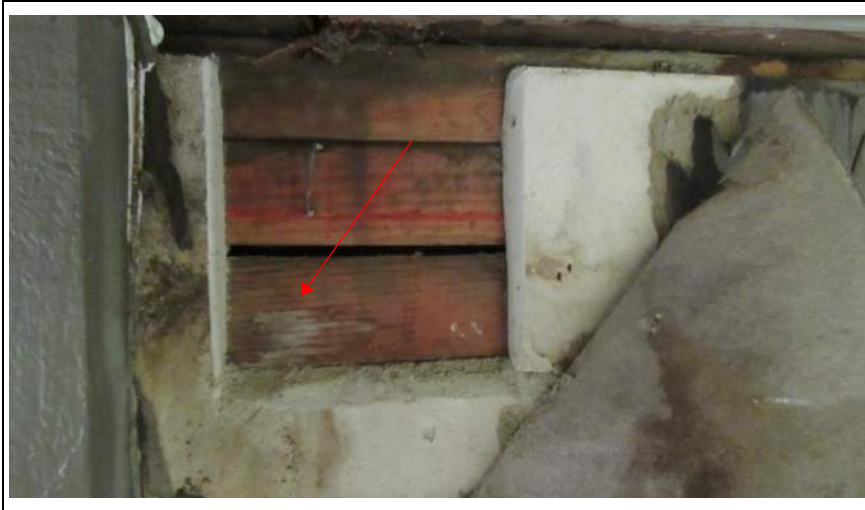
**Photo 22**

Opening 2 - Unit 31:  
Water staining on the framing  
behind the gypsum sheathing,  
indicating bulk water is entering the  
stud cavity.
