# Gabriel Commons

## Property Condition Assessment

3831-3897 SW Canby St., Oregon 97216

CBS Ref.: 16-045.00

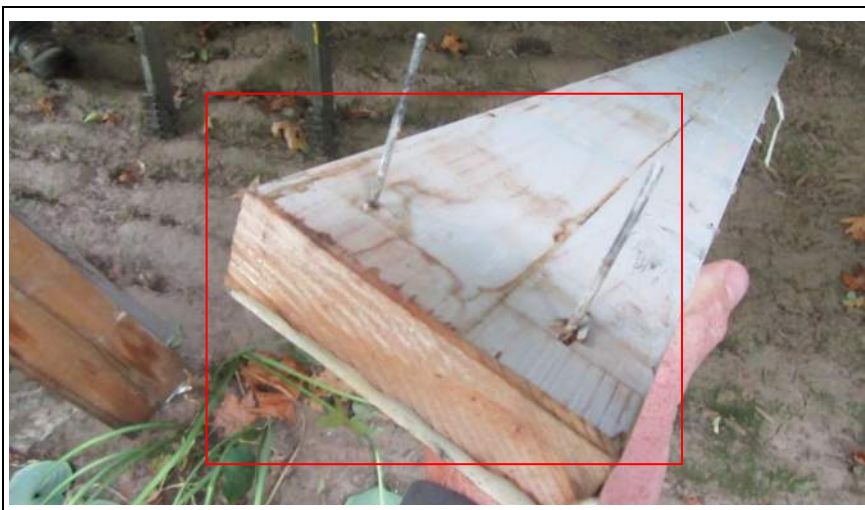
**Photo 24**

Opening 2 - Unit 31:  
Water staining behind the trim and  
corroded fasteners.

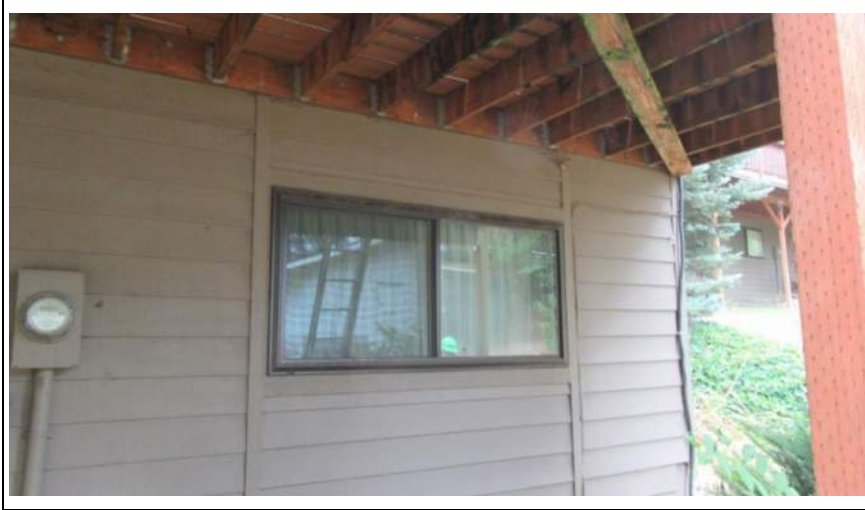
**Photo 25**

Opening 3 - Unit 93:  
Siding removed under balcony  
ledge and above window head.

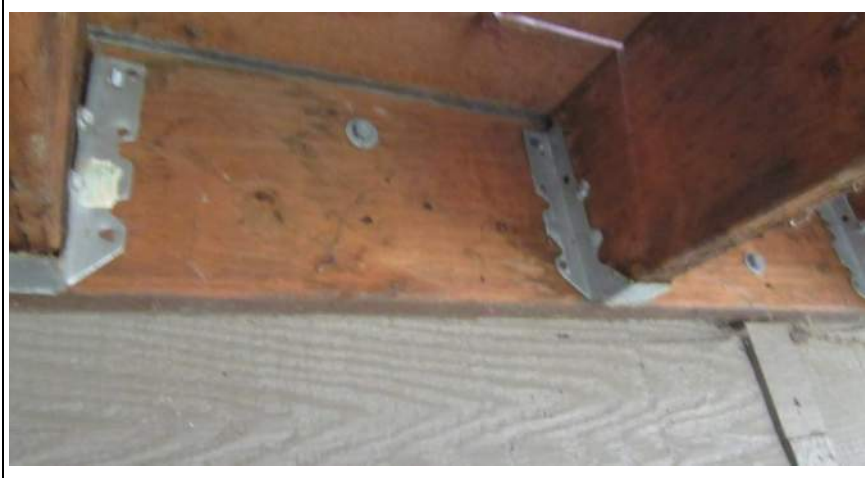
**Photo 26**

Opening 3 - Unit 93:  
Sheet metal flashing is installed  
above the ledger. Voids are present  
between the siding and bottom edge  
of the ledger.

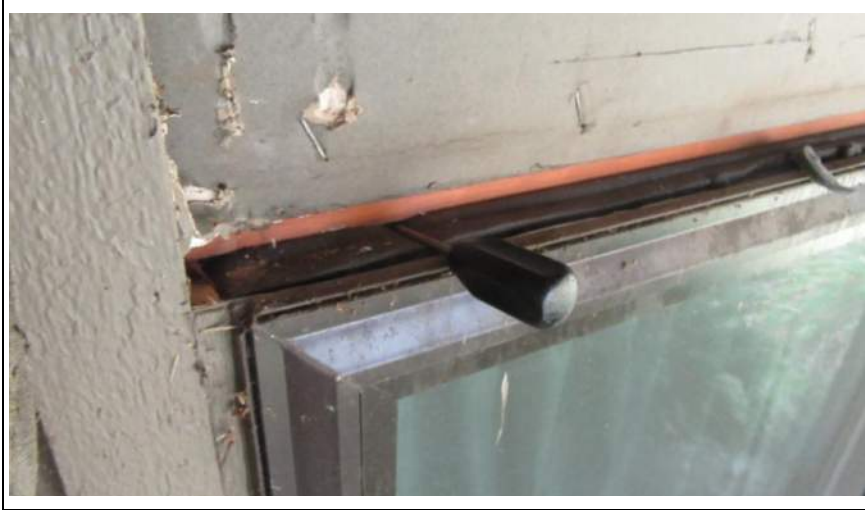
**Photo 31**

Opening 3 - Unit 93:

The stucco-type window is installed within the rough opening without the application of membrane flashings. The window is not installed in a manner that would prevent air leakage.

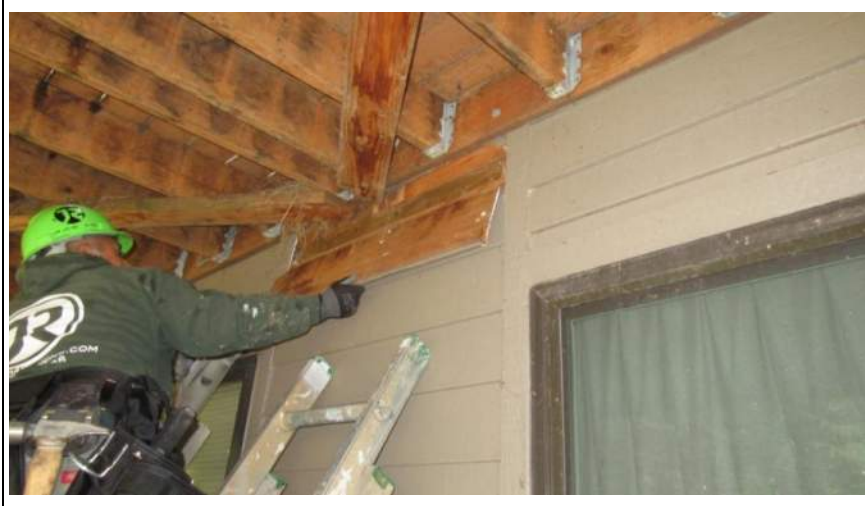
**Photo 32**

Adjacent to the window head, additional siding was removed under the ledger.

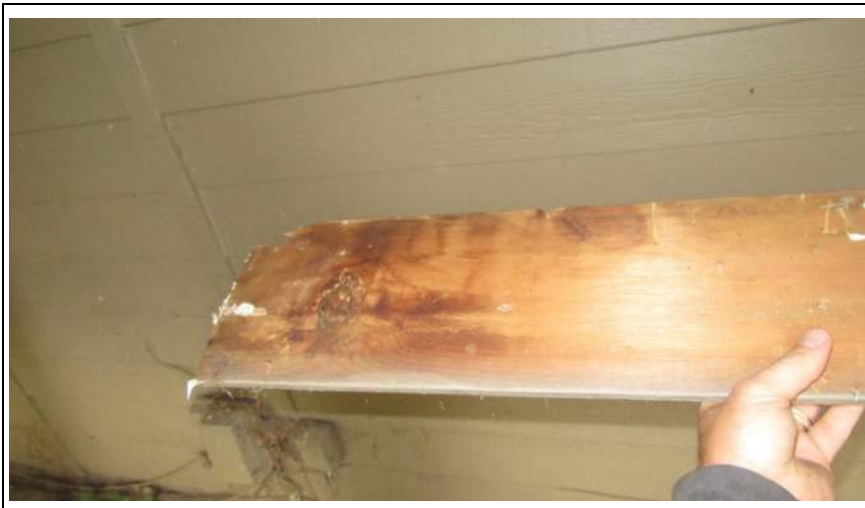
**Photo 33**

Typical water staining behind the siding.

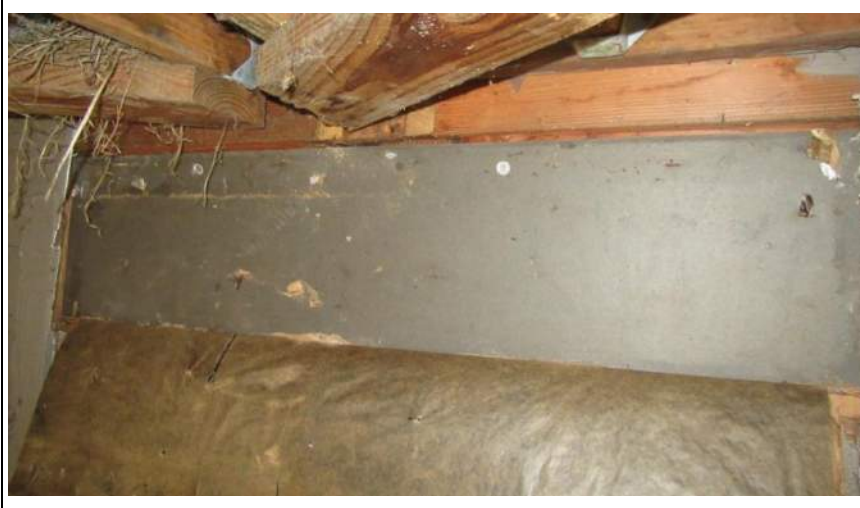
**Photo 34**

Opening 3 - Unit 93:  
Partial weather barrier was installed on this section of the wall. Staining on the sheathing is typical at the vertical transitions.

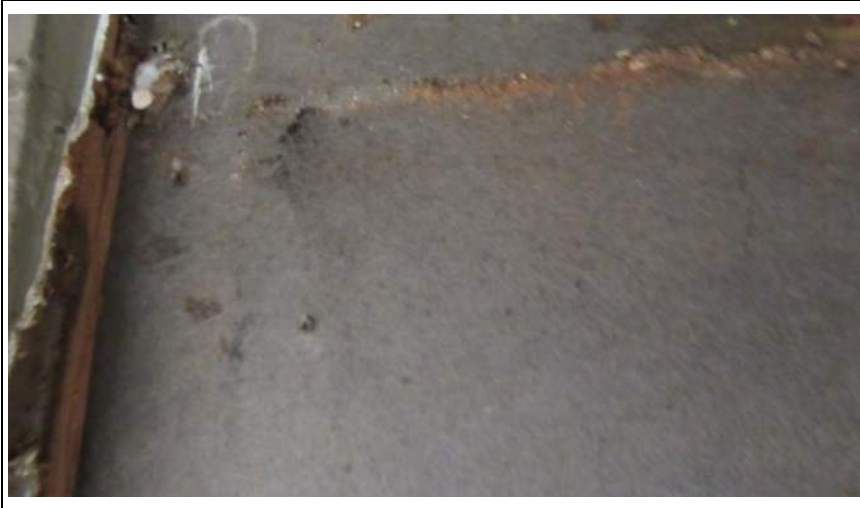
**Photo 35**

Opening 3 - Unit 93:  
Organic growth visible on the sheathing.

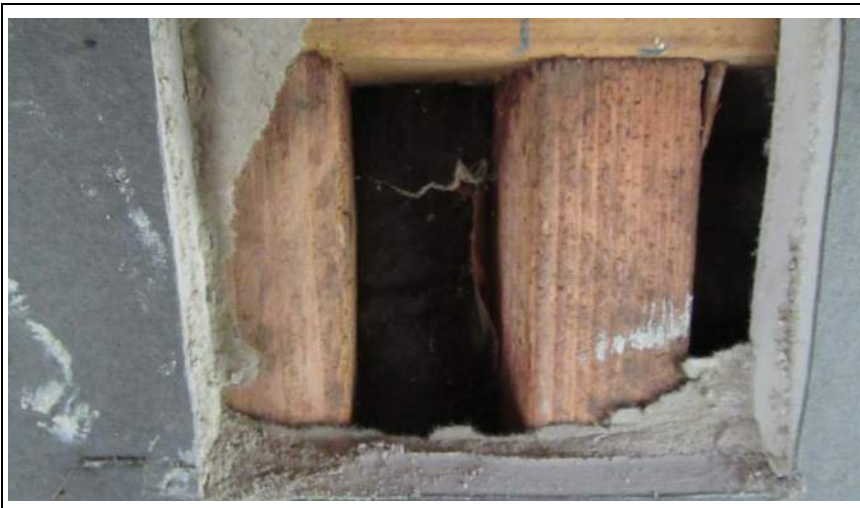
**Photo 36**

Opening 3 - Unit 93:  
Stud framing did not have water staining at this location.

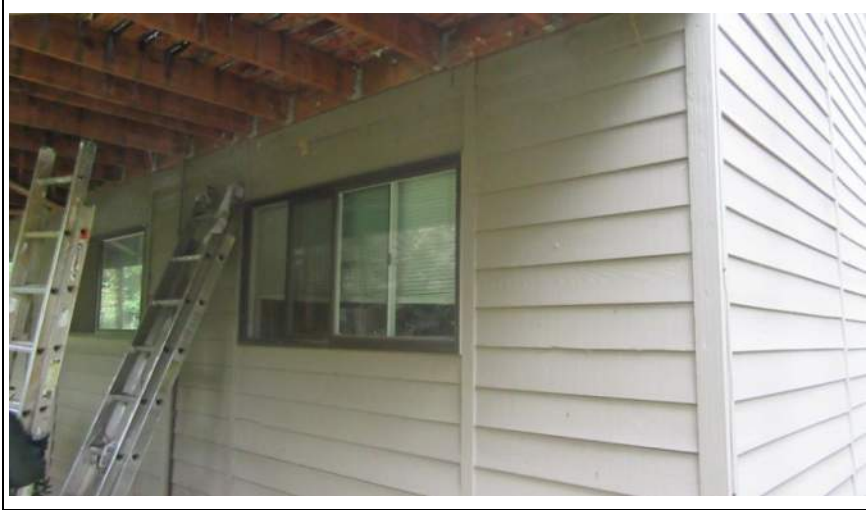
**Photo 37**

Opening 4 - Unit 85:  
Siding removed under the balcony  
ledger and above the window head.

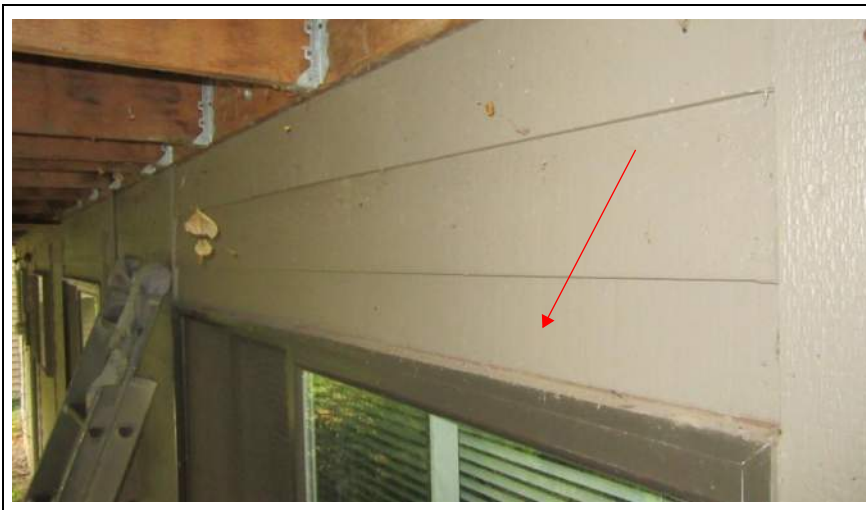
**Photo 38**

Opening 4 - Unit 85:  
Sheet metal flashing is not provided  
above the window head.

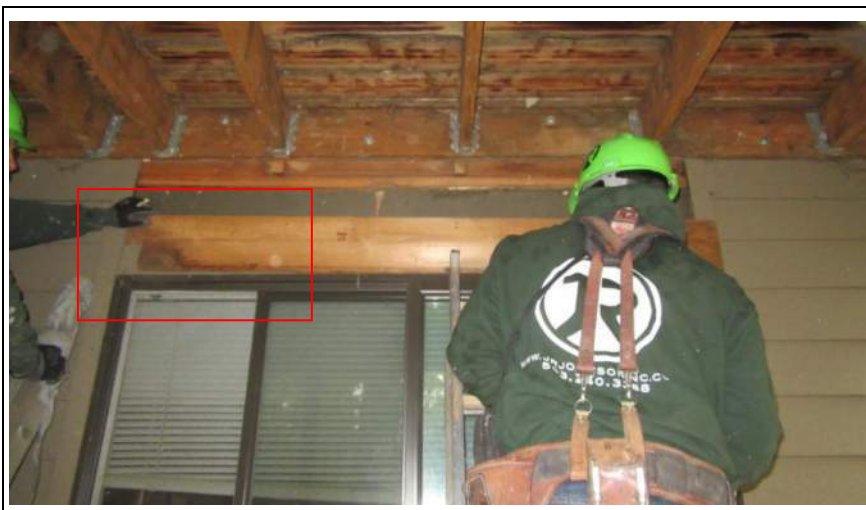
**Photo 39**

Opening 4 - Unit 85:  
Water staining on the back side of  
the siding.

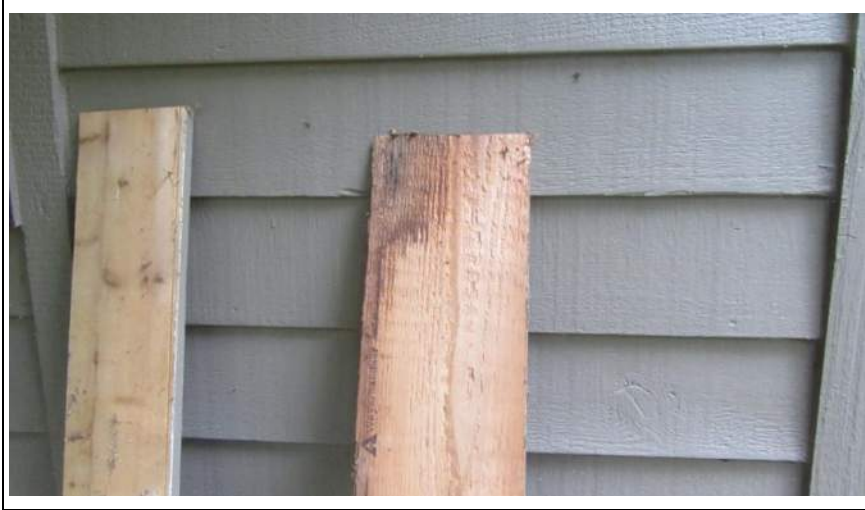
**Photo 40**

Opening 4 - Unit 85:  
Typical staining on siding.

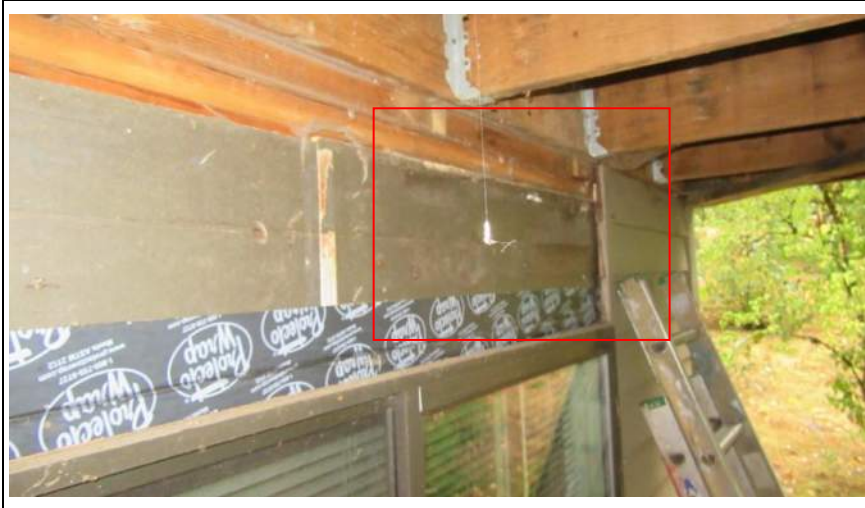
**Photo 41**

Opening 4 - Unit 85:  
Weather barrier is not provided. The  
window is sealed directly to the  
sheathing.  
Visible water staining on the gypsum  
sheathing.

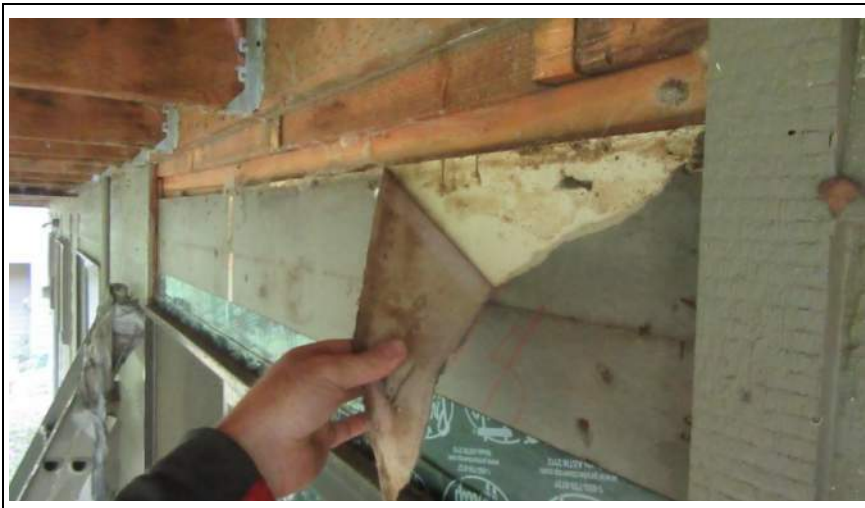
**Photo 42**

Opening 4 - Unit 85:  
Gypsum sheathing has failed due to  
exposure to water.

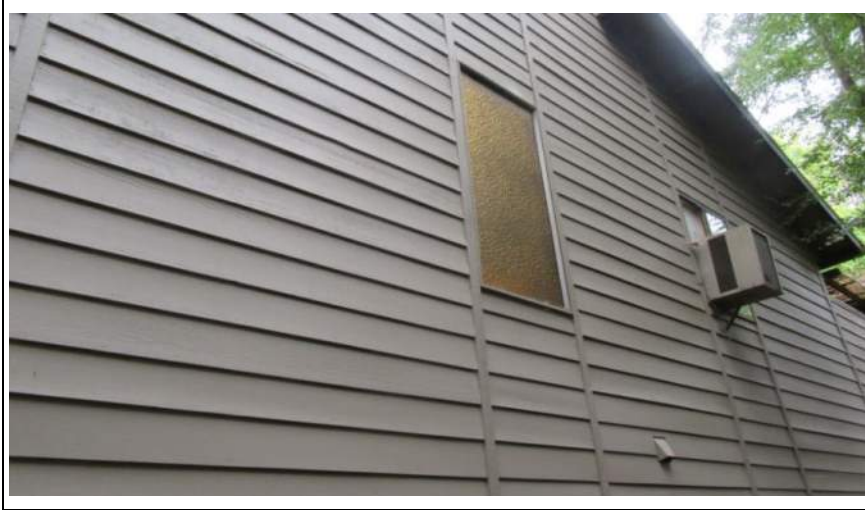
**Photo 43**

Opening 5 - Unit 81:  
Siding removed below original  
aluminum window.

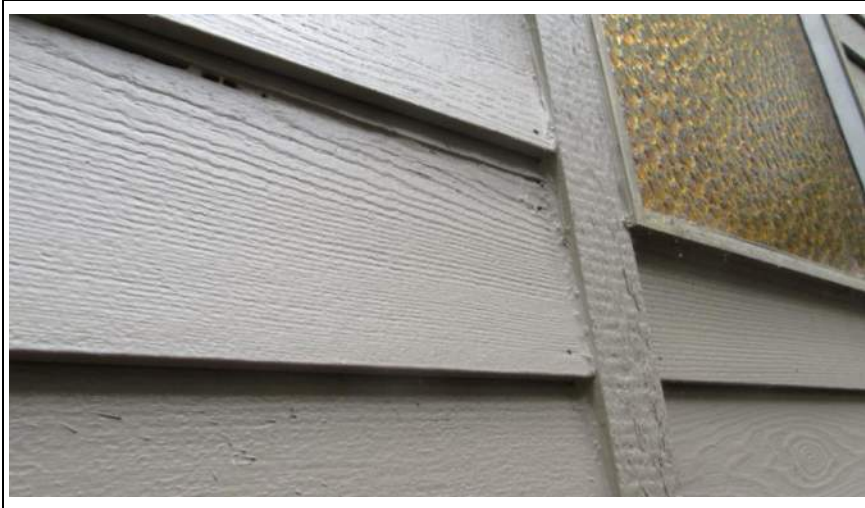
**Photo 44**

Opening 5 - Unit 81:  
Visible damaged siding adjacent to  
window.

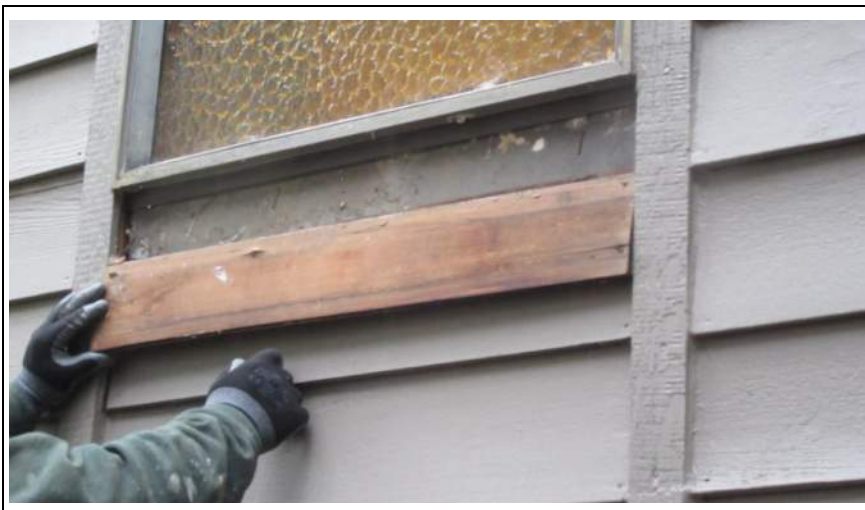
**Photo 45**

Opening 5 - Unit 81:  
Typical water staining behind siding.

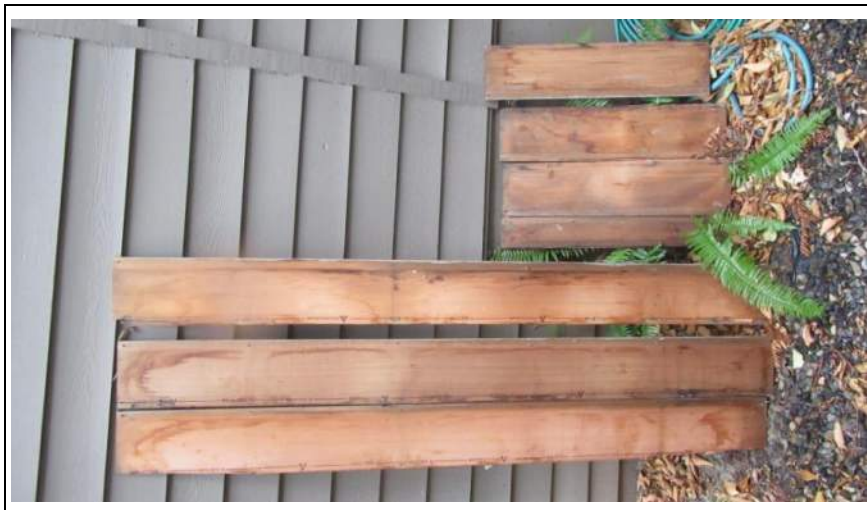
**Photo 47**

Typical water staining on the back side of the siding. Tannins have leached out of the siding due to prolonged water exposure.

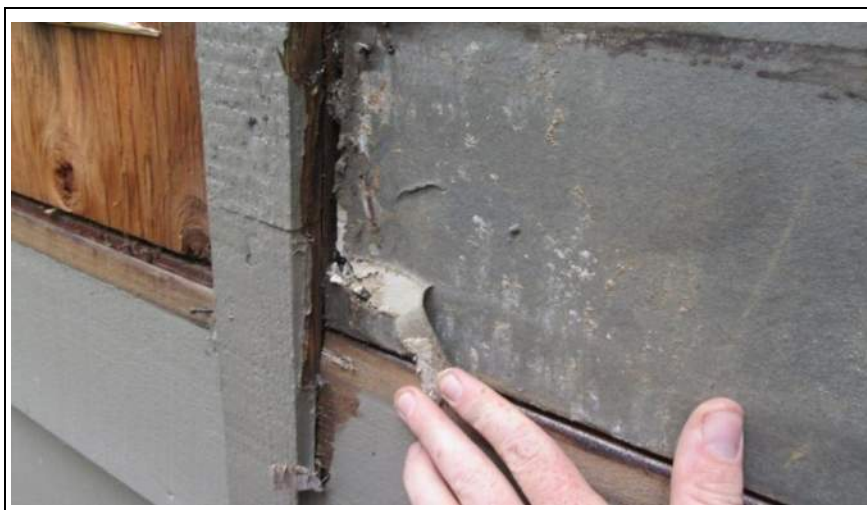
**Photo 48**

Organic growth and damaged gypsum sheathing.

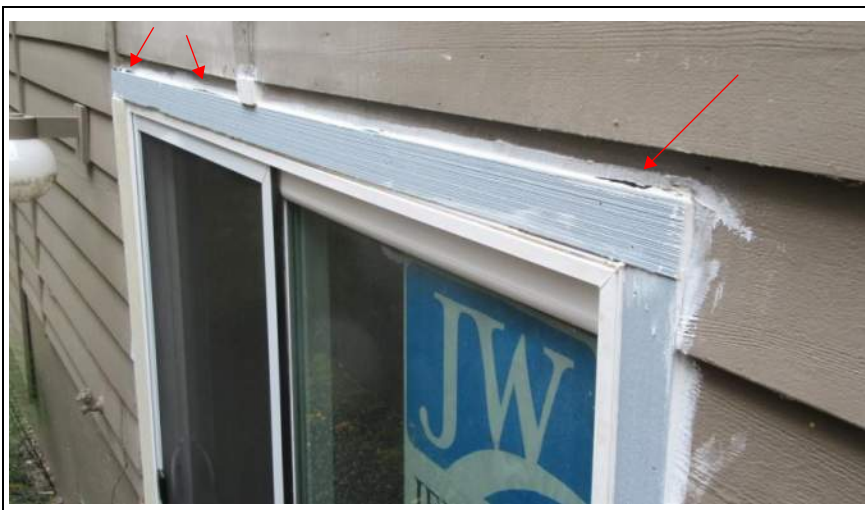
**Photo 54**

Opening 6 - Unit 77:  
Open voids in the cladding due to  
omitted head flashing and poor  
sealant application.

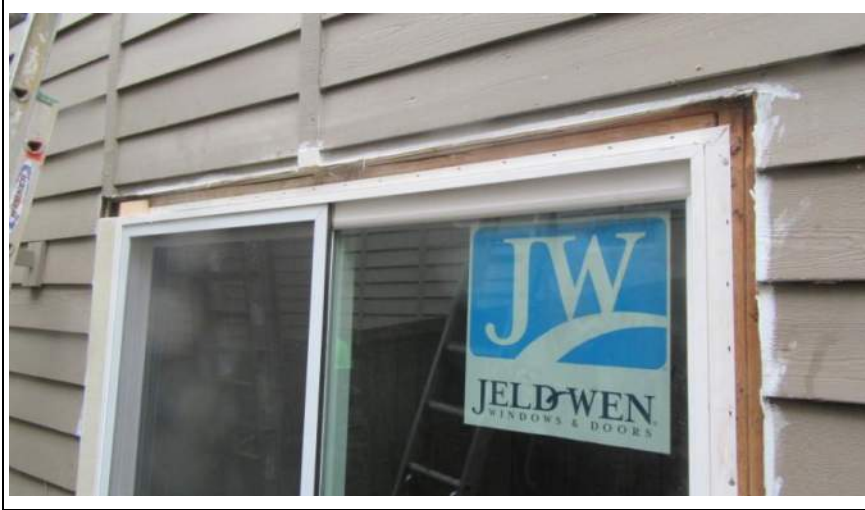
**Photo 55**

Opening 6 - Unit 77:  
Slider was not flashed in the rough opening.

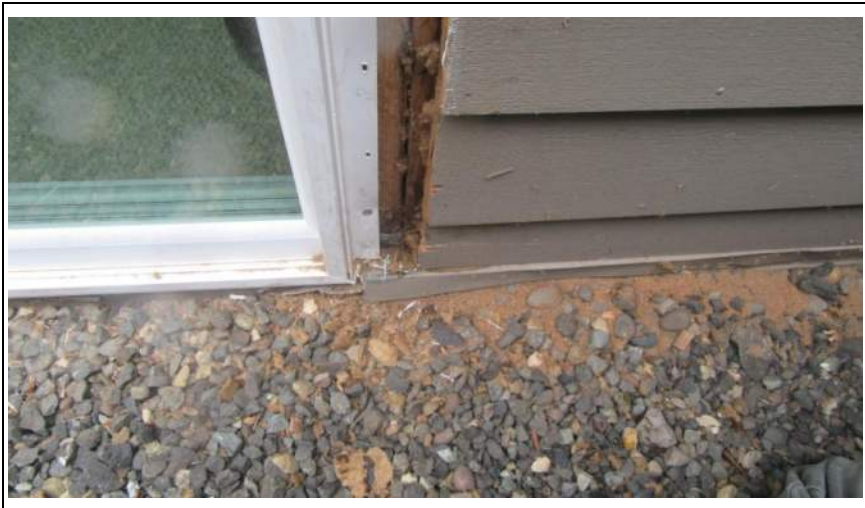
**Photo 56**

Opening 6 - Unit 77:  
Water staining on wood framing was observed at the base of wall.

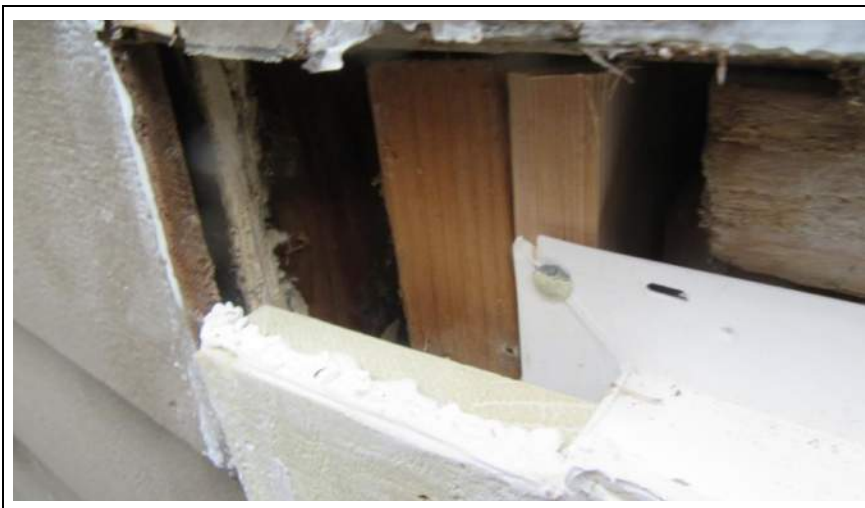
**Photo 57**

Opening 6 - Unit 77:  
Sheathing was removed and not replaced behind the sliding door.  
The sliding door was not properly fastened to the stud framing.

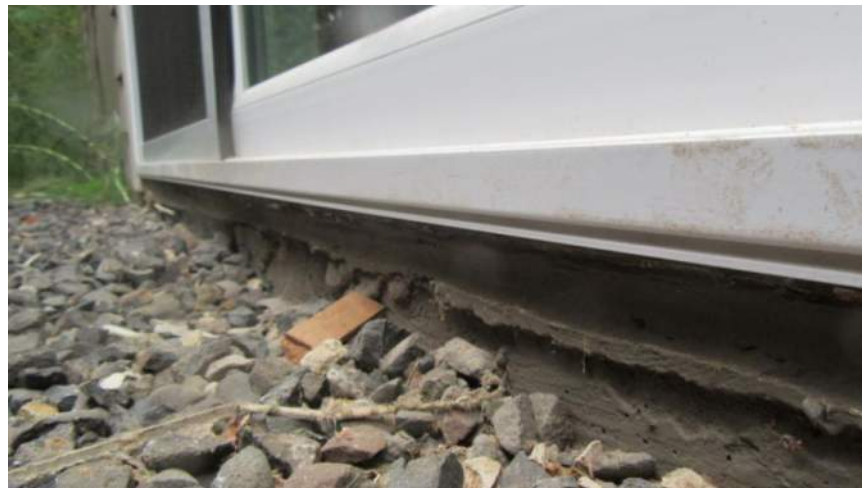
**Photo 58**

Opening 6 - Unit 77:

The sliding door sits directly on the threshold and is not flashed to prevent water ingress.

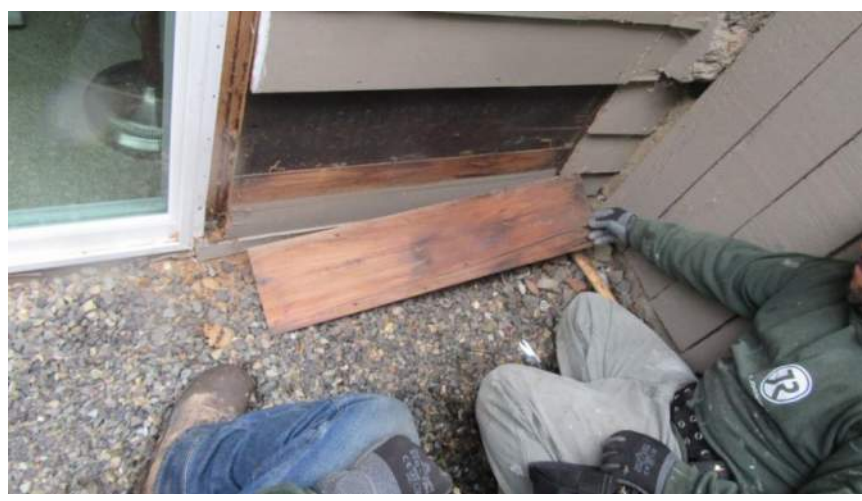
**Photo 59**

Opening 6 - Unit 77:

Siding adjacent to the door is water damaged.

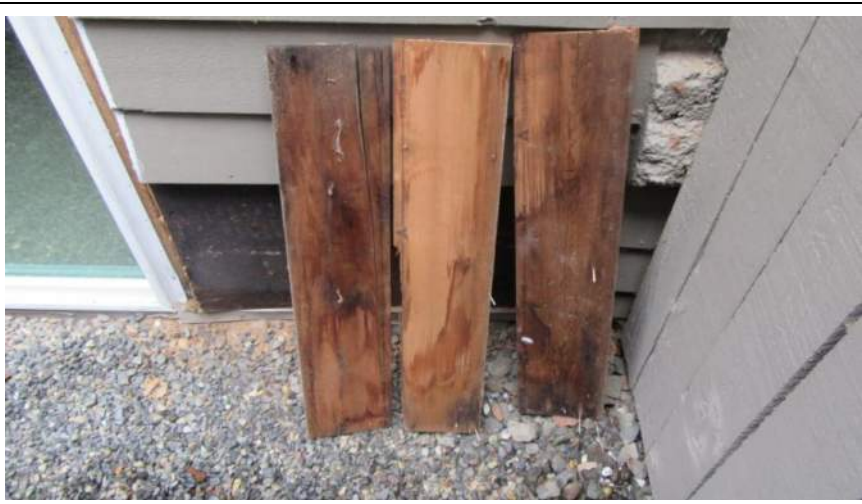
**Photo 60**

Opening 6 - Unit 77:

Water damaged siding.

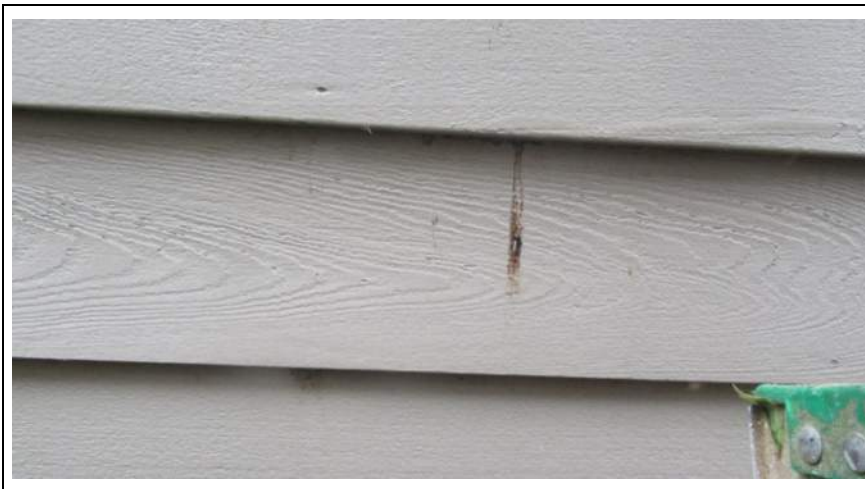
**Photo 62**

Opening 7 - Unit 77:  
Streaking was emanating from behind the cladding.

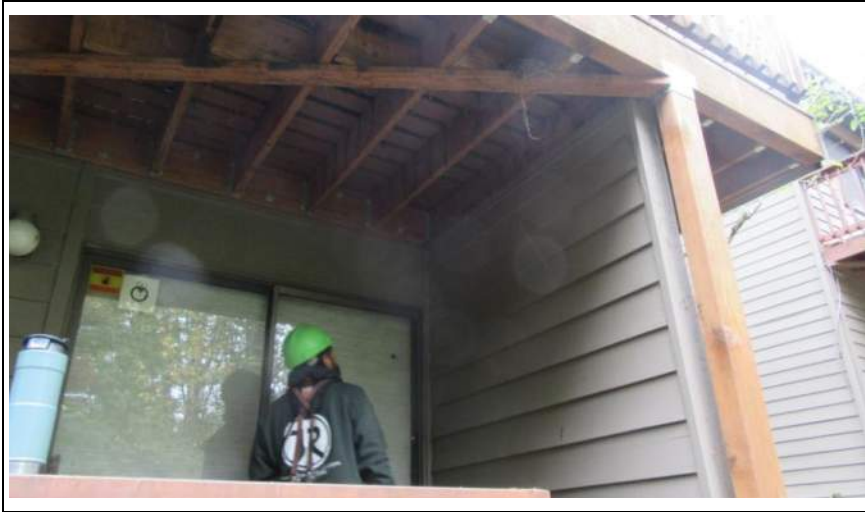
**Photo 67**

Opening 8 - Unit 81:  
Siding removed below balcony  
ledger and at top of privacy wall.

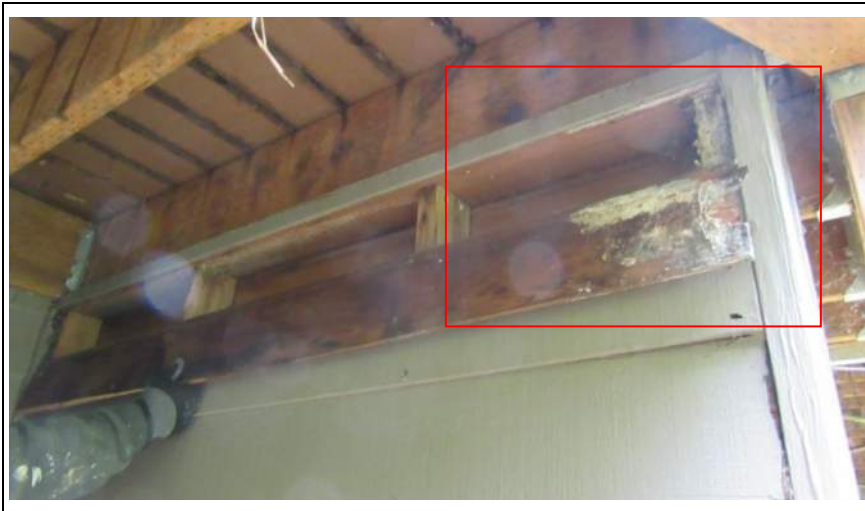
**Photo 68**

Opening 8 - Unit 81:  
At privacy wall, no sheathing is  
provided. Siding and stud framing  
are water damaged.

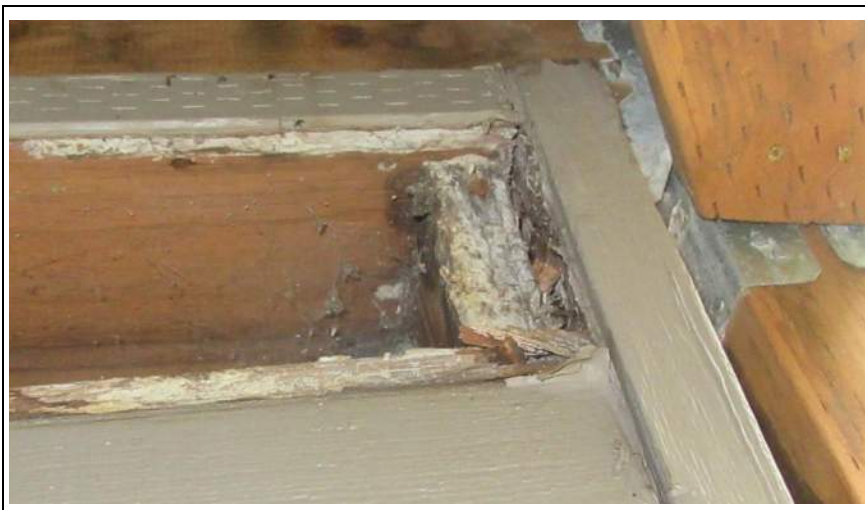
**Photo 69**

Opening 8 - Unit 81:  
Water damaged wood framing.

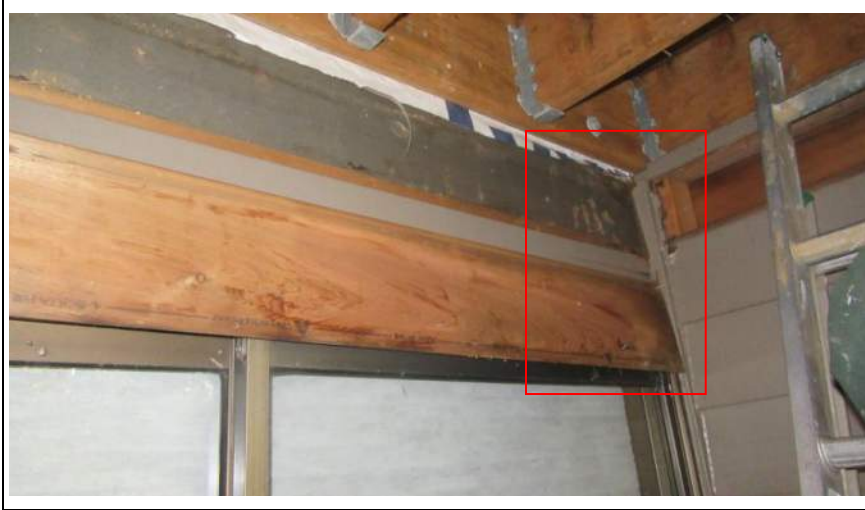
**Photo 70**

Opening 8 - Unit 81:  
Staining on the underside of the lap siding.

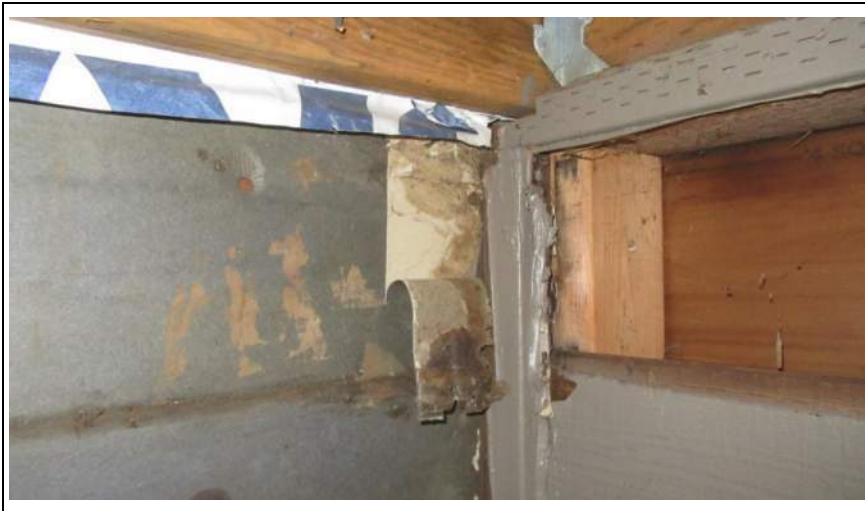
**Photo 71**

Opening 8 - Unit 81:  
Water damaged wall sheathing near the inside corner.

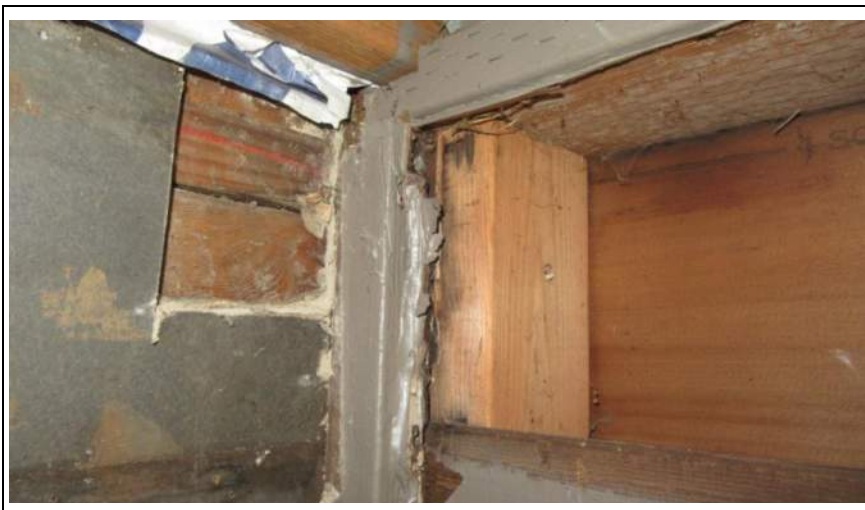
**Photo 72**

Opening 8 - Unit 81:  
Water staining on wood framing.

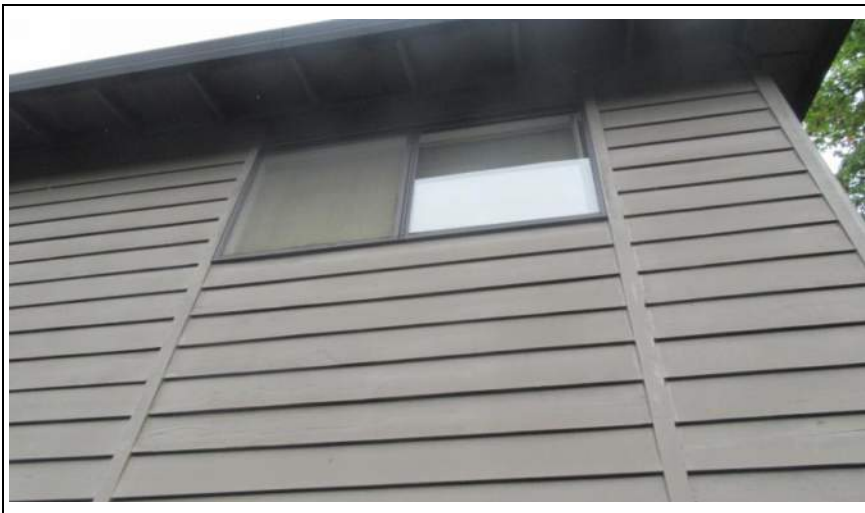
**Photo 71**

Opening 9 - Unit 89:  
Typical condition. Window installed with vertical trim at the jambs and siding applied directly above and below the window.

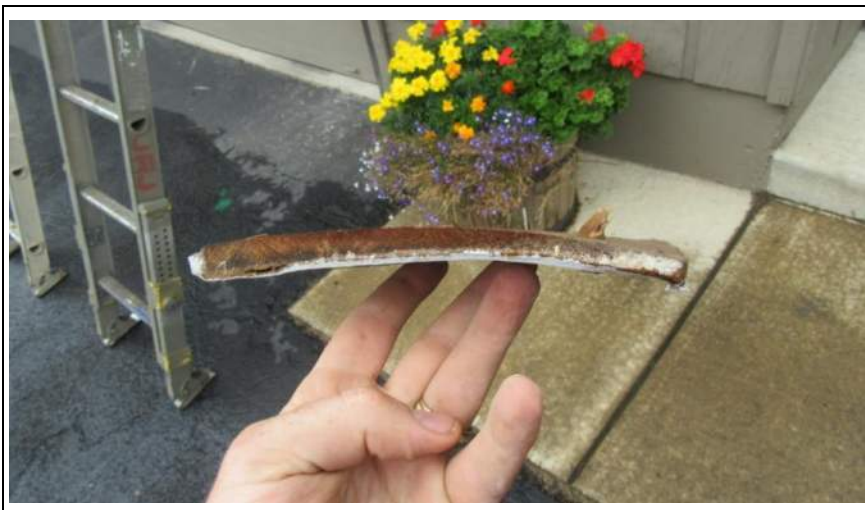
**Photo 72**

Opening 9 - Unit 89:  
Typical siding condition, siding is cupping as it nears the end of its useful life.

| Commonly Owned Component | Component Description and Comments | Component Condition | Expected Useful Life (Years) | Remaining Useful Life (Years) | Estimated Replacement Date | Component Quantity | Units |
|---|---|---|---|---|---|---|---|
| Cedar Lap Siding | Siding is at the end of its useful life. Association should begin budgeting for replacement and assume 60% of wall sheathing will require replacement. | Fair/Poor | 35 | 1 | 2018 | 48000 | SF |

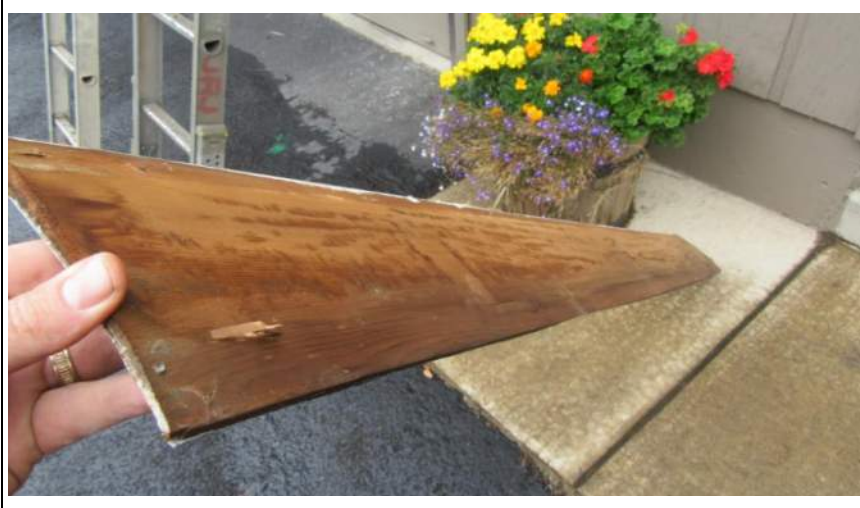
**Photo 70**

Opening 9 - Unit 89:  
Staining on the back side of the siding. Tannins are leaching out due to prolonged exposure to moisture.

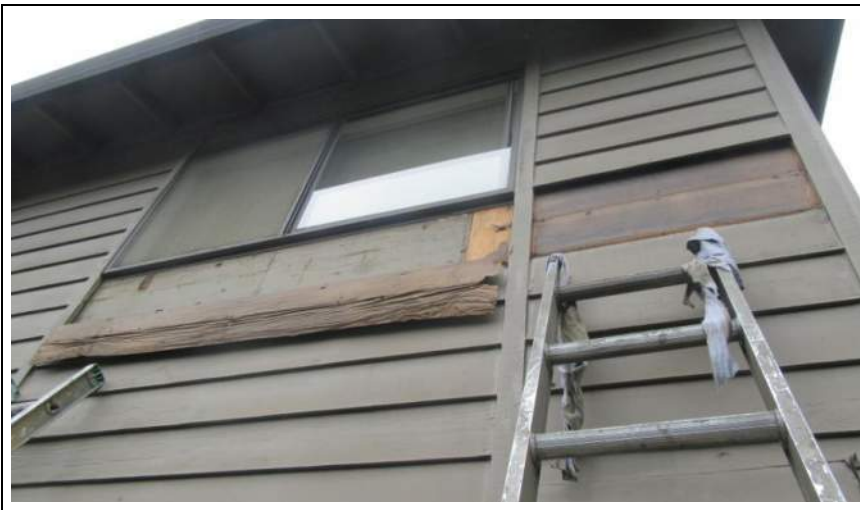
**Photo 71**

Opening 9 - Unit 89:  
Weather barrier installed below window sill but not integrated with membrane flashing at the rough opening.

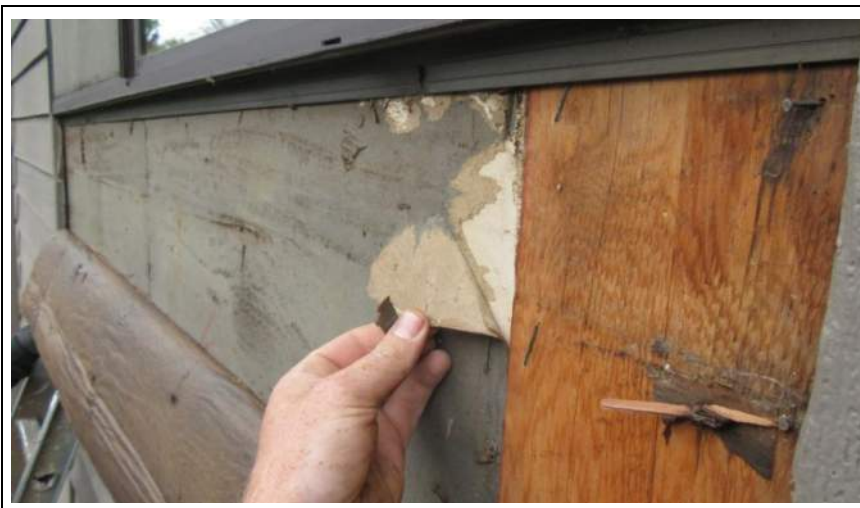
**Photo 72**

Opening 9 - Unit 89:  
The gypsum sheathing has been damaged due to wetting. Visible staining and organic growth was visible on the surface of the sheathing.

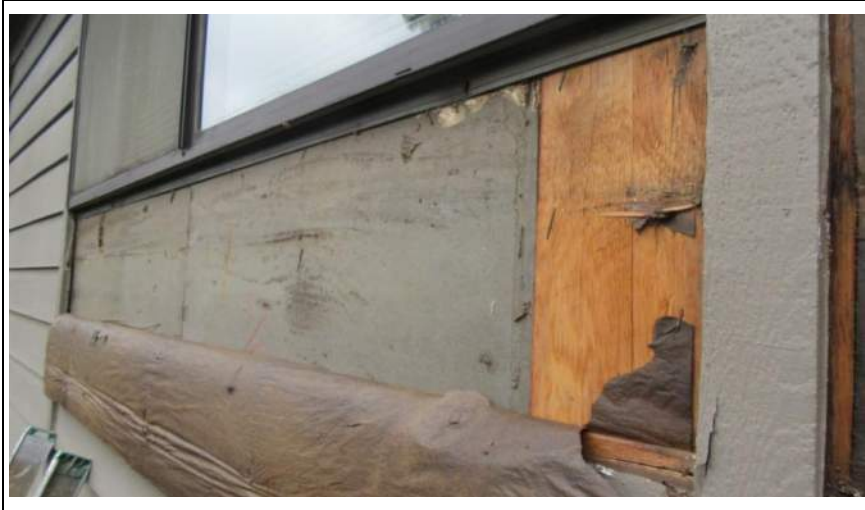
**Photo 71**

Opening 9 - Unit 89:  
Window rough opening is not  
flushed.
